# STORMWATER REPORT

**39<sup>th</sup> Street Office**  
1212 39<sup>th</sup> Avenue SW  
Puyallup, WA

Prepared for:  
Presidential Homes  
1212 39<sup>th</sup> Avenue SW  
Puyallup, WA 98373

September 21, 2021  
Revised March 9, 2022  
Our Job No. 21545

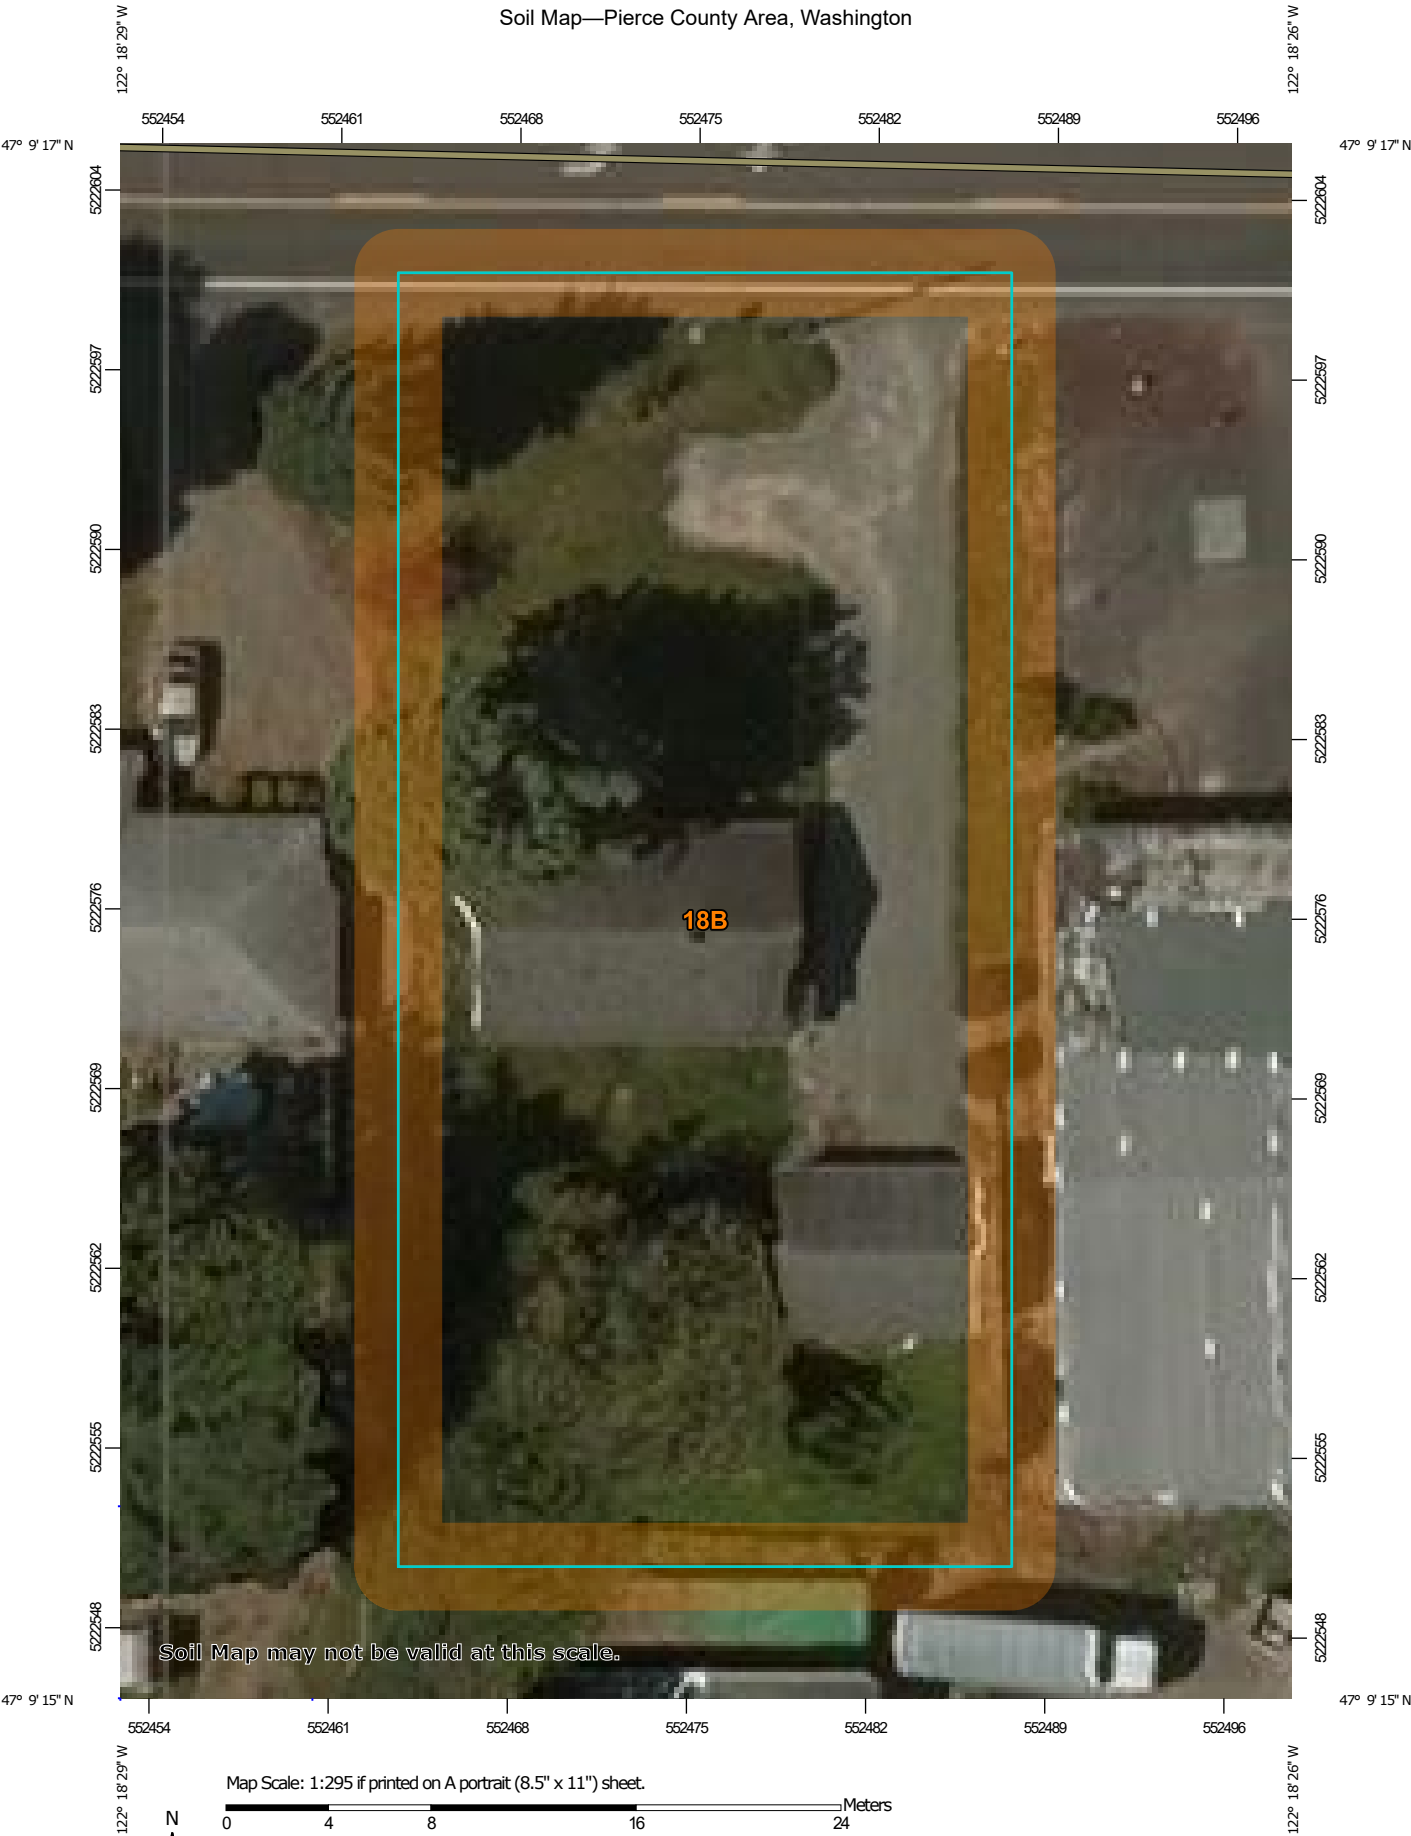
**FIGURE 2**  
**SOILS MAP**

Soil Map—Pierce County Area, Washington

Soils at the site have been mainly identified as Indianola loamy sand (18B) as determined by the National Cooperative Soil Survey of Natural Resources Conservation Service (NRCS). Indianola soils are typically derived from sandy glacial outwash, form on slopes of 0 to 5 percent, have a "slight" erosion hazard when exposed, and are include in hydrologic soils group A.

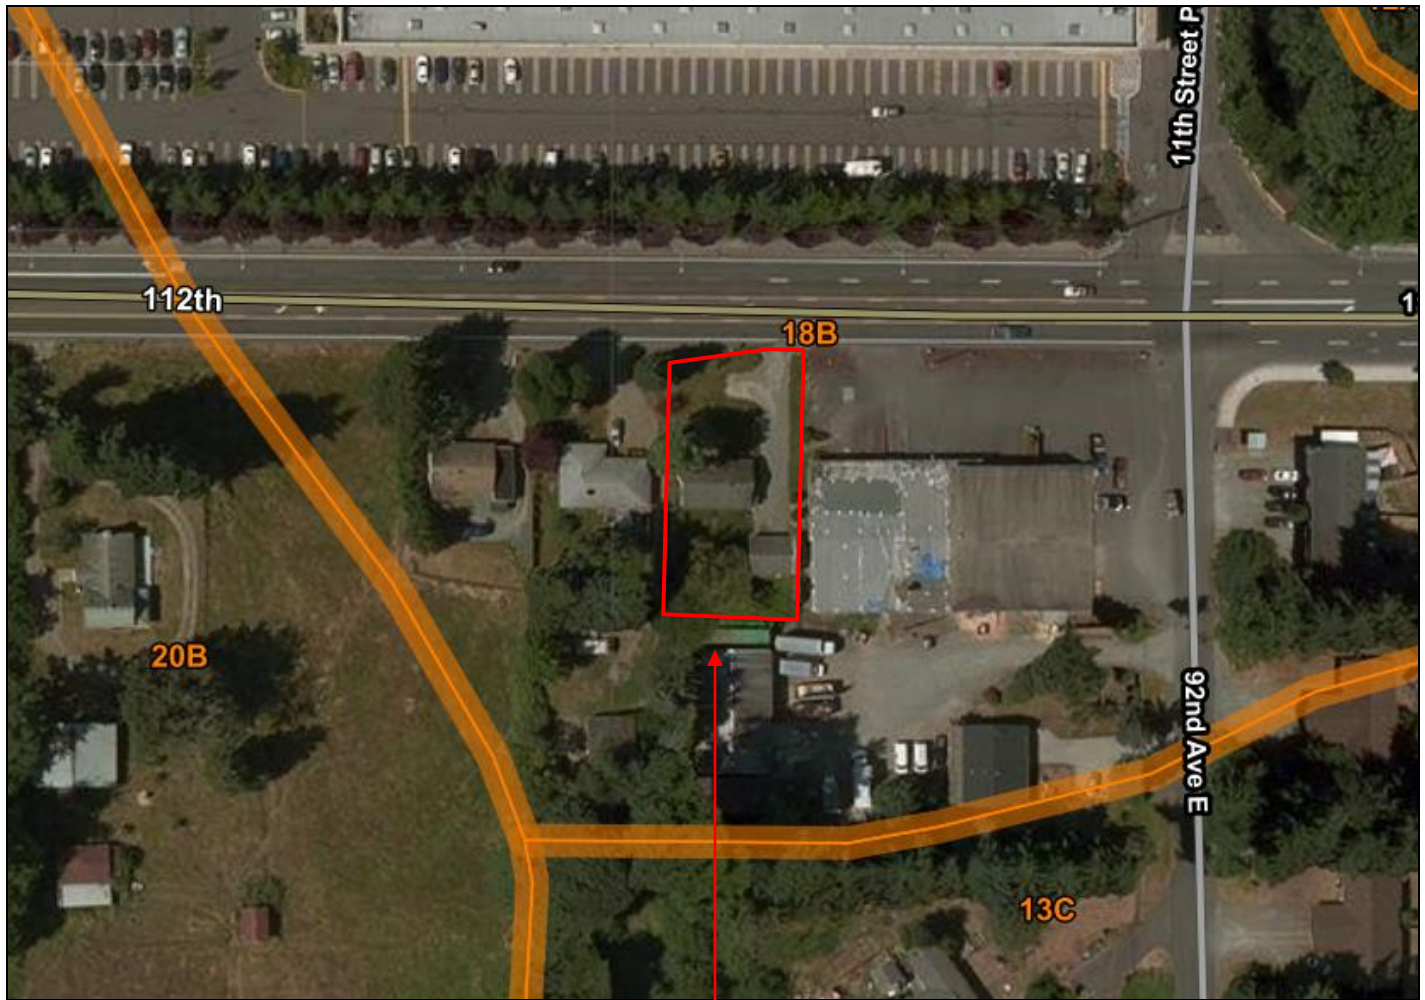
Figure 3

### NRCS Soils Map

The Natural Resources Conservation Survey (NRCS) Web Soil Survey maps the site as being underlain by Indianola loamy sand (18B). The Indianola soils are typically derived from sandy glacial outwash, form on slopes of 0 to 5 percent, have a "slight" erosion hazard when exposed, and are included in hydrologic soils group A. An NRCS soils map for the site area is included as Figure 3.
