Updated Soils Report
Proposed Restaurant
1115 & 1129 East Main
Puyallup, Washington
PN: 7845100032 & 0420271171
Doc ID: TacoTimeNorthwest.EMainSt.SRu

INTRODUCTION

This *Updated Soils Report* summarizes our site observations and geotechnical data review, and addresses the feasibility of stormwater infiltration for the proposed restaurant to be constructed at 1115 and 1129 East Main in Puyallup, Washington. The approximate site location is shown on Figure 1.

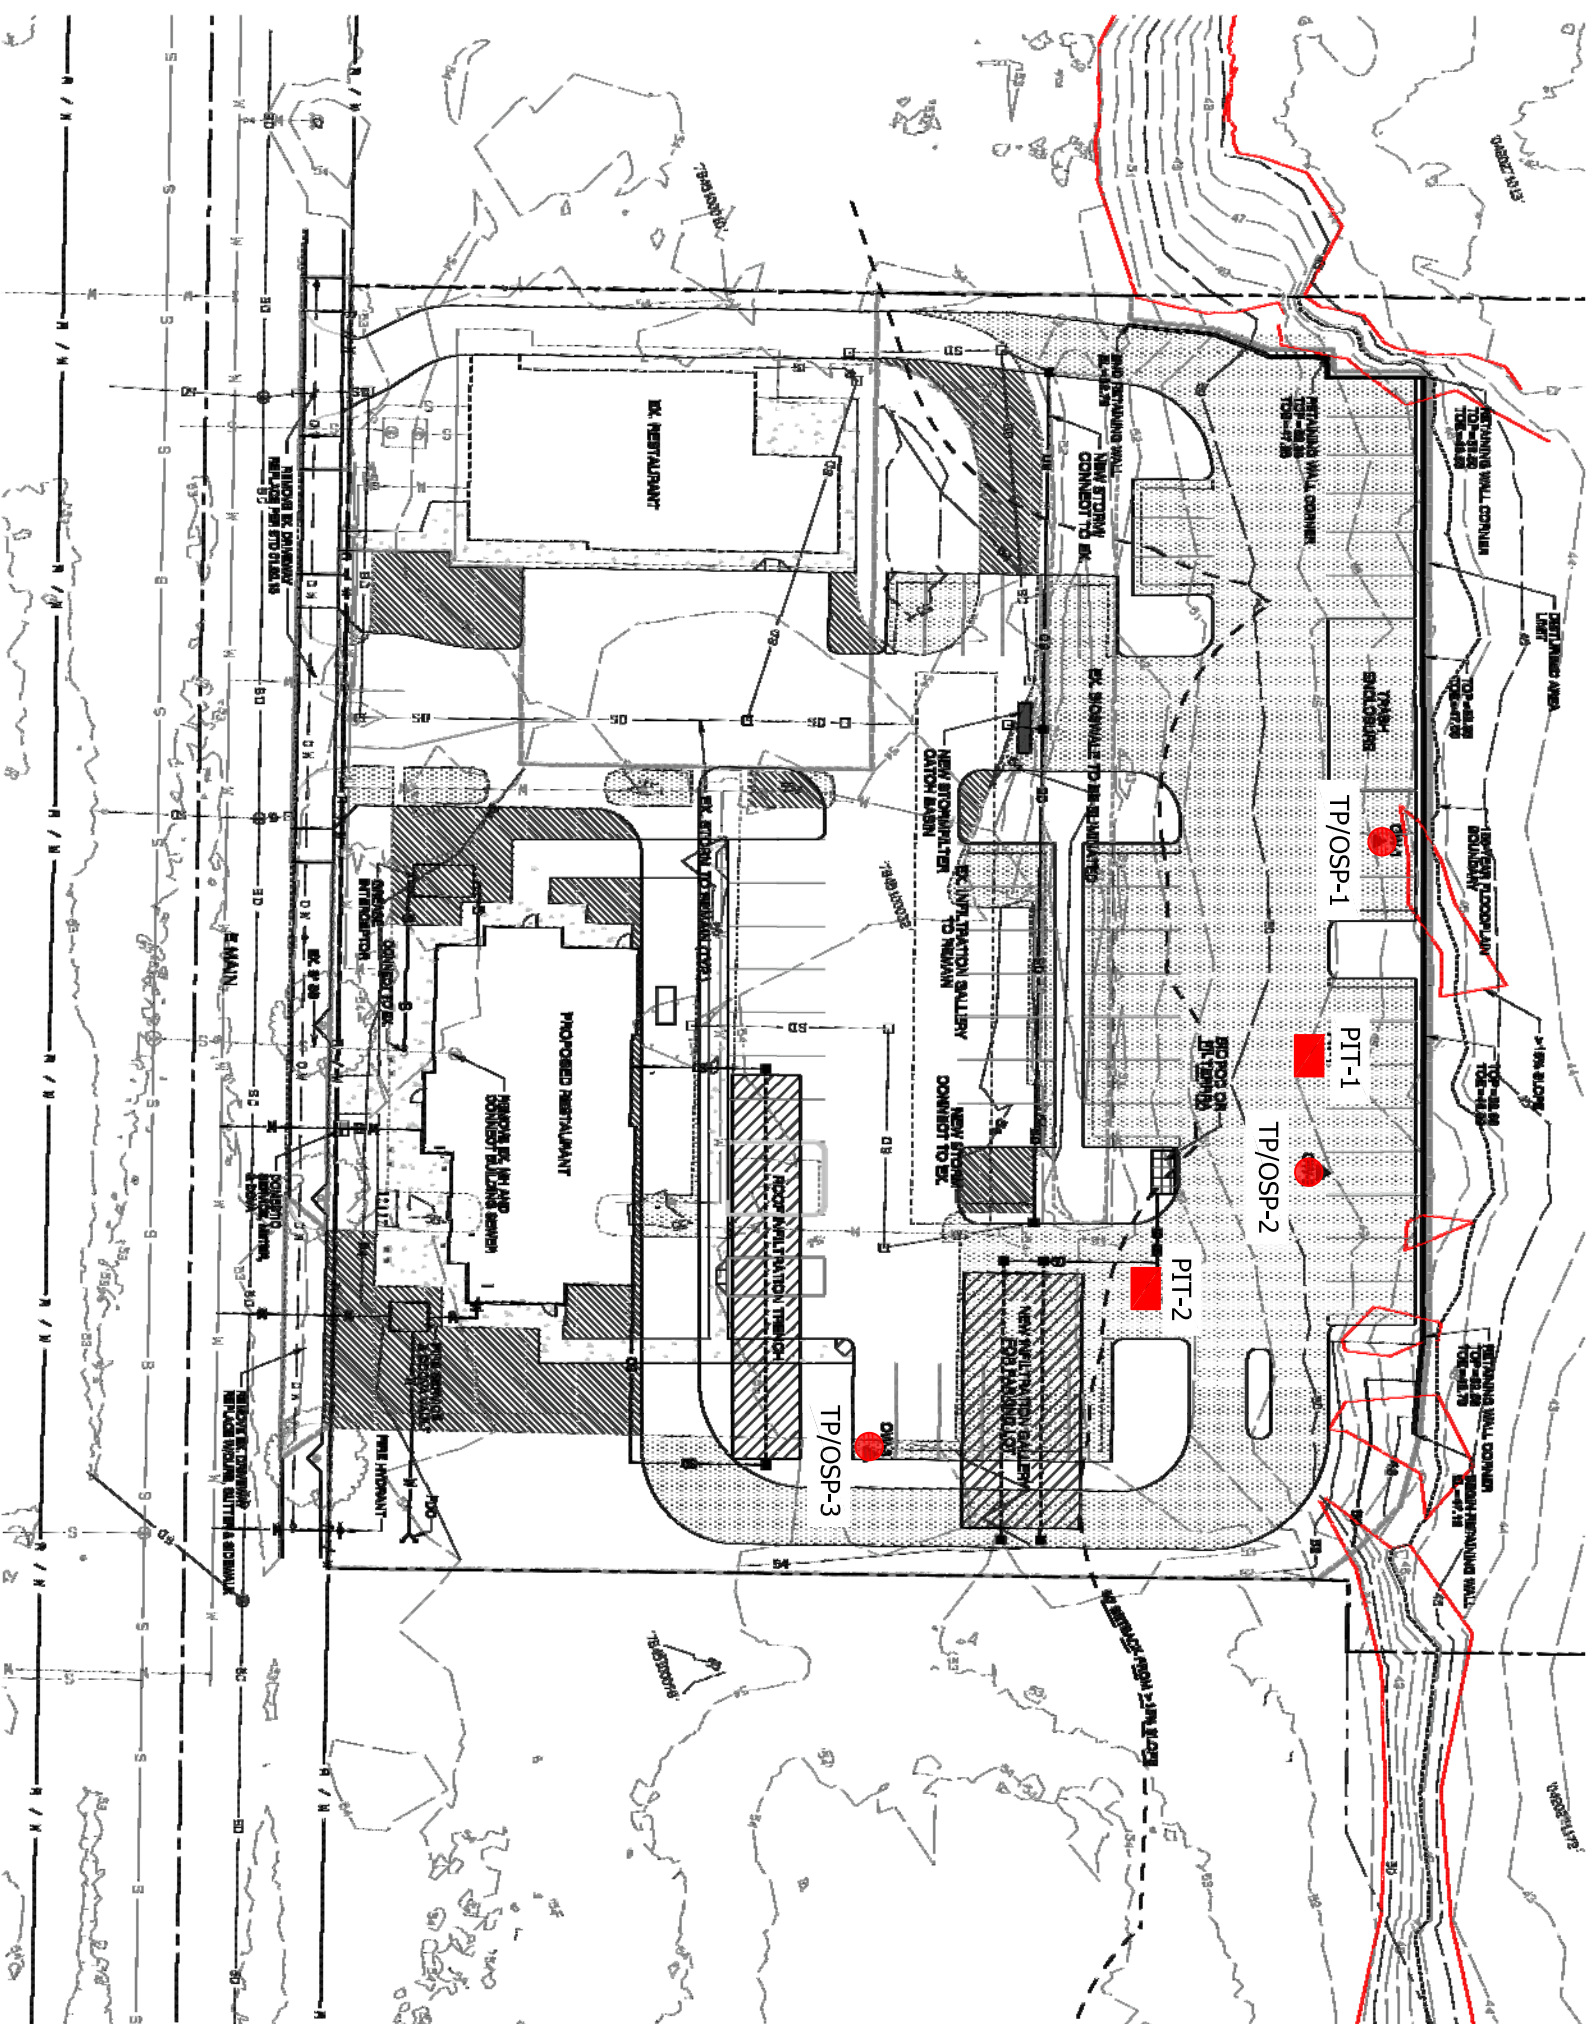
Site & Exploration Plan
 1115 & 1129 East Main
 Puyallup, Washington
 PN: 7845100032 & 0420271171

- TP/OSP - # Test Pit/ Open Standpipe Piezometer number and approximate location
- PIT - # Pilot Infiltration Test number and approximate location

Notes:
 Site plan prepared by Azure Green
 Consultants dated February 2,
 2023.

Based on topographic information obtained from Pierce County Public GIS and our site observations, the ground surface of the site generally slopes down to the north. In the southern portion of the site, in the area of the existing commercial development, the ground surface is relatively level. In the central portion of the site, the ground surface slopes down to the north at approximately 4 to 8 percent. These slopes continue at similar inclinations throughout the northern portion of the site. The total topographic relief of the site is on the order of approximately 15 feet. The existing site configuration and topography are shown on the Site & Exploration Map, Figure 2 and Site Vicinity Map, Figure 3.

indicated on the attached Site & Exploration Map, Figure 2. The USCS is included in Appendix A as Figure A-1, while the descriptive logs of our test pits and PITs are included as Figures A-2 through A-4.

We performed two small scale Pilot Infiltration Tests (PITs) in the area of the parking lot infiltration gallery (PIT-1) and the proposed roof Infiltration area (PIT-2) in accordance with the 2019 SWMMWW. The approximate location of each Small-Scale PIT is labeled on the attached Site & Exploration Plan, Figure 2.

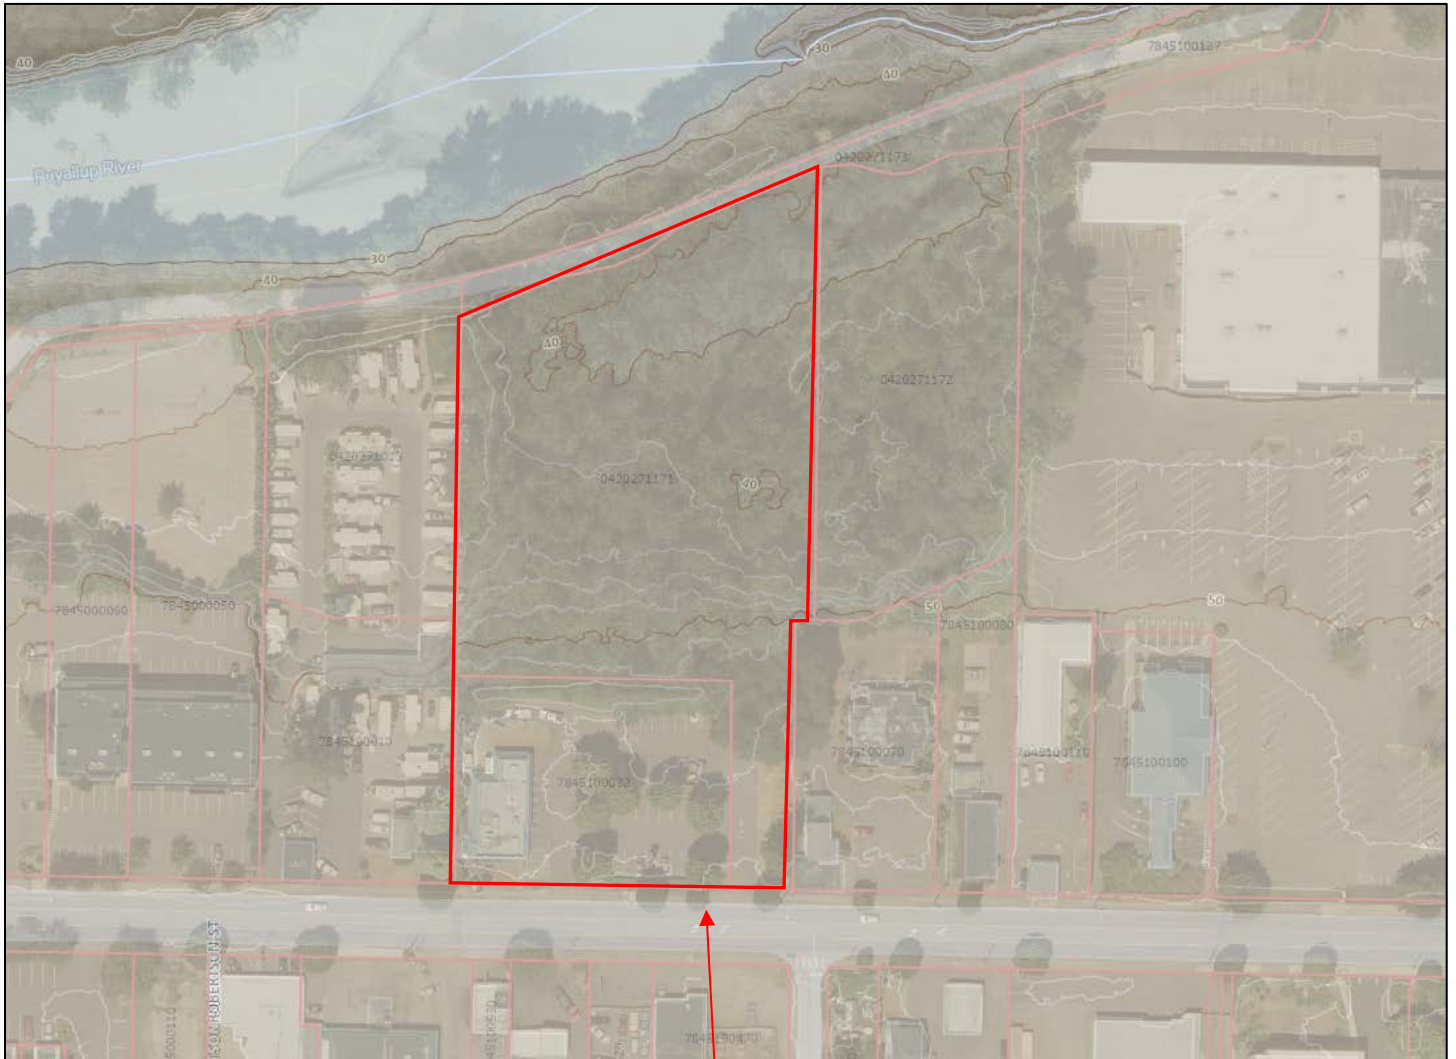
Site Vicinity Map
 Proposed Taco Time
 1115 & 1129 East Main
 Puyallup, Washington
 PN: 7845100032 & 0420271171

Approximate Site Location

Map created from Peirce County Public GIS (<https://matterhornwab.co.pierce.wa.us/publicgis/>)

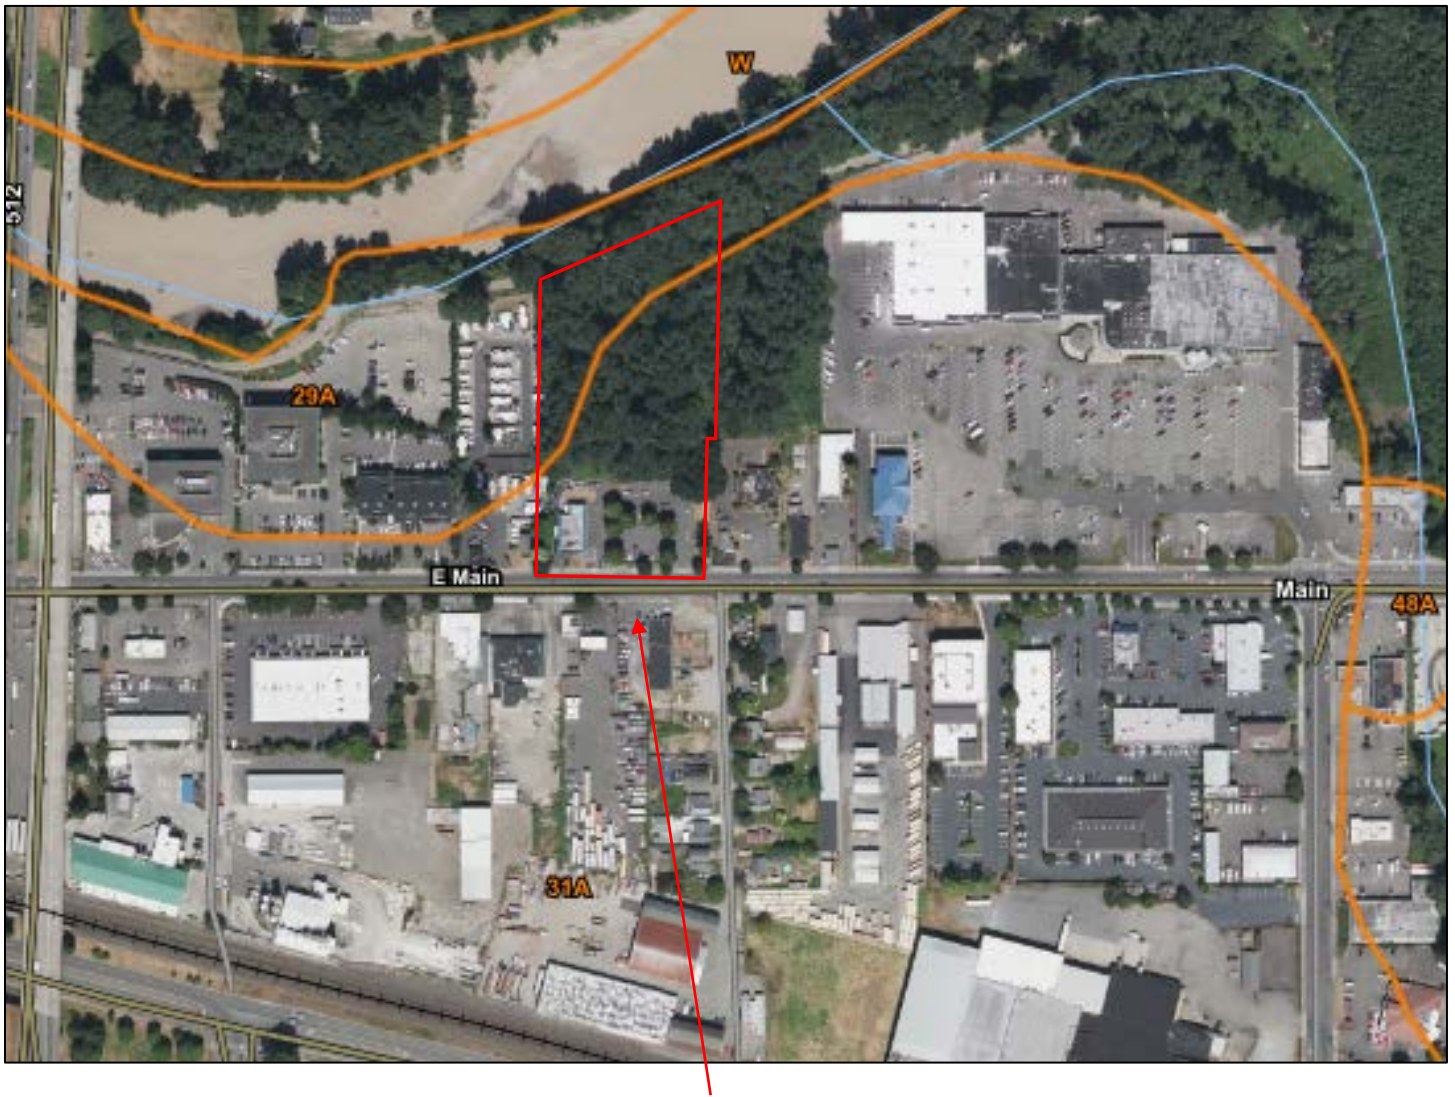
NRCS Soils Map

Map created from Web Soil Survey (<http://websoilsurvey.sc.egov.usda.gov/App/WebSoilSurvey.aspx>)

Soil Type	Soil Name	Parent Material	Slopes	Erosion Hazard	Hydrologic Soils Group
W	Water	-	-	-	-
29A	Pilchuck fine sandy loam	Mixed alluvium under hardwoods and conifers	<3	None	C
31A	Puyallup fine sandy loam	Alluvium	0 to 3	Slight	A

The Natural Resource Conservation Service (NRCS) Web Soil Survey maps the site as being underlain by Pilchuck fine sandy loam (29A) and Puyallup sandy loam (31A). Detailed descriptions of the above listed soil types are included below. A copy of the NRCS soils map is included as Figure 4.
