DRAINAGE REPORT AND STORMWATER POLLUTION PREVENTION PLAN

2401 INTER

PUYALLUP, WASHINGTON PARCEL NO. 2105200150

September, 2022

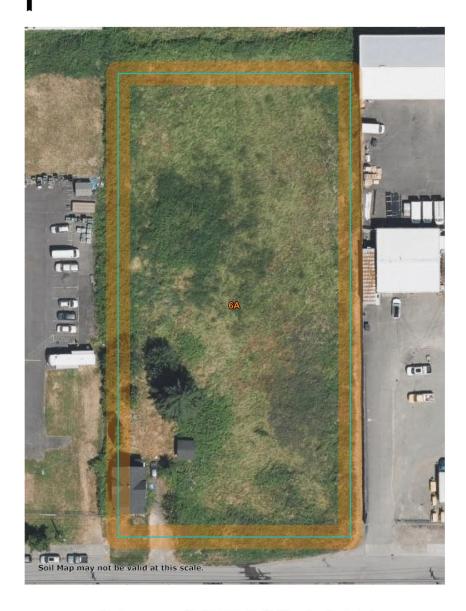
Figure 2: Site Soils

6A = BRISCOT LOAM

The USDA National Resource Conservation Service (NRCS) Web Soil Survey maps the proposed project as consisting of 100% Briscot loam (6A). According to the geotechnical report, the soil infiltrates at 0.35 in/hr, however, the groundwater was very high and therefore storm water will not be infiltrated but stored in a Stormtech Chamber and drain to the swale at the north end of the property. (see Figure 2 in Appendix A)
