VELASQUEZ PROPERTY

STORMWATER SITE PLAN

March 8, 2023

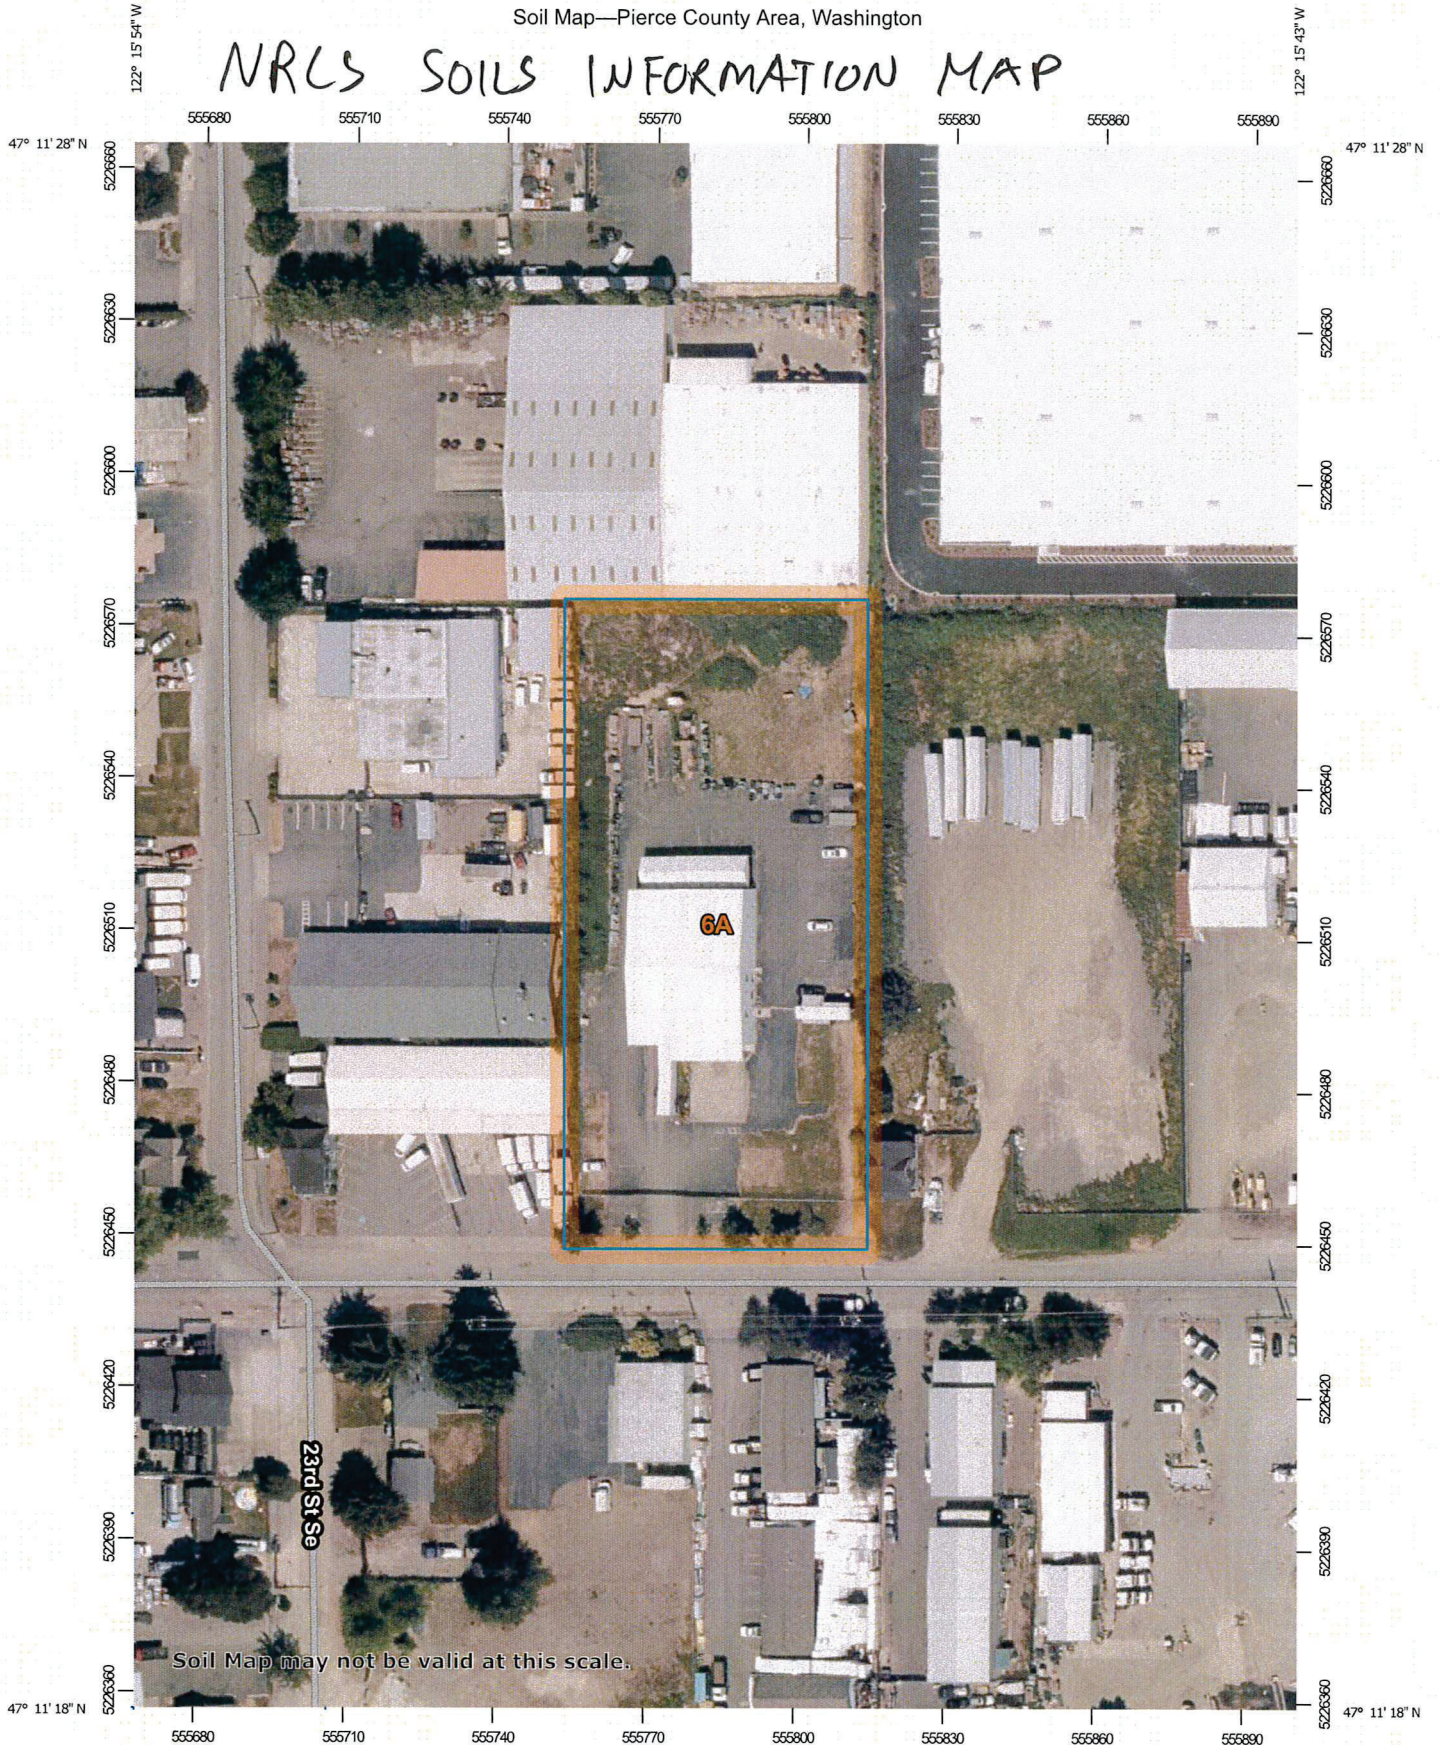
NRCS SOILS INFORMATION MAP

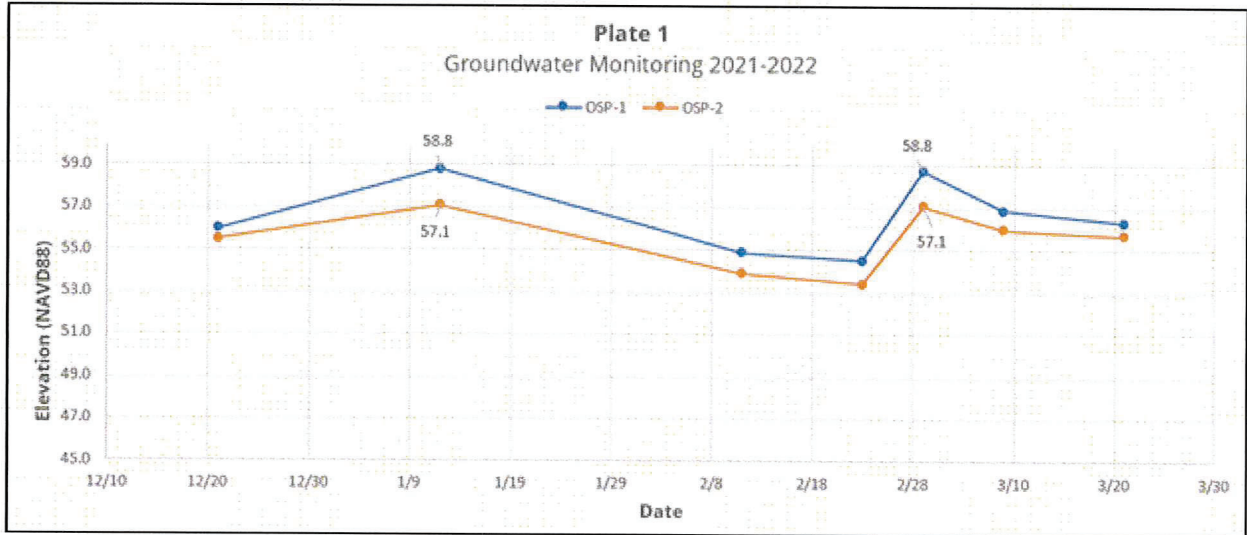
Based on our wet season monitoring, it appears that seasonal high groundwater occurs at about Elevation 59 feet (NAVD 88) at the locations monitored, approximately 1.2 feet below the ground surface. These levels were recorded on January 12, 2022 and March 1, 2022. Plate 1, below, summarizes the groundwater levels recorded as part of our groundwater monitoring program during our monitoring period.

At the time of exploration, groundwater seepage was observed at depths of 4 to 4.5 feet below existing grades. Groundwater monitoring wells were installed at the site at the time of exploration. The locations of the observation wells are shown on the Site & Exploration Plan, Figure 2. Groundwater readings for the observation wells were manually measured on a bi-monthly basis from December 21, 2021 to March 21, 2022.

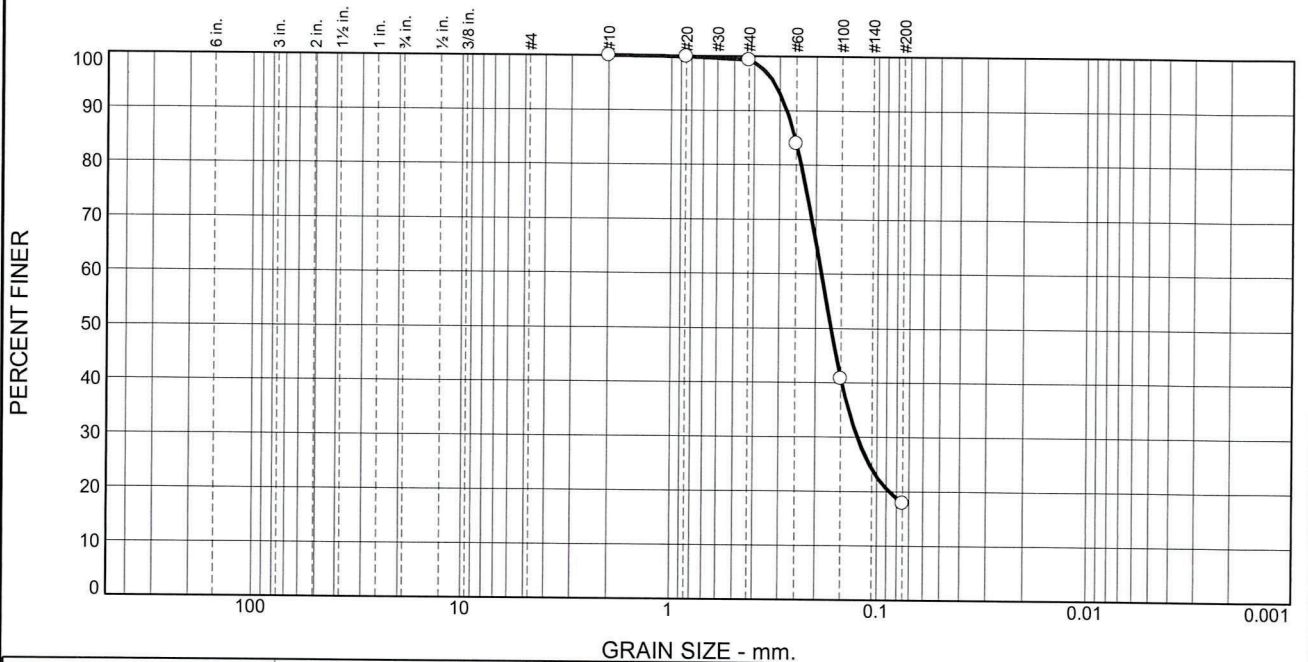
Particle Size Distribution Report

% +3"	% Gravel		% Sand			% Fines	
	Coarse	Fine	Coarse	Medium	Fine	Silt	Clay
0.0	0.0	0.0	0.0	0.7	81.4	17.9

Test Results (ASTM D 6913 & ASTM D 1140)			
Opening Size	Percent Finer	Spec.* (Percent)	Pass? (X=Fail)
#10	100.0		
#20	99.9		
#40	99.3		
#60	83.9		
#100	40.8		
#200	17.9
