Stormwater Site Plan/Report

PUYALLUP MEDICAL OFFICES

1617 S Meridian

FES Project #23062

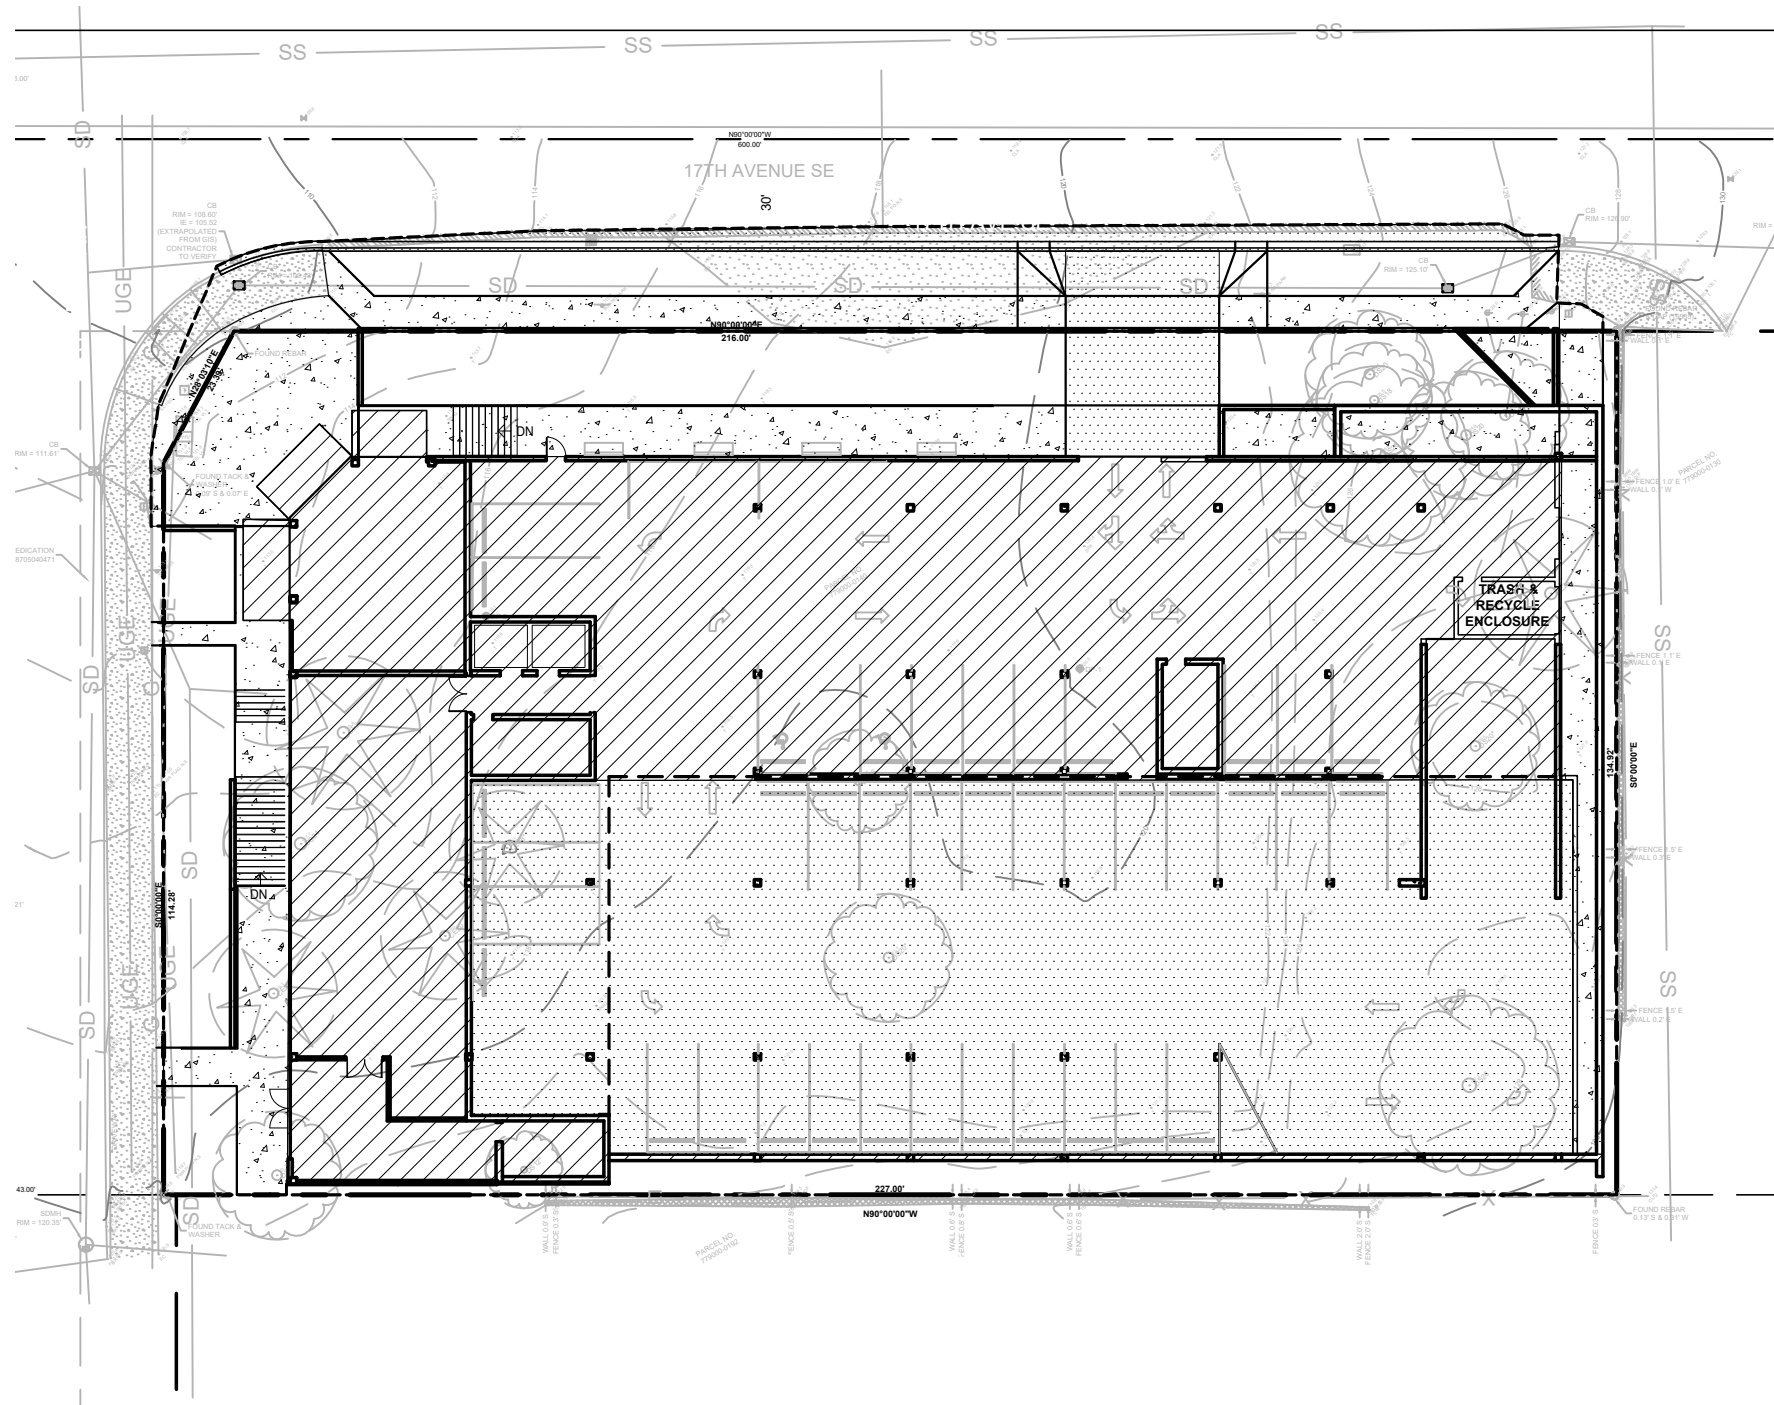
STORM ANALYSIS
PUYALLUP MEDICAL OFFICES
DEVELOPED CONDITIONS

PROPOSED ON-SITE DEVELOPED	sf	ac
PARCEL AREA	30,513	0.700
DISTURBED AREA	30,513	0.700
IMPERVIOUS	26,470	0.608
TOTAL PGHS	10,392	0.239
BUILDING ROOF	12,481	0.287
WALKWAYS	3,596	0.083
ASPHALT DRIVEWAY	471	0.011
ASPHALT PARKING (PGHS)	9,921	0.228
PERVIOUS (LS)	4,044	0.093
PROP. OFF-SITE DEVELOPMENT	sf	ac
DISTURBED AREA	3,481	0.080
IMPERVIOUS	2,088	0.048
TOTAL PGHS	1,008	0.023
ASPHALT ROADWAY/GUTTER (PGHS)	708	0.016
CONCRETE SIDEWALK	1,080	0.025
ASPHALT DRIVEWAY (PGHS)	300	0.007
PERVIOUS (LS)	1,393	0.032

The post-developed conditions for the map on page 17 state the pervious area is 0.262 acres. Revise accordingly. [drainage report, pg 17]
