Subject: Geotechnical Addendum – Response to Comments

Proposed Sunset Pointe Residential Development

2301 – 23rd Street Southeast

Puyallup, Washington

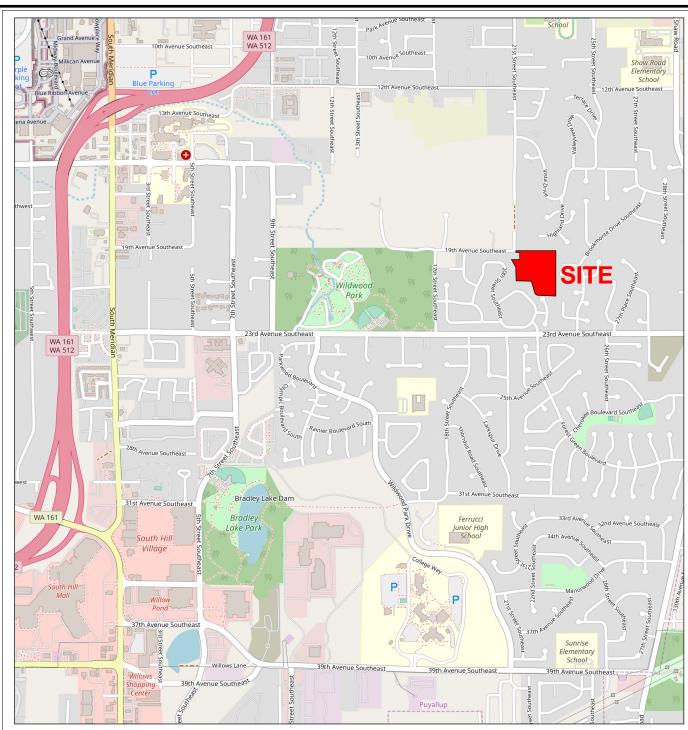
Drwn. CAM	Date 02/21/2020	Proj. No.	5559.03
Checked CGH	Date Feb. 2020	Plate	1

Reference: Pierce County, Washington OpenStreetMap.org

The site consists of one tax parcel (Pierce County Parcel No. 0420353027) totaling about 9.09 acres. The approximate site location is depicted on Plate 1 (Vicinity Map). Overall site topography consists of a central low area that trends roughly north to south, which likely represents a former, post-glacial drainage channel or similar geomorphological feature. We understand the project is pursing construction of a residential plat that will consist of 18 home building sites and infrastructure improvements. The lots will be located within the topographically higher areas, where gradients are gentler. Infiltration is considered infeasible from a geotechnical standpoint based on the conditions encountered during our various subsurface explorations and recent insitu infiltration testing, and therefore, will not be pursued. As such, detention and targeted dispersion will likely be pursued for stormwater management.

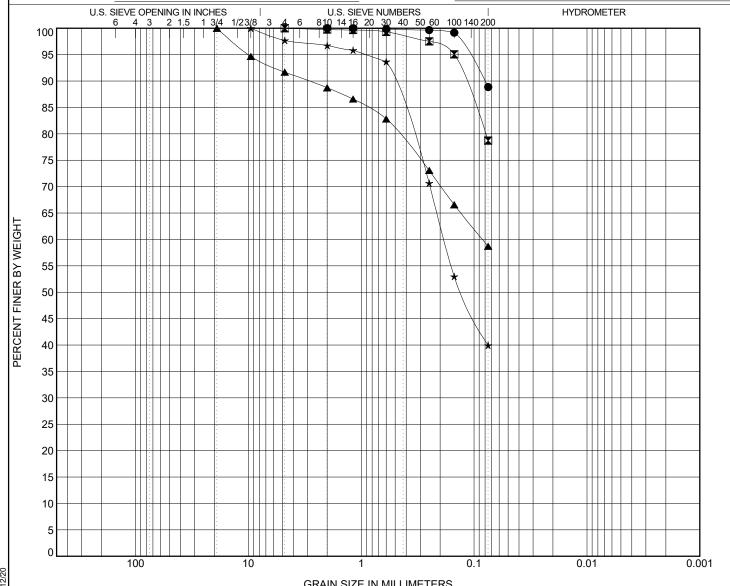
GRAIN SIZE DISTRIBUTION

GRAIN SIZE IN MILLIMETERS

COBBLES	GRA	VEL		SAND)	SILT OR CLAY
COBBLES	coarse	fine	coarse	medium	fine	SILT OR CLAY

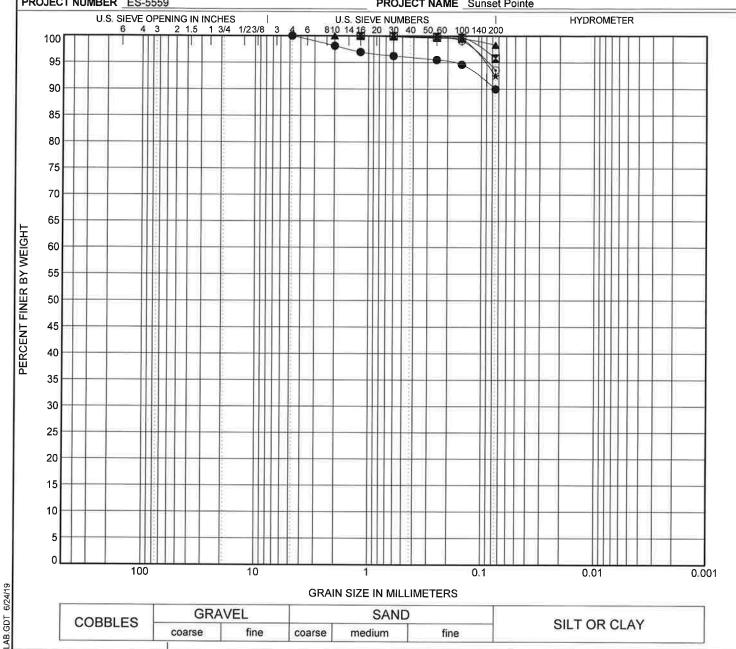
GRAIN SIZE IN MILLIMETERS

COBBLES	GRA	VEL		SAND			
COBBLES	coarse	fine	coarse	medium	fine	SILT OR CLAY

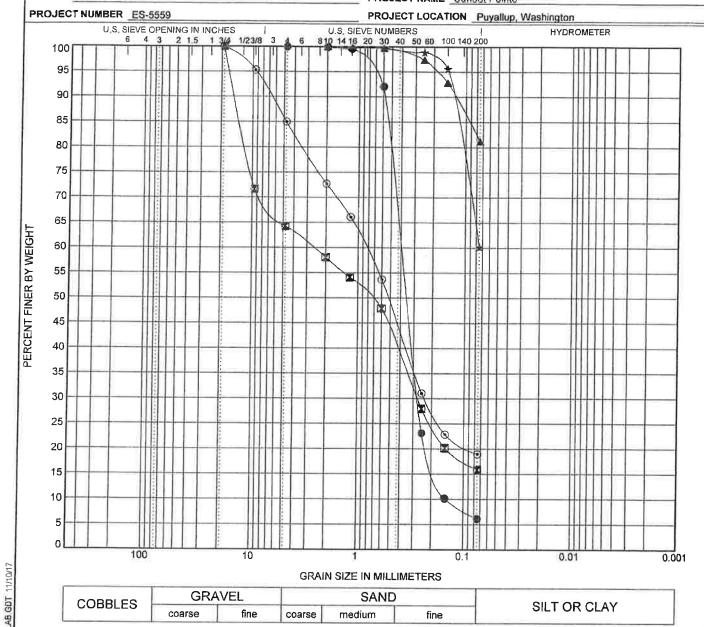
GRAIN SIZE IN MILLIMETERS

COBBLES	GRA	VEL		SAND		CILT OD CLAY
COBBLES	coarse	fine	coarse	medium	fine	SILT OR CLAY
