## **Preliminary Drainage Report**

**For the Dos Lagos Lot 'C'  
Parcel Number: 0419106030  
4202 5<sup>th</sup> St SE  
Puyallup, Washington**

**April 2021  
Job No: 12896**

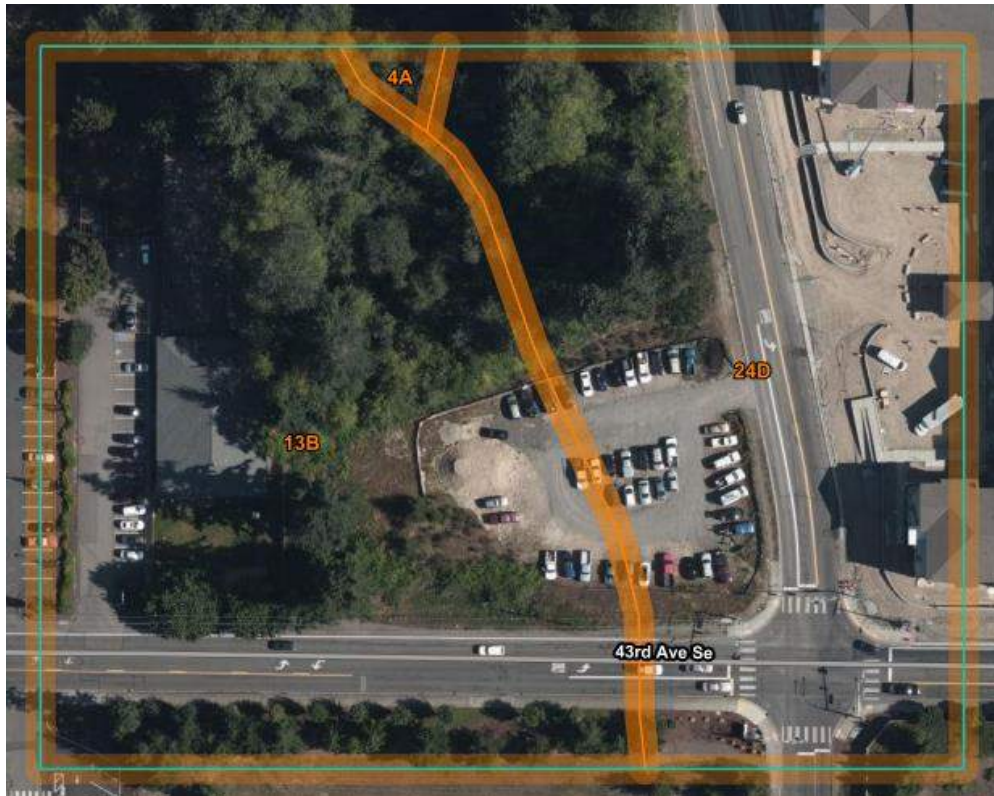
**Figure 3: Site Position in NRCS soil mapping (excerpt)**

Soil mapping was conducted using the United States Department of Agriculture Natural Resources Conservation Service (NRCS, The Survey) website. The site position within the NRCS soil map is illustrated in Figure 3 below. The soil map for all properties can also be found in the geotechnical report, along with soil descriptions and soil logs, in Appendix D.

Map Unit Symbol	Map Unit Name	Acres in AOI	Percent of AOI
4A	Bellingham silty clay loam	0.0	0.8%
13B	Everett very gravelly sandy loam, 0 to 8 percent slopes	3.4	54.9%
24D	Neilton gravelly loamy sand, 8 to 25 percent slopes	2.7	44.3%
<b>Totals for Area of Interest</b>		<b>6.2</b>	<b>100.0%</b>

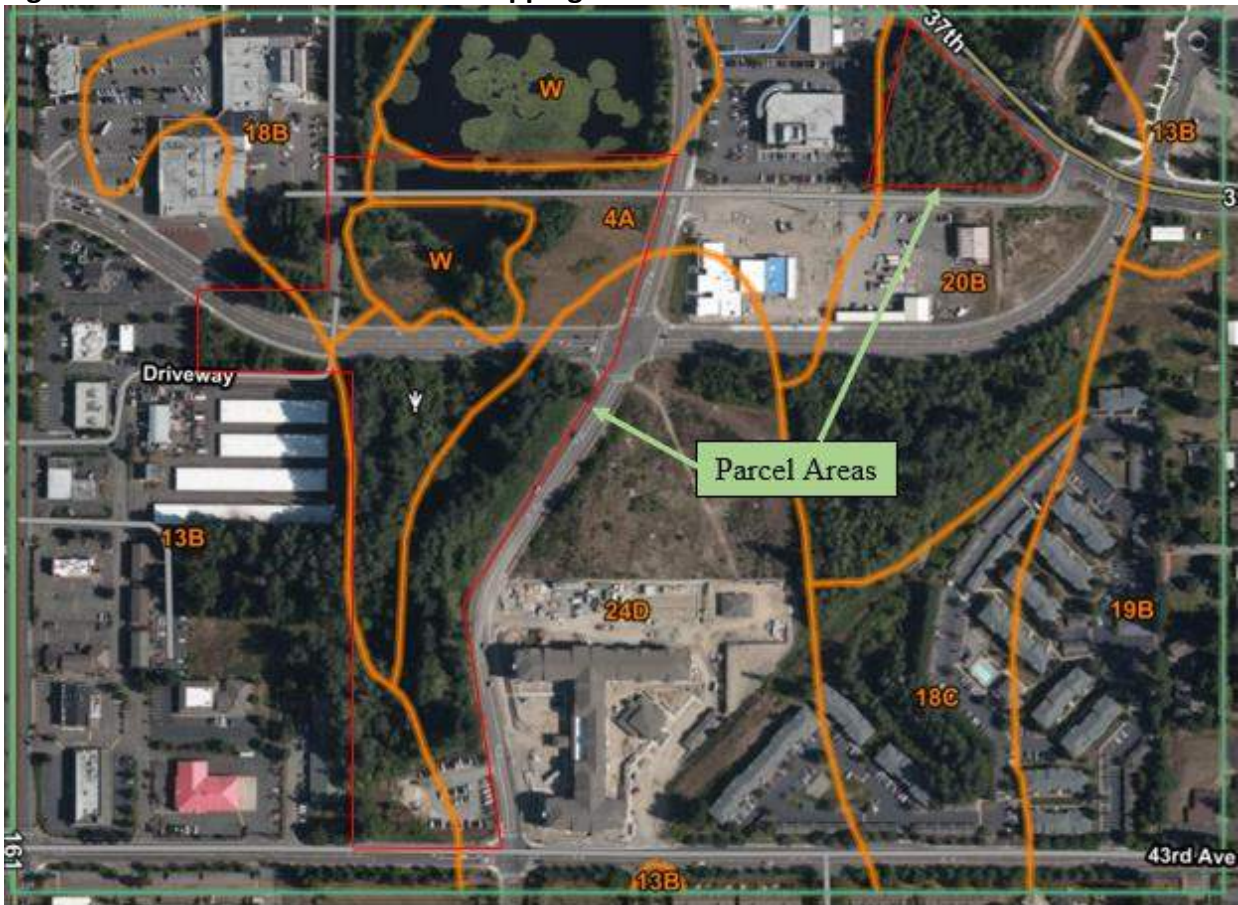
**Figure 3: Site Position in NRCS Soil Mapping**

Map Unit Symbol	Map Unit Name	Acres in AOI	Percent of AOI
4A	Bellingham silty clay loam	10.9	10.5%
13B	Everett very gravelly sandy loam, 0 to 8 percent slopes	28.3	27.3%
18B	Indianola loamy sand, 0 to 5 percent slopes	5.7	5.5%
18C	Indianola loamy sand, 5 to 15 percent slopes	6.7	6.5%
19B	Kapowsin gravelly ashy loam, 0 to 6 percent slopes	10.7	10.4%
20B	Kitsap silt loam, 2 to 8 percent slopes	13.3	12.9%
24D	Neilton gravelly loamy sand, 8 to 25 percent slopes	21.6	20.8%
W	Water	6.3	6.1%
<b>Totals for Area of Interest</b>		<b>103.5</b>	<b>100.0%</b>

As discussed in the ‘Published Information Accuracy’ section above; on-site reconnaissance is necessary to verify soil conditions on specific properties. Both the Survey and the geologic map describe materials of similar characteristics and origin. Per the Survey, the type of soil in Site B is Indianola loamy sand in the extreme western portion and Bellingham silty clay loam in the rest of the site; Site C is Everett very gravelly sandy loam; Site D is Bellingham silty clay loam in the lower, western portion, and Neilton gravelly loamy sand in the higher, eastern bench area (the soils found in the 8-10’ depths in Site D are most likely found throughout the next lowest bench elevation on the site); Site E is Everett very gravelly sandy loam in the lower, western portion, and Neilton gravelly loamy sand in the higher, eastern portion. Our in-situ examination of soil supports the Survey and USGS findings (soil log forms to be included in final report, see Appendix A for transcribed soil logs), except that much of Site B and Site E have 3-5 feet of fill with occasional debris placed on top of the native soil. Below this is the native layers described above. Site C was not examined on-site for in-situ soil properties at this time. Find individual Test Pit Soil Log descriptions in “Attachments.” Figure 3 below illustrates the site position within the soil environment.

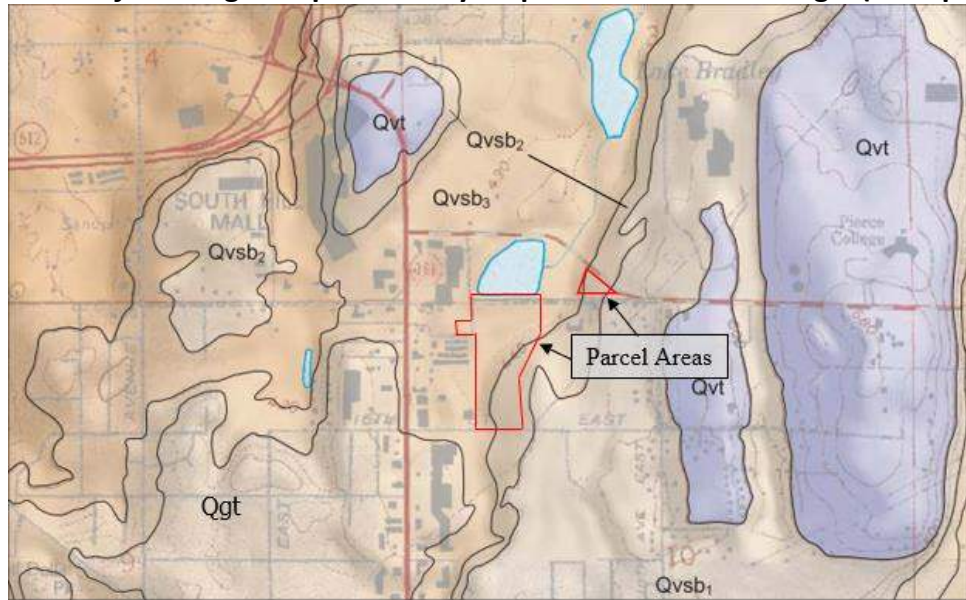
**Figure 4: USGS Draft Geologic Map of the Puyallup 7.5 Minute Quadrangle (Excerpt)**

- Qvs Steilacoom Gravel of Walters and Kimmel (1968)—Sandy gravel and cobbles; clean to silty; poorly to well sorted; horizontally to cross bedded; loose to dense. Deposits vary from veneer of <1 to 15 m ( 3 to ~ 50 ft) thick. Deposited by multiple outburst floods from subsequently lower elevations of Glacial Lake Puyallup. Locally subdivided first by channel affiliation (Clover Creek or Bradley) and secondarily by relative age in descending series of deposits; higher number denotes younger (lower) deposit. Clover Creek channel (Bretz, 1913) begins in section 8, T19N, R4E. Bradley channel; herein named for Lake Bradley in section 3, T19N, R4E; begins in section 2, T19N, R4E. Numbering system contiguous w/adjacent Tacoma South quadrangle where multiple Clover Creek deposits are mapped (Troost, 2006). Mapable deposits consist of:

- Qvs b3 Bradley deposit at elevation 420 – 440 ft
  - Qvs b2 Bradley deposit at elevation 440 – 460 ft

The property is situated on the broad deposit of glacial outburst flood deposits that occurred during and at the end of the Vashon Stade of the Fraser glaciation period. As glacial Lake Puyallup, located at the base of the Cascade Range foothills, would fill with seasonal runoff, the valley glaciers (acting as a natural dam) would repeatedly fail releasing vast amounts of water that would erode the lowland formations and subsequently deposit new sediment as floodwater abated. This local landscape still includes Kettle depressions formed by portions of ice blocks that were trapped in place. Outwash deposits surrounded the ice blocks. Figure 4 below illustrates the site position in the regional geology.

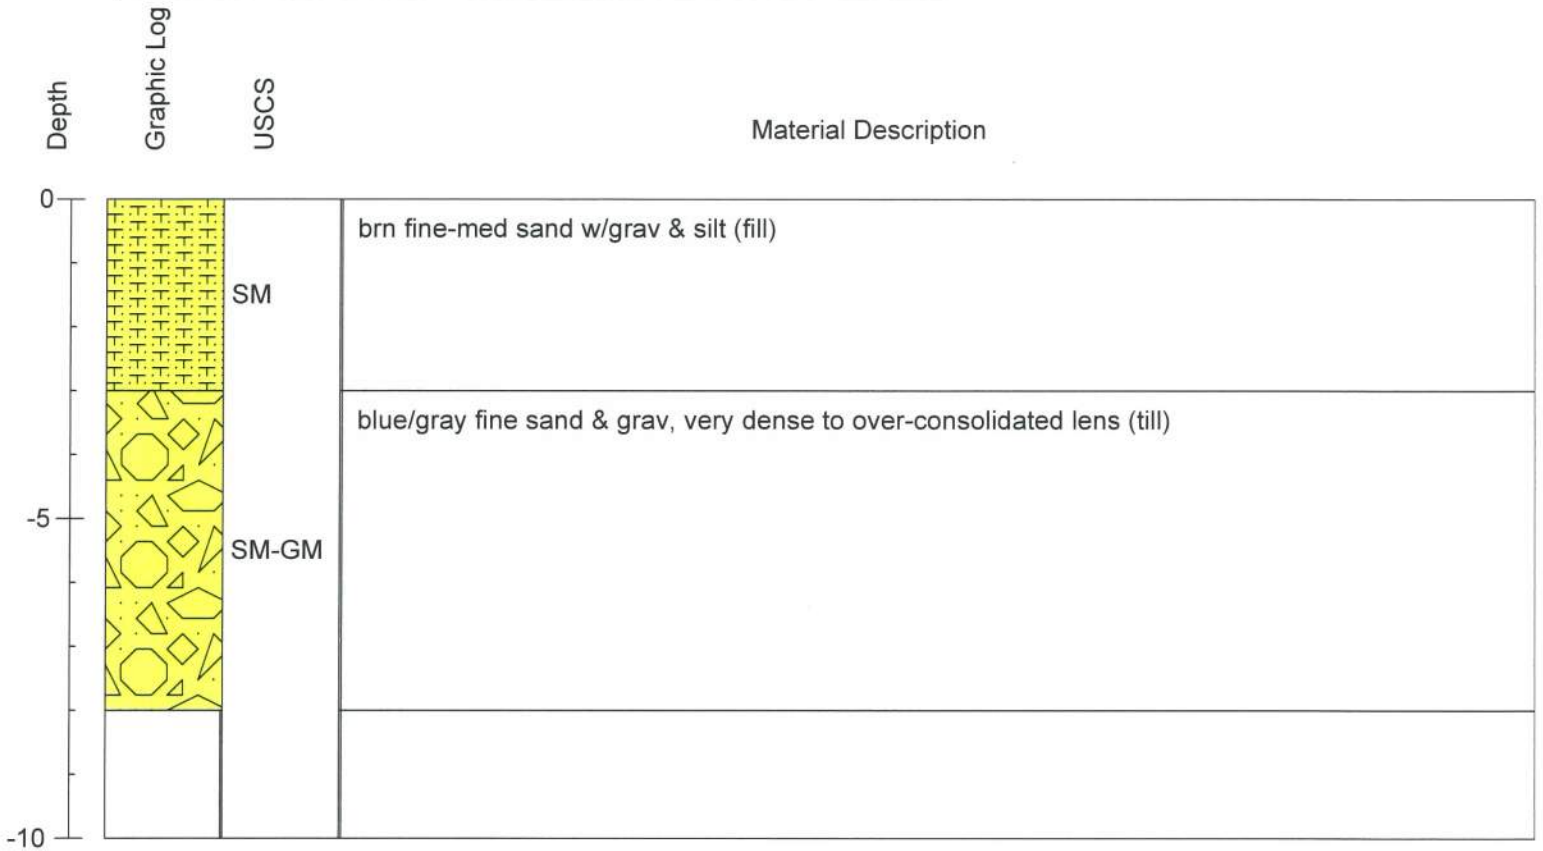
Test Pit Number: TP 2  
 Project Name: Dos Lagos  
 Ground Elevation: 440 Test Pit Size: 2x6  
 Ground Water Levels:  
 At Time of Excavation: None  
 At End of Excavation: None  
 Static Water Depth: None

Client: Dos Lagos Asset, LLC  
 Job Number: 12896  
 Date Started: 7/7/20  
 Date Completed: 7/7/20  
 Excavation Contractor: N/A  
 Excavation Method: Track Mounted Excavator  
 Logged By: JET Checked By: BC  
 Notes: Significant fill present, no organics within, preloaded condition.  
None

The depths on the test pit logs are based on an average of measurements across the test pit and should be considered accurate to +/- 0.5 ft.

Bottom of Test Pit at: 8.0 ft  
 Ground Water/Seepage: None Observed  
 Side Wall Caving: None Observed

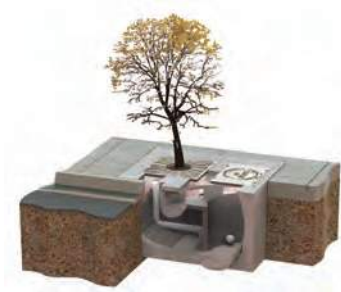
**BIPOD TREE**

Vault with media and tree(s).
