Preliminary Drainage Report

**For the Dos Lagos Lot 'E'
Parcel Number: 0419106028
405 39th Ave SE
Puyallup, Washington**

**May 2021
Job No: 12896**

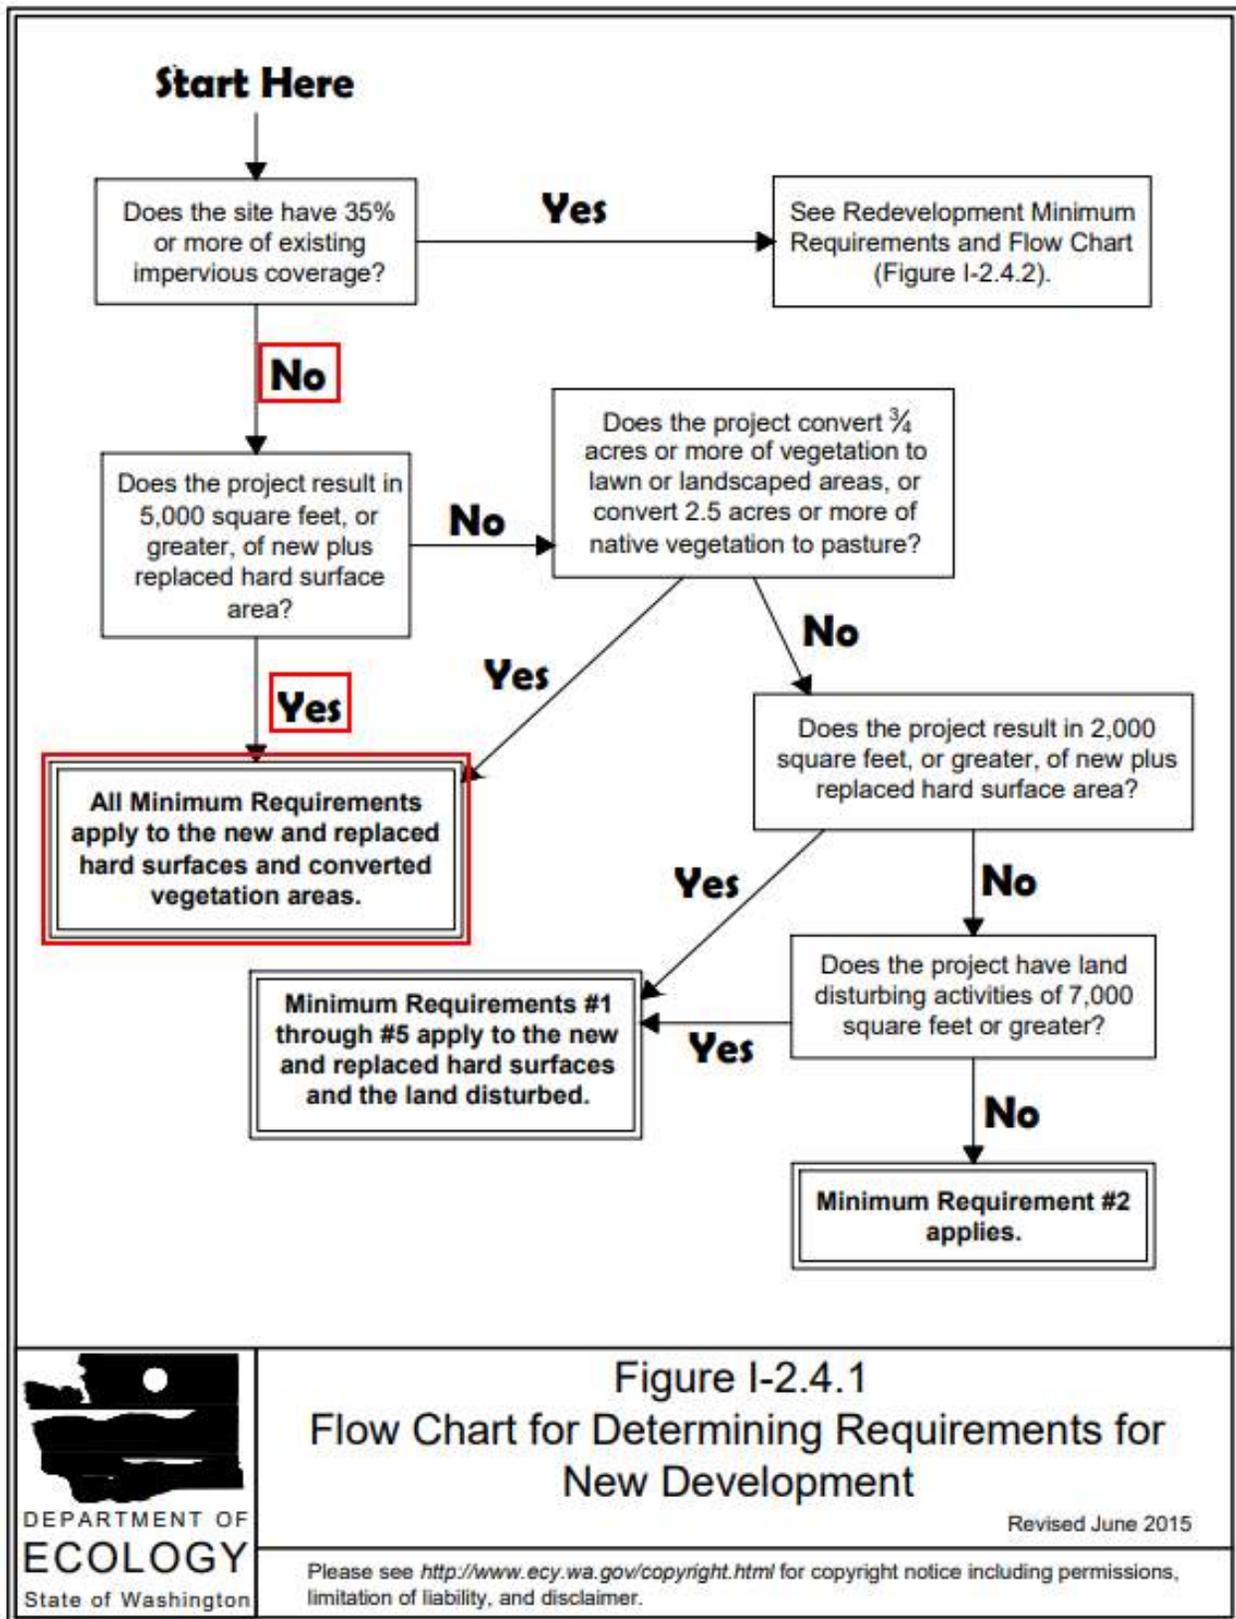
Figure 2: Flow Chart for Determining Requirements for New Development

The project shall comply with the requirements of the 2012 Stormwater Management Manual for Western Washington, as Amended in December 2014 (The 2014 SWMMWW), referred to hereon as ‘The Manual’, with amendments from City of Puyallup Municipal Code (PMC), Section 21.10. The Dos Lagos Lot ‘E’ Project is a new development project and proposes to add approximately 14,669 sq. ft. of impervious area in the form of building roofs, and an additional 33,645 sq. ft. of impervious surfaces in the form of concrete sidewalks and vehicle parking resulting in approximately 48,314 sq. ft. of total impervious surfaces. Less than 35% of the site consists of existing impervious coverage, and since more than 5,000 sq. ft. of new impervious surfaces are proposed to be added, minimum requirements 1 through 10 apply. The Washington State Department of Ecology (DOE) flow chart, “Figure I-2.4.1 – Flow Chart for Determining Requirements for New Development,” is found in Figure 2 on the following page.

Figure I-2.4.1
Flow Chart for Determining Requirements for
New Development

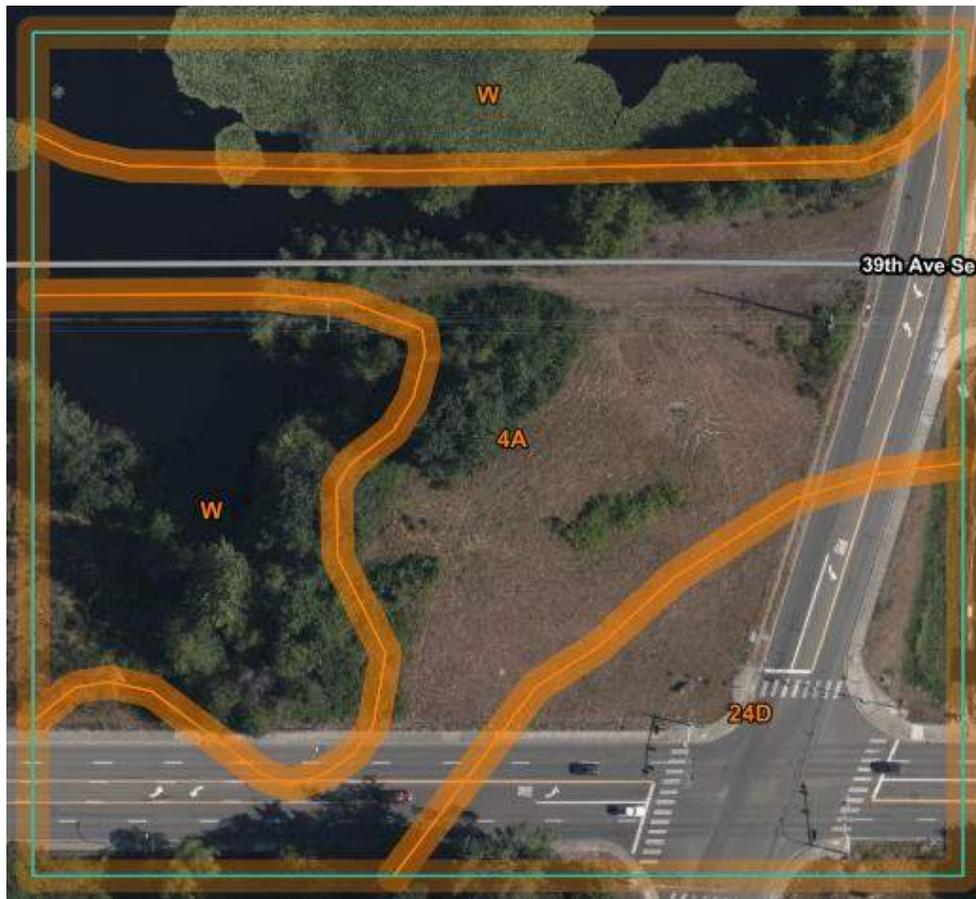
Figure 3: Site Position in NRCS soil mapping (excerpt)

Soil mapping was conducted using the United States Department of Agriculture Natural Resources Conservation Service (NRCS, The Survey) website. The site position within the NRCS soil map is illustrated in Figure 3 below. The soil map for all properties can also be found in the geotechnical report, along with soil descriptions and soil logs, in Appendix D.

Map Unit Symbol	Map Unit Name	Acres in AOI	Percent of AOI
4A	Bellingham silty clay loam	2.8	46.2%
24D	Neilton gravelly loamy sand, 8 to 25 percent slopes	1.2	19.7%
W	Water	2.1	34.2%
Totals for Area of Interest		6.1	100.0%

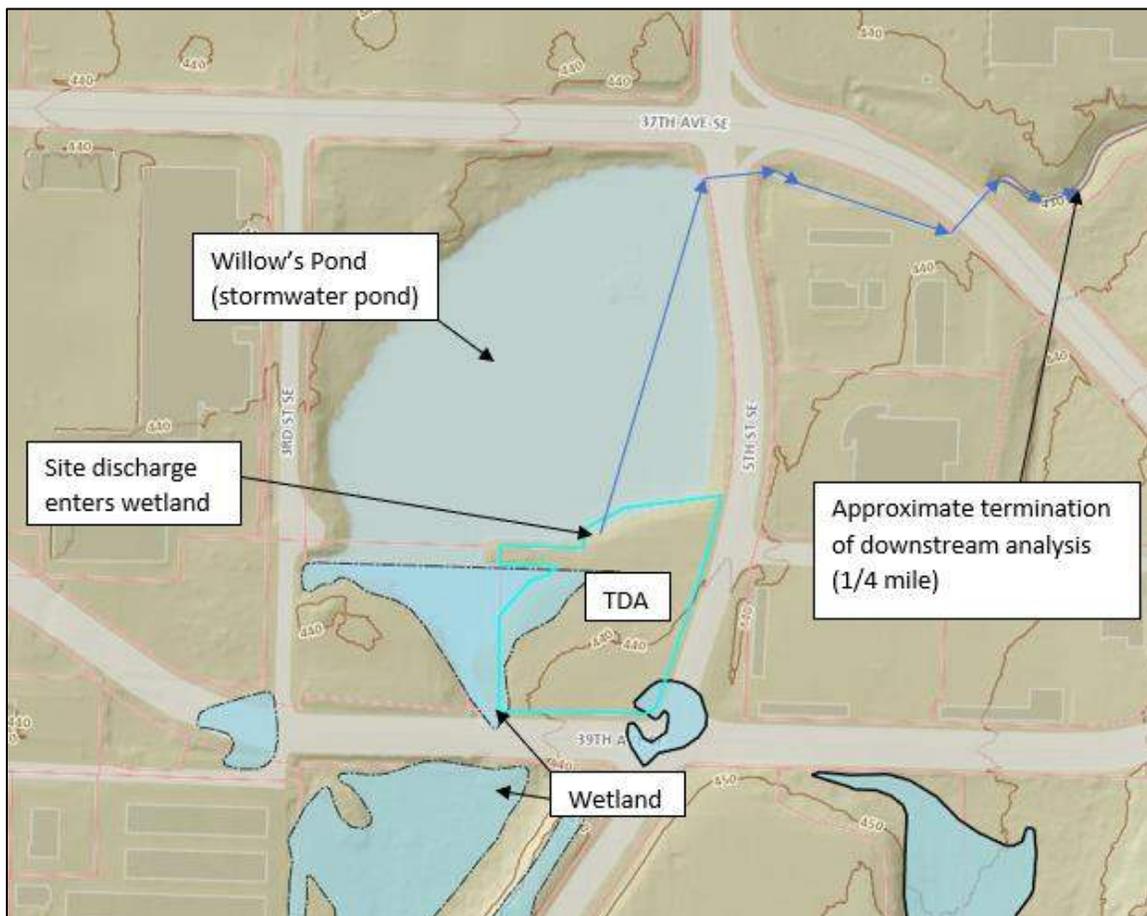
Figure 4: Downstream Analysis Map

A downstream (offsite) analysis has been completed by LS&E for this project. An offsite analysis study area definition map (Figure 4) is shown below. The study area for this project extends approximately ¼ mile to a portion of the unnamed stream that is released from Willow's Pond, in the vicinity of its crossing under 37th Ave SE. This stream eventually drains into Bradley Lake, then downstream for an unspecified distance.

No adverse impacts to downstream waters are anticipated as stormwater runoff will transmit first through the stormwater treatment cartridges, then into the detention facility before being dispersed into the wetland buffer via dispersion trench. These facilities have been sized using the MGS Flood continuous runoff model program. The stormwater treatment cartridges are designed to provide enhanced water quality treatment of the pavement runoff, which has received General Use Level Designation (GULD) for enhanced treatment by the Washington State Department of Ecology.

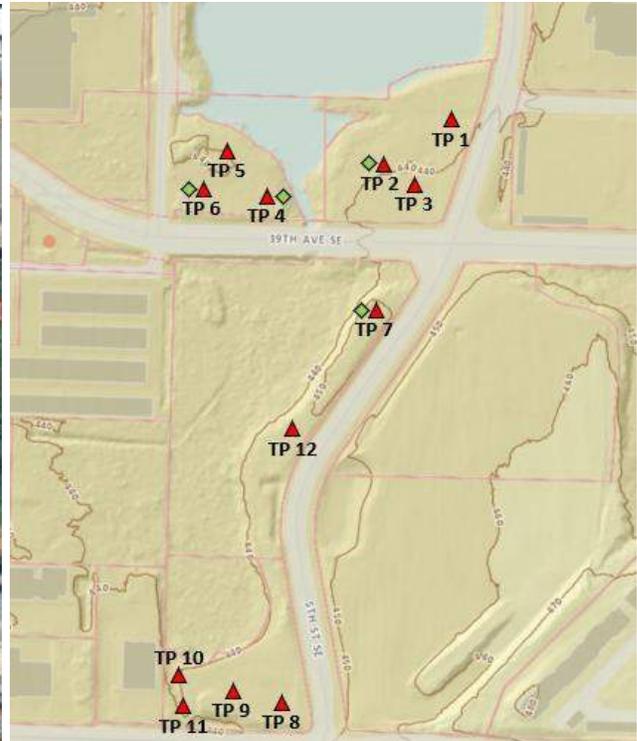
Figure 2: Test Pit (▲) and CEC Sample (◆) Locations

The sites in this project are in the City of Puyallup and situated on glacial till, flood, lacustrine, or outwash deposits. Figure 1, below, illustrates the location of individual parcels and sites of the project and Figure 2 illustrates the test locations on the sites. The site descriptions are as follows:

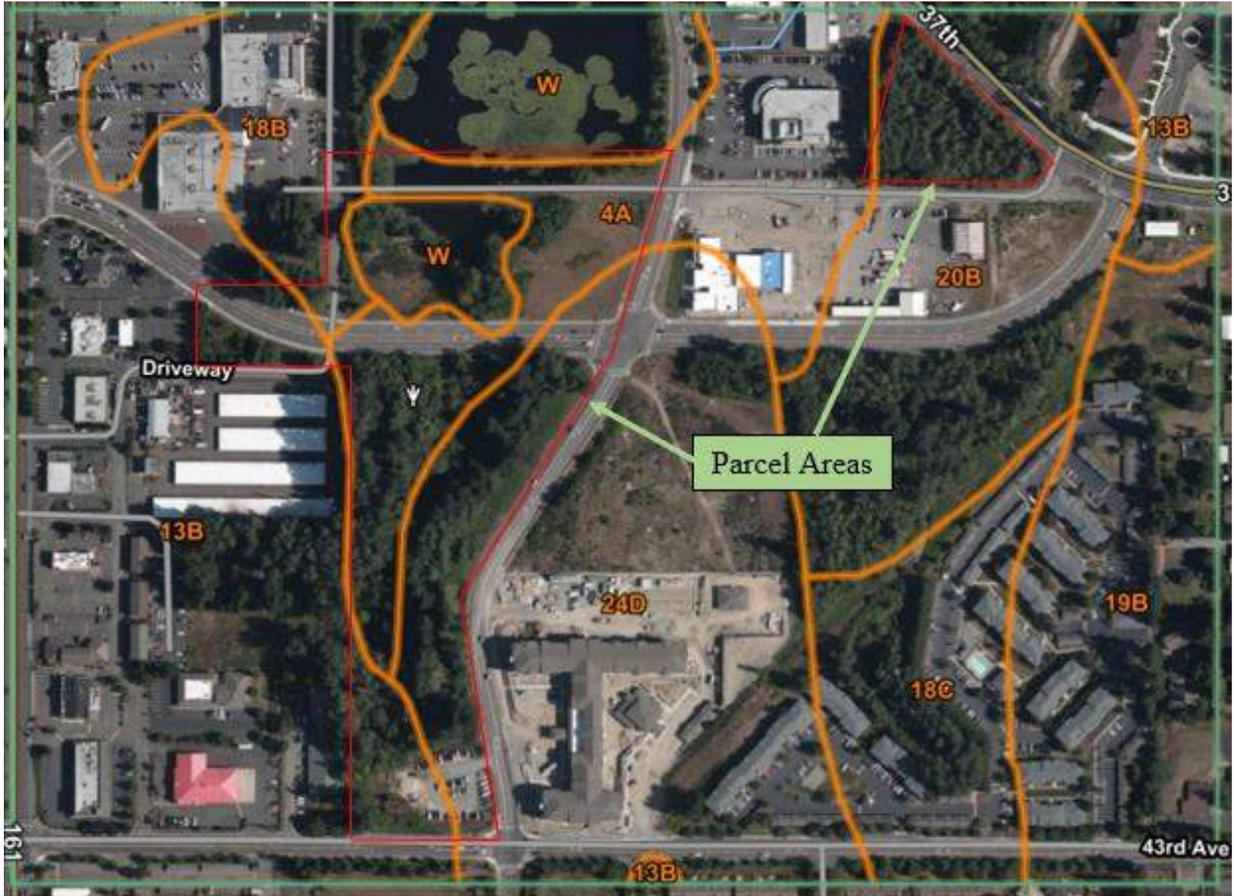
Figure 3: Site Position in NRCS Soil Mapping

As discussed in the ‘Published Information Accuracy’ section above; on-site reconnaissance is necessary to verify soil conditions on specific properties. Both the Survey and the geologic map describe materials of similar characteristics and origin. Per the Survey, the type of soil in Site B is Indianola loamy sand in the extreme western portion and Bellingham silty clay loam in the rest of the site; Site C is Everett very gravelly sandy loam; Site D is Bellingham silty clay loam in the lower, western portion, and Neilton gravelly loamy sand in the higher, eastern bench area (the soils found in the 8-10’ depths in Site D are most likely found throughout the next lowest bench elevation on the site); Site E is Everett very gravelly sandy loam in the lower, western portion, and Neilton gravelly loamy sand in the higher, eastern portion. Our in-situ examination of soil supports the Survey and USGS findings (soil log forms to be included in final report, see Appendix A for transcribed soil logs), except that much of Site B and Site E have 3-5 feet of fill with occasional debris placed on top of the native soil. Below this is the native layers described above. Site C was not examined on-site for in-situ soil properties at this time. Find individual Test Pit Soil Log descriptions in “Attachments.” Figure 3 below illustrates the site position within the soil environment.

Map Unit Symbol	Map Unit Name	Acres in AOI	Percent of AOI
4A	Bellingham silty clay loam	10.9	10.5%
13B	Everett very gravelly sandy loam, 0 to 8 percent slopes	28.3	27.3%
18B	Indianola loamy sand, 0 to 5 percent slopes	5.7	5.5%
18C	Indianola loamy sand, 5 to 15 percent slopes	6.7	6.5%
19B	Kapowsin gravelly ashy loam, 0 to 6 percent slopes	10.7	10.4%
20B	Kitsap silt loam, 2 to 8 percent slopes	13.3	12.9%
24D	Neilton gravelly loamy sand, 8 to 25 percent slopes	21.6	20.8%
W	Water	6.3	6.1%
Totals for Area of Interest		103.5	100.0%

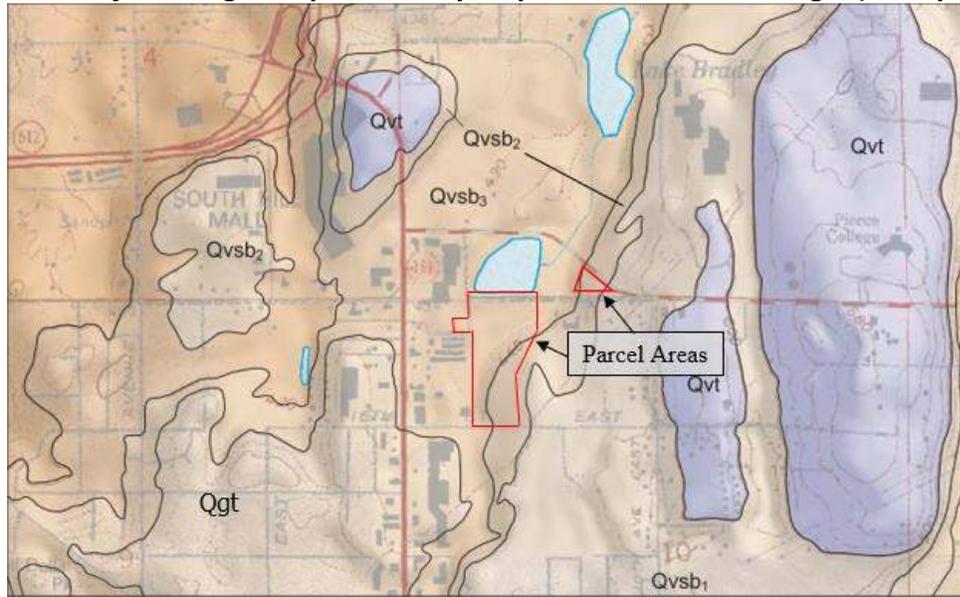
Figure 4: USGS Draft Geologic Map of the Puyallup 7.5 Minute Quadrangle (Excerpt)

The property is situated on the broad deposit of glacial outburst flood deposits that occurred during and at the end of the Vashon Stade of the Fraser glaciation period. As glacial Lake Puyallup, located at the base of the Cascade Range foothills, would fill with seasonal runoff, the valley glaciers (acting as a natural dam) would repeatedly fail releasing vast amounts of water that would erode the lowland formations and subsequently deposit new sediment as floodwater abated. This local landscape still includes Kettle depressions formed by portions of ice blocks that were trapped in place. Outwash deposits surrounded the ice blocks. Figure 4 below illustrates the site position in the regional geology.

- Qvs Steilacoom Gravel of Walters and Kimmel (1968)—Sandy gravel and cobbles; clean to silty; poorly to well sorted; horizontally to cross bedded; loose to dense. Deposits vary from veneer of <1 to 15 m (3 to ~ 50 ft) thick. Deposited by multiple outburst floods from subsequently lower elevations of Glacial Lake Puyallup. Locally subdivided first by channel affiliation (Clover Creek or Bradley) and secondarily by relative age in descending series of deposits; higher number denotes younger (lower) deposit. Clover Creek channel (Bretz, 1913) begins in section 8, T19N, R4E. Bradley channel; herein named for Lake Bradley in section 3, T19N, R4E; begins in section 2, T19N, R4E. Numbering system contiguous w/adjacent Tacoma South quadrangle where multiple Clover Creek deposits are mapped (Troost, 2006). Mapable deposits consist of:

- Qvs b3 Bradley deposit at elevation 420 – 440 ft
 - Qvs b2 Bradley deposit at elevation 440 – 460 ft

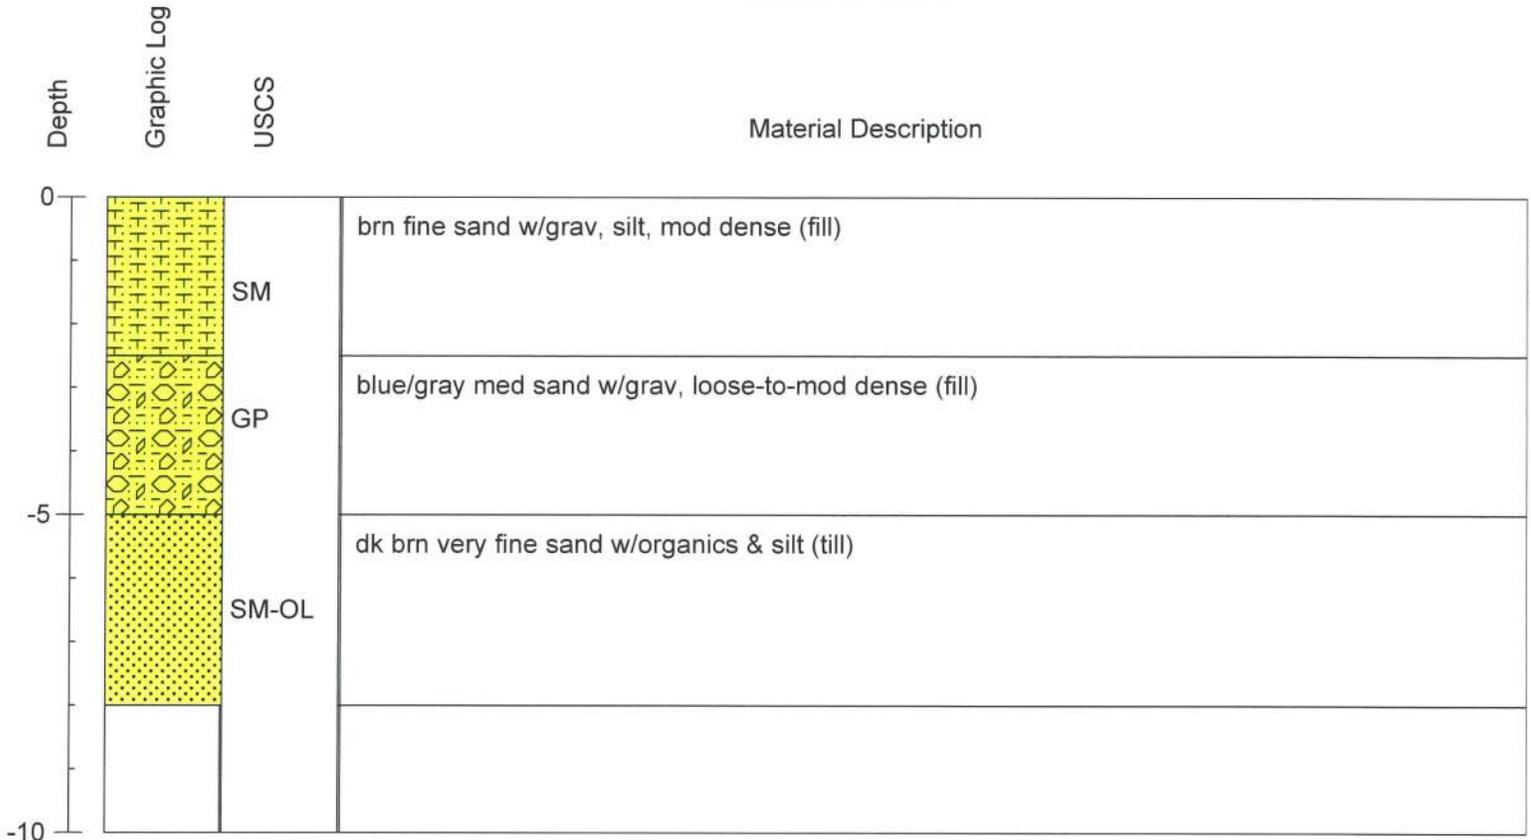
Test Pit Number: TP 1
 Project Name: Dos Lagos
 Ground Elevation: 438 Test Pit Size: 2x6
 Ground Water Levels:
 At Time of Excavation: None
 At End of Excavation: None
 Static Water Depth: None

The depths on the test pit logs are based on an average of measurements across the test pit and should be considered accurate to +/- 0.5 ft.

Bottom of Test Pit at: 8.0 ft
 Ground Water/Seepage: None Observed
 Side Wall Caving: _____

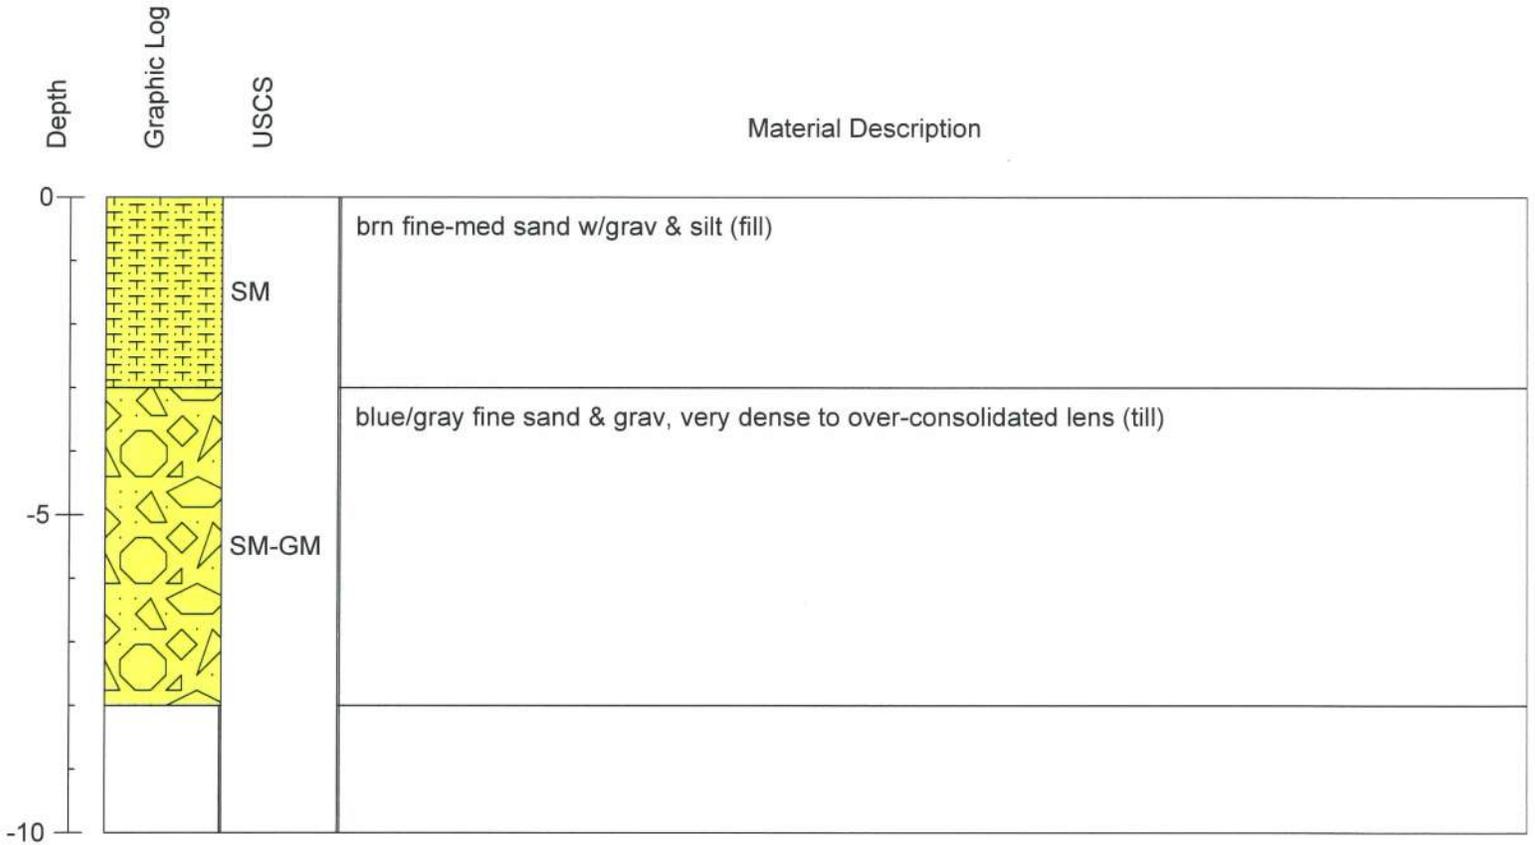
Client: Dos Lagos Asset, LLC
 Job Number: 12896
 Date Started: 7/7/20
 Date Completed: 7/7/20
 Excavation Contractor: N/A
 Excavation Method: Track Mounted Excavator
 Logged By: JET Checked By: BC
 Notes: Significant fill present, no organics within, preloaded condition.
None

Test Pit Number: TP 2
 Project Name: Dos Lagos
 Ground Elevation: 440 Test Pit Size: 2x6
 Ground Water Levels:
 At Time of Excavation: None
 At End of Excavation: None
 Static Water Depth: None

Bottom of Test Pit at: 8.0 ft
 Ground Water/Seepage: None Observed
 Side Wall Caving: None Observed

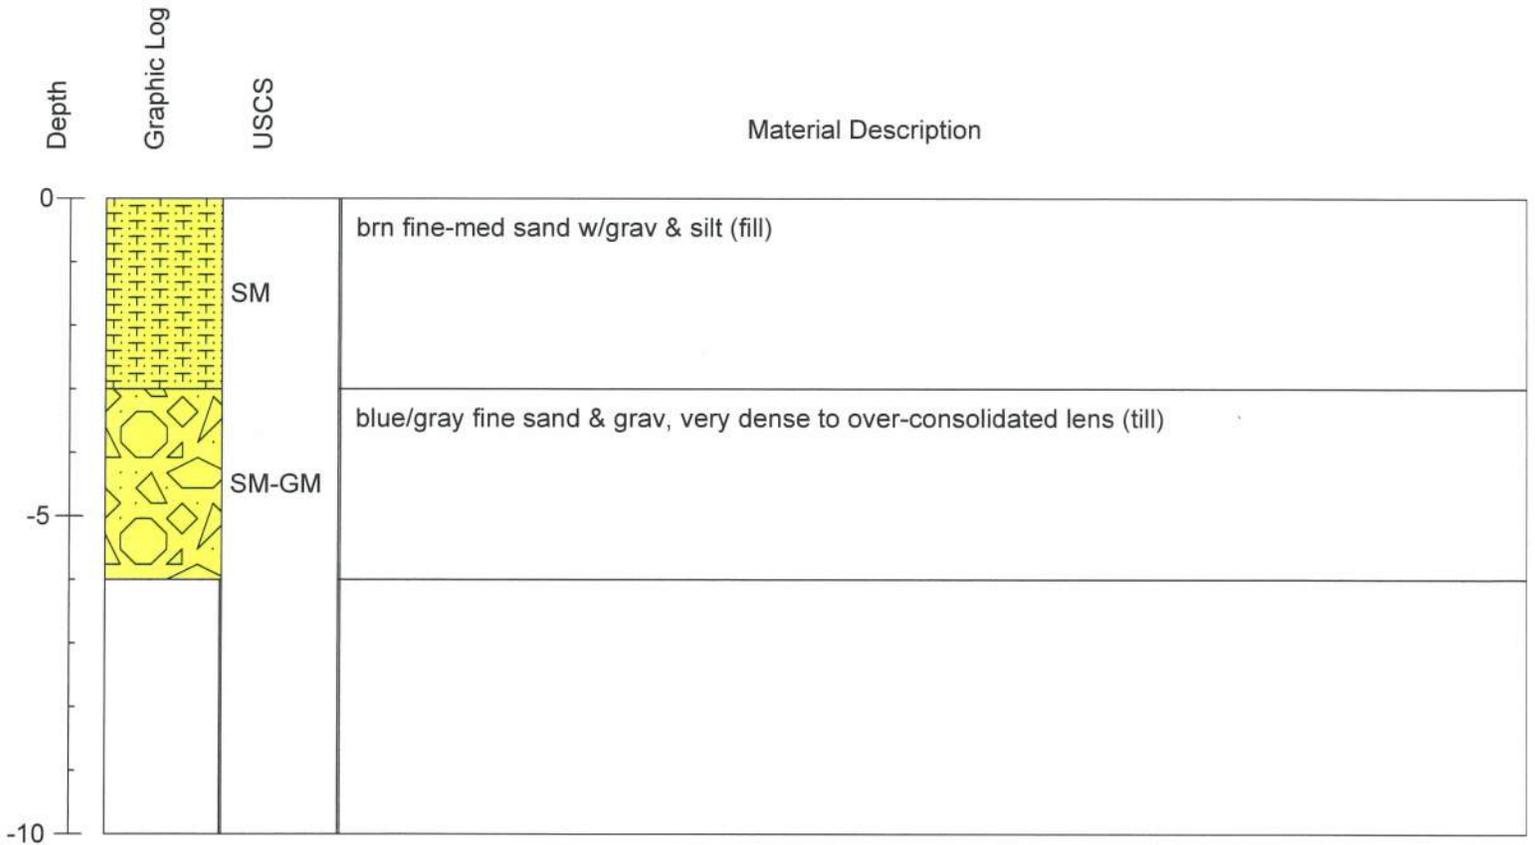
Client: Dos Lagos Asset, LLC
 Job Number: 12896
 Date Started: 7/7/20
 Date Completed: 7/7/20
 Excavation Contractor: N/A
 Excavation Method: Track Mounted Excavator
 Logged By: JET Checked By: BC
 Notes: Significant fill present, no organics within, preloaded condition.
None

Test Pit Number: TP 3
 Project Name: Dos Lagos
 Ground Elevation: 440 Test Pit Size: 2x6
 Ground Water Levels:
 At Time of Excavation: None
 At End of Excavation: None
 Static Water Depth: None

Bottom of Test Pit at: 6.0 ft
 Ground Water/Seepage: None Observed
 Side Wall Caving: None Observed

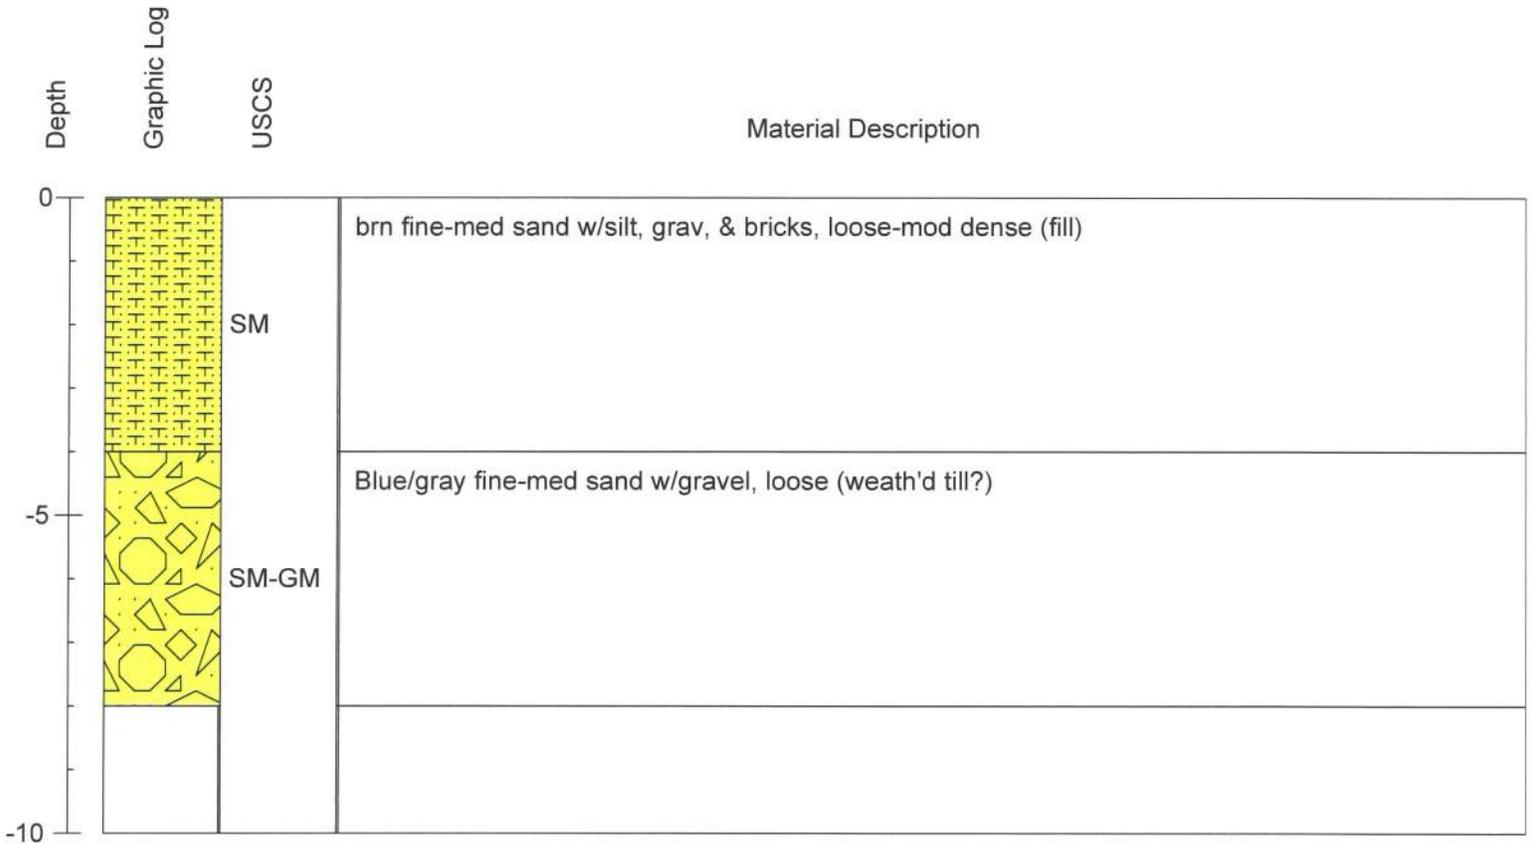
Client: Dos Lagos Asset, LLC
 Job Number: 12896
 Date Started: 7/7/20
 Date Completed: 7/7/20
 Excavation Contractor: N/A
 Excavation Method: Track Mounted Excavator
 Logged By: JET Checked By: BC
 Notes: Significant fill present, no organics within, preloaded condition. Bricks found at depth.
None

Test Pit Number: TP 4
 Project Name: Dos Lagos
 Ground Elevation: 438 Test Pit Size: 2x6
 Ground Water Levels:
 At Time of Excavation: None
 At End of Excavation: None
 Static Water Depth: None

Bottom of Test Pit at: 8.0 ft
 Ground Water/Seepage: None Observed
 Side Wall Caving: None Observed

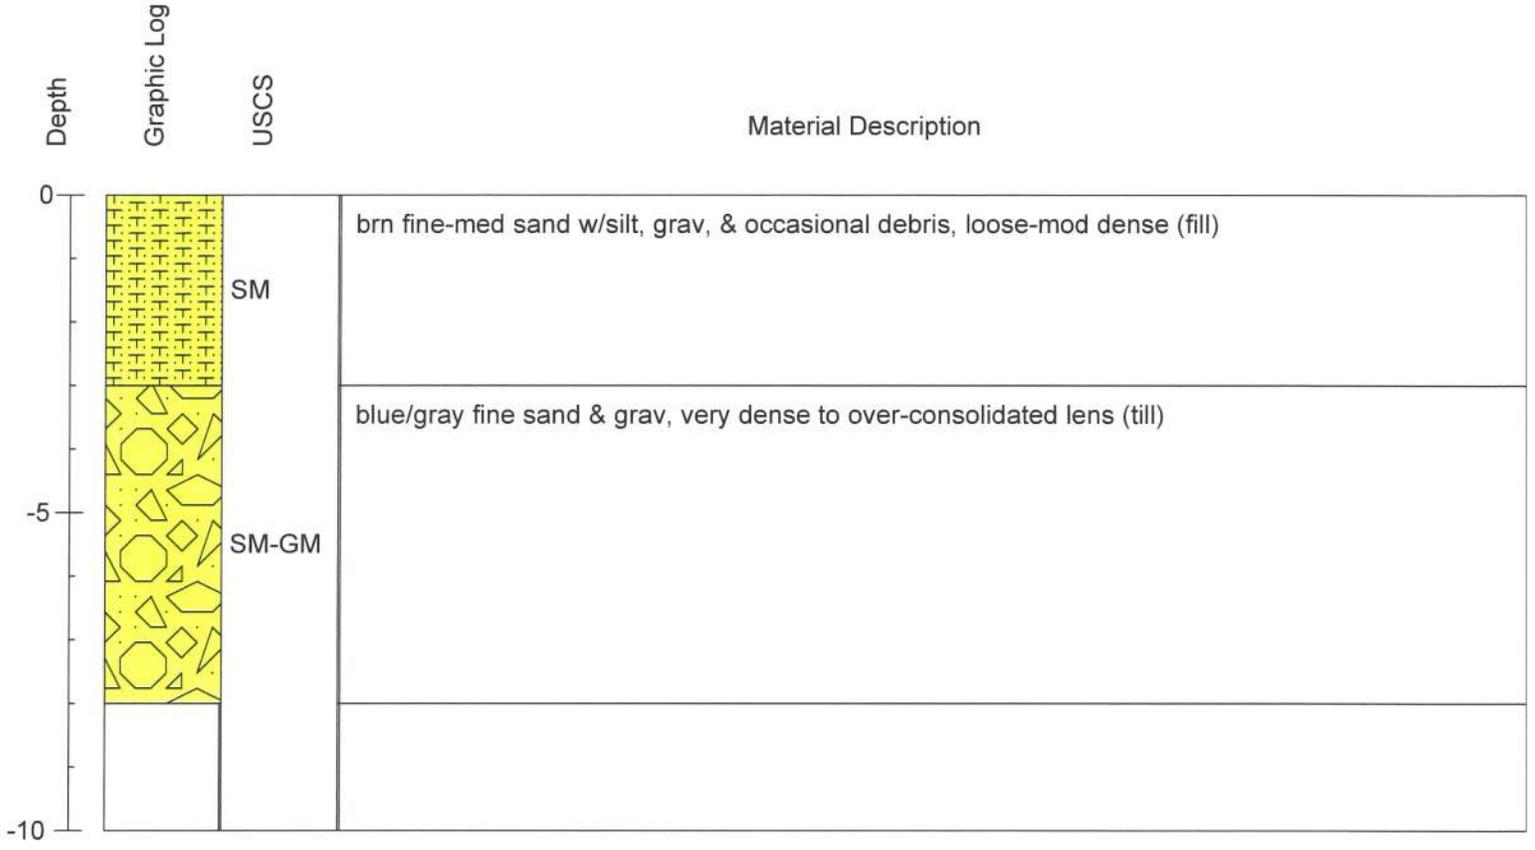
Client: Dos Lagos Asset, LLC
 Job Number: 12896
 Date Started: 7/7/20
 Date Completed: 7/7/20
 Excavation Contractor: N/A
 Excavation Method: Track Mounted Excavator
 Logged By: JET Checked By: BC
 Notes: Significant fill present, no organics within, preloaded condition.
None

Test Pit Number: TP 5
 Project Name: Dos Lagos
 Ground Elevation: 438 Test Pit Size: 2x6
 Ground Water Levels:
 At Time of Excavation: None
 At End of Excavation: None
 Static Water Depth: None

Bottom of Test Pit at: 8.0 ft
 Ground Water/Seepage: None Observed
 Side Wall Caving: None Observed

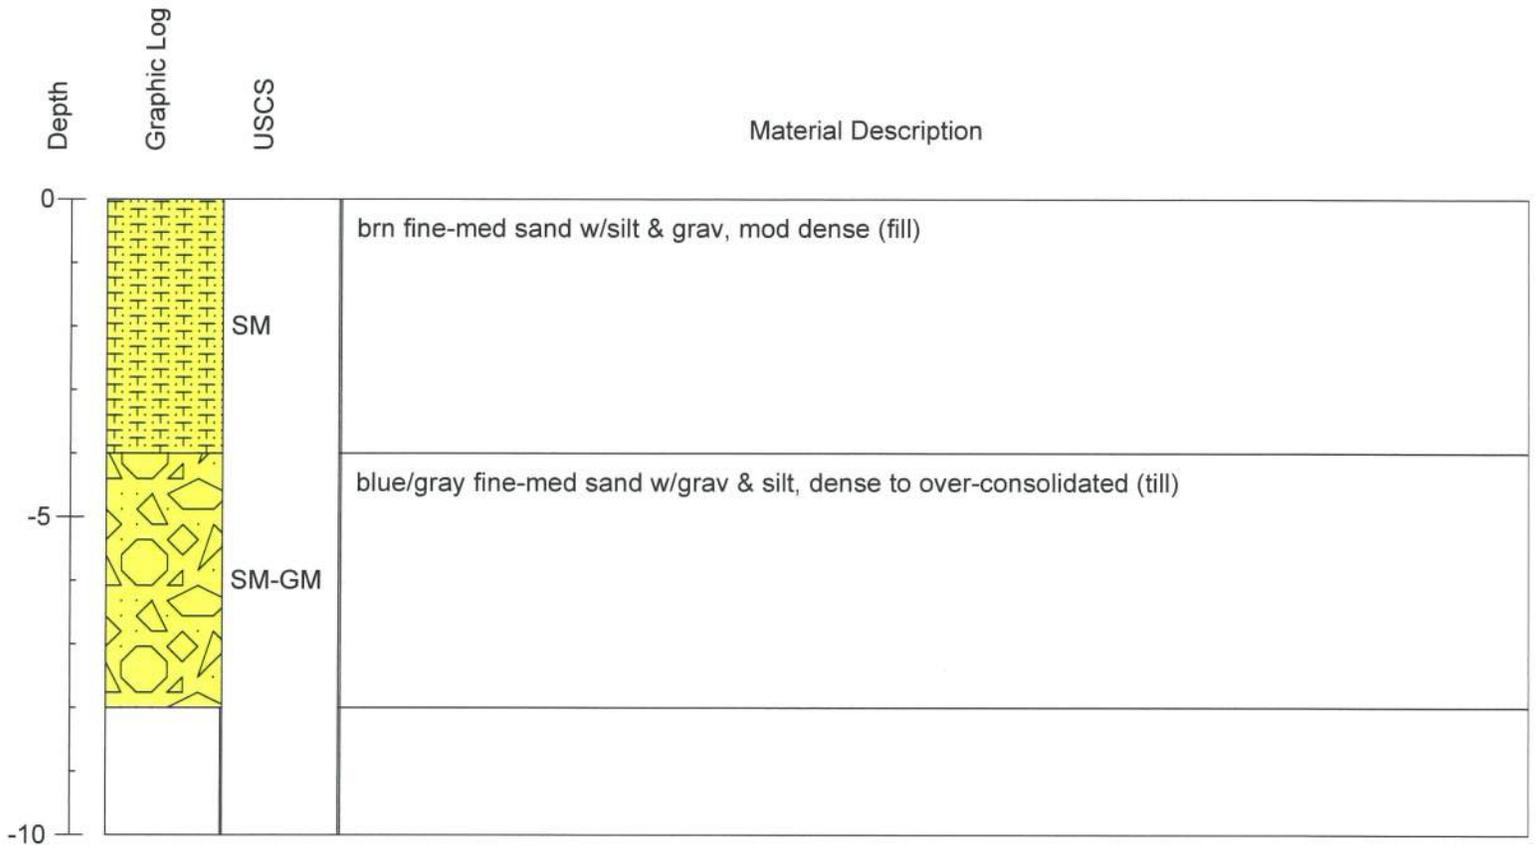
Client: Dos Lagos Asset, LLC
 Job Number: 12896
 Date Started: 7/7/20
 Date Completed: 7/7/20
 Excavation Contractor: N/A
 Excavation Method: Track Mounted Excavator
 Logged By: JET Checked By: BC
 Notes: Significant fill present, no organics within, preloaded condition.
None

Test Pit Number: TP 6
 Project Name: Dos Lagos
 Ground Elevation: 438 Test Pit Size: 2x6
 Ground Water Levels:
 At Time of Excavation: None
 At End of Excavation: None
 Static Water Depth: None

Bottom of Test Pit at: 8.0 ft
 Ground Water/Seepage: None Observed
 Side Wall Caving: None Observed

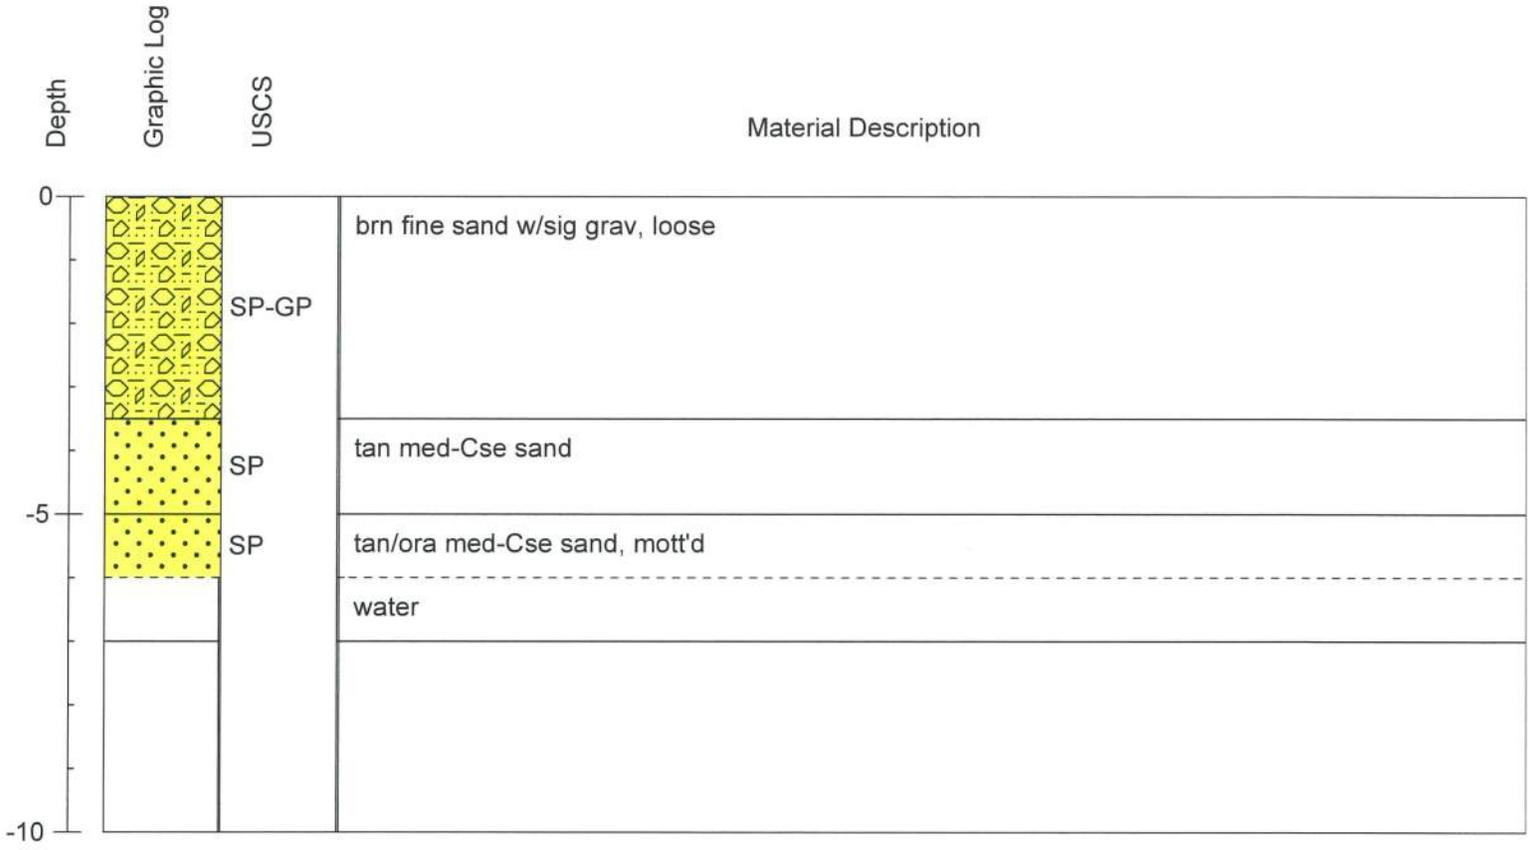
Client: Dos Lagos Asset, LLC
 Job Number: 12896
 Date Started: 7/7/20
 Date Completed: 7/7/20
 Excavation Contractor: N/A
 Excavation Method: Track Mounted Excavator
 Logged By: JET Checked By: BC
 Notes: Water at 6 ft.
None

Test Pit Number: TP 10
 Project Name: Dos Lagos
 Ground Elevation: 436 Test Pit Size: 2x6
 Ground Water Levels:
 At Time of Excavation: None
 At End of Excavation: None
 Static Water Depth: None

Bottom of Test Pit at: 7.0 ft
 Ground Water/Seepage: None Observed
 Side Wall Caving: None Observed

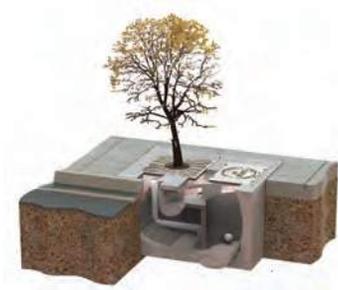
BIPOD TREE

Vault with media and tree(s).
