SEPTIC SYSTEM LOCATION APPROVAL

RE: Septic system approval for 409 43RD Ave SW, Puyallup WA 98373

Permit #: P-19-0061

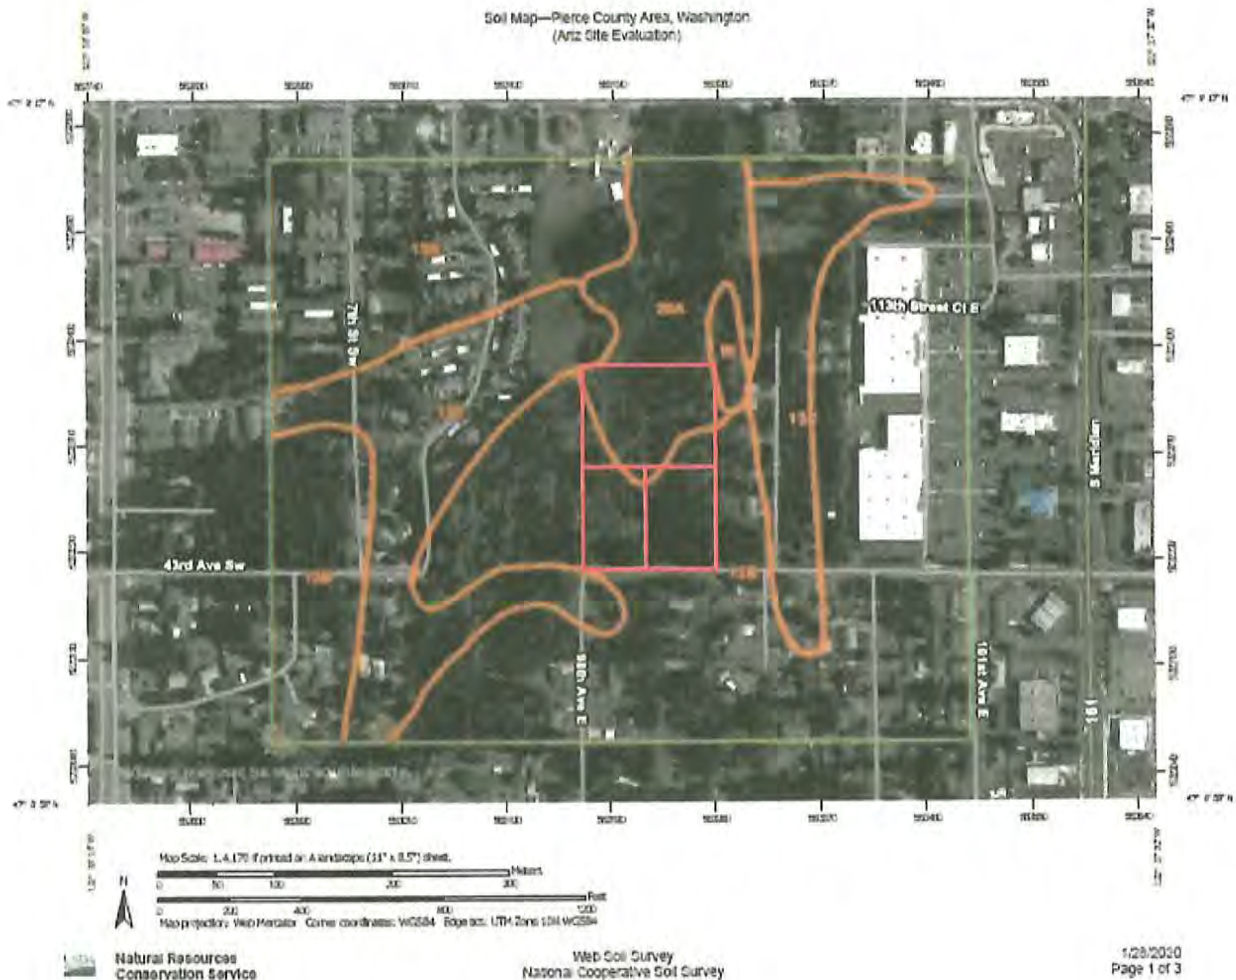
Map Unit Legend

Map Unit Symbol	Map Unit Name	Acres in AOE	Percent of AOE
13B	Everett very gravelly sandy loam, 0 to 6 percent slopes	49.2	87.5%
13C	Everett very gravelly sandy loam, 6 to 15 percent slopes	16.3	22.3%
25A	Neilon fine sandy loam	6.7	9.3%
W	Water	0.8	0.9%
Totals for Areas of Interest		72.9	100.0%

Everett 13B – Everett gravelly sandy loam, 0 – 6 percent slopes

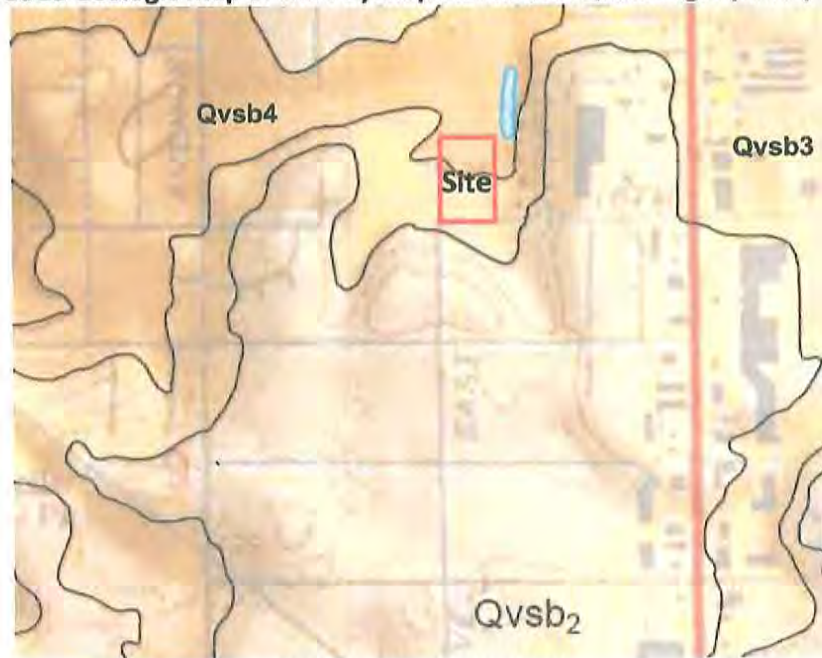
USGS Geologic Map of the Puyallup 7.5 Minute Quadrangle (Excerpt)

Qvs	Steilacoom Gravel of Walters and Kimmel (1968)—Sandy gravel and cobbles; clean to silty; poorly to well sorted; horizontally to cross bedded; loose to dense. Deposits vary from veneer of 1 to 15 m (3 to ~50 ft) thick. Deposited by multiple outburst floods from subsequently lower elevations of Glacial Lake Puyallup. Locally subdivided first by channel affiliation (Clover Creek or Bradley) and secondarily by relative age in descending series of deposits; higher number denotes younger (lower) deposit. Clover Creek channel (Bretz, 1913) begins in section 8, T19N, R4E. Bradley channel; herein named for Lake Bradley in section 3, T19N, R4E; begins in section 2, T19N, R4E. Numbering system contiguous w/adjacent Tacoma South quadrangle where multiple Clover Creek deposits are mapped (Troost, 2006). Mappable deposits consist of:
Qvs 2c1	Clover Creek deposit at elevation ~380 ft
Qvs 3a	Bradley deposit at elevation ~400 ft

According to the USGS *Draft* Geologic Map of the Puyallup 7.5 Minute Quadrangle in Figure 2 below: this plateau region was formed by the gradual emplacement glacial drift stratigraphy; followed by the erosion of the previously emplaced glacial drift deposits by channelized glacial meltwater incision along the west side, and by ice lobe truncation within the Puyallup valley. The map shows that the slope section dipping to the northeast provides a depositional record of the pre-vashon mixed fine and coarse deposits, overlain by the Vashon advance outwash, overlain by the Vashon till, and finally overlain by the Vashon recessional outwash. The slope face represents the location where the much larger glacier within the valley truncated the slope face thus exposing a stratigraphic record of deposits. Figure 2 illustrates the site's position relative to the geology.

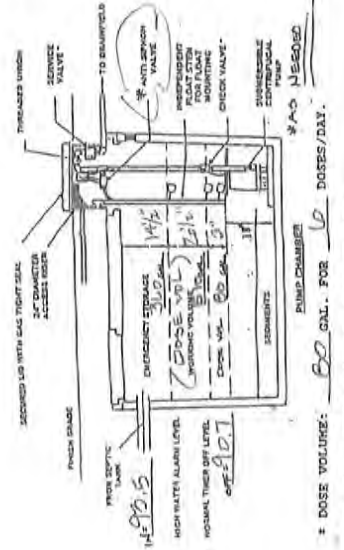
- * DO NOT INSTALL TANKS IN RESERVE AREA.
- * TANK(S) MUST BE WATERTIGHT TO A LEVEL ABOVE ANY POSSIBLE SEASONAL GROUND WATER.
