SEPTIC SYSTEM LOCATION APPROVAL

RE: Septic system approval for 433 43RD Ave SW, Puyallup WA 98373

Permit #: P-19-0061

SEPTIC EASEMENT

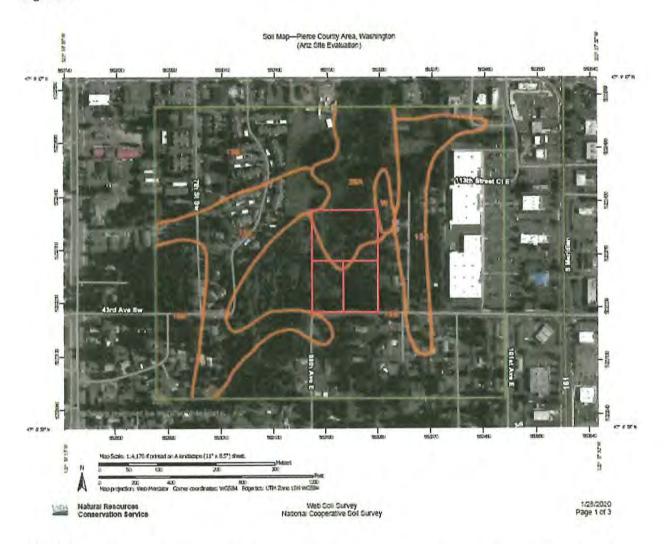
Map Unit Legend

As discussed in the 'Published Information Accuracy' section above, on-site reconnaissance is necessary to verify soil conditions on specific properties. The NRCS identifies the soil on the two southern lots as Everett gravelly sandy loam (13B) In this case; test pits excavated north and east of the proposed structure as a

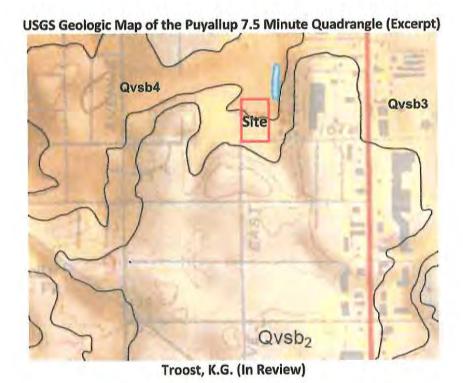
According to the USGS *Draft* Geologic Map of the Puyallup 7.5 Minute Quadrangle in Figure 2 below: this plateau region was formed by the gradual emplacement glacial drift stratigraphy; followed by the erosion of the previously emplaced glacial drift deposits by channelized glacial meltwater incision along the west side, and by ice lobe truncation within the Puyallup valley. The map shows that the slope section dipping to the northeast provides a depositional record of the pre-vashon mixed fine and coarse deposits, overlain by the Vashon advance outwash, overlain by the Vashon till, and finally overlain by the Vashon recessional outwash. The slope face represents the location where the much larger glacier within the valley truncated the slope face thus exposing a stratigraphic record of deposits. Figure 2 illustrates the site's position relative to the geology.

Qvs Steilacoom Gravel of Walters and Kimmel (1968)—Sandy gravel and cobbles; clean to silty; poorly to well sorted; horizontally to cross bedded; loose to dense. Deposits vary from veneer of 1 to 15 m (3 to ~ 50 ft) thick. Deposited by multiple outburst floods from subsequently lower elevations of Glacial Lake Puyallup. Locally subdivided first by channel affiliation (Clover Creek or Bradley) and secondarily by relative age in descending series of deposits; higher number denotes younger (lower) deposit. Clover Creek channel (Bretz, 1913) begins in section 8, T19N, R4E. Bradley channel; herein named for Lake Bradley in section 3, T19N, R4E; begins in

Tacoma South quadrangle where multiple Clover Creek deposits are mapped (Troost, 2006). Mapable deposits consist of Clover Creek deposit at elevation ~380 ft Bradley deposit at elevation ~400 ft Bradley deposit at elevation 420 – 440 ft
