GEOTECHNICAL ENGINEERING INVESTIGATION

Proposed Fairfield Hotel Expansion
202 15th Ave SW
Puyallup, Washington 98371
Parcel#: 6026420010

October 14, 2025
Project No. 2GJ01201100

GEOTECHNICAL ENGINEERING REPORT

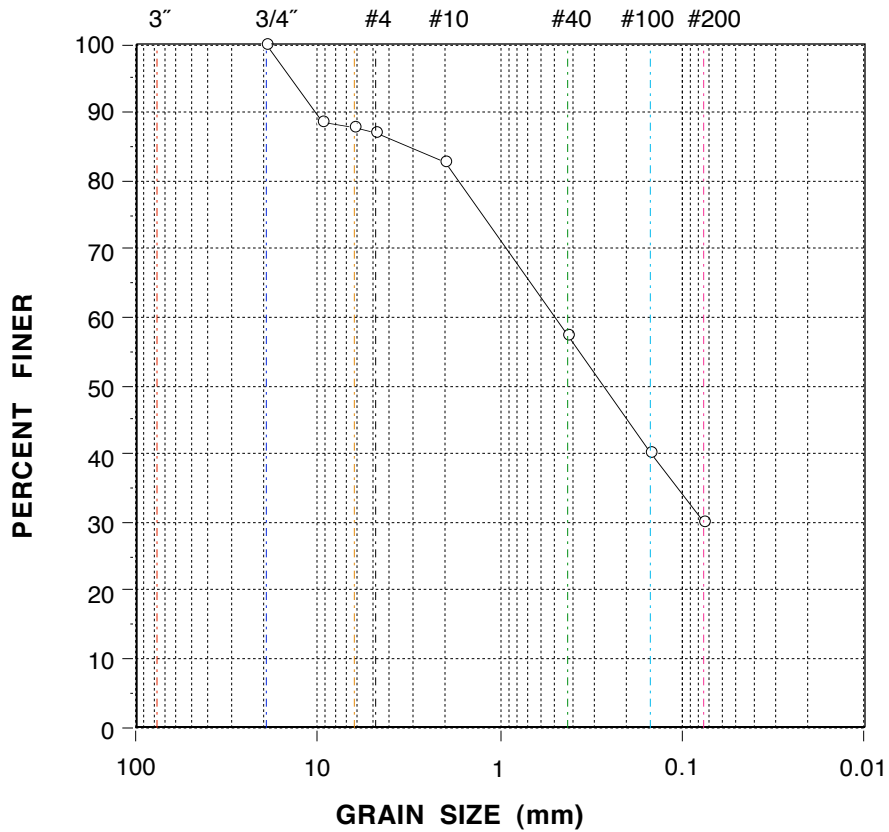
Grain Size Distribution

SAMPLE LOCATION: B1-2
SAMPLED DEPTH: 10'
SOIL TYPE: Silty Clayey Sand (SM/SC)

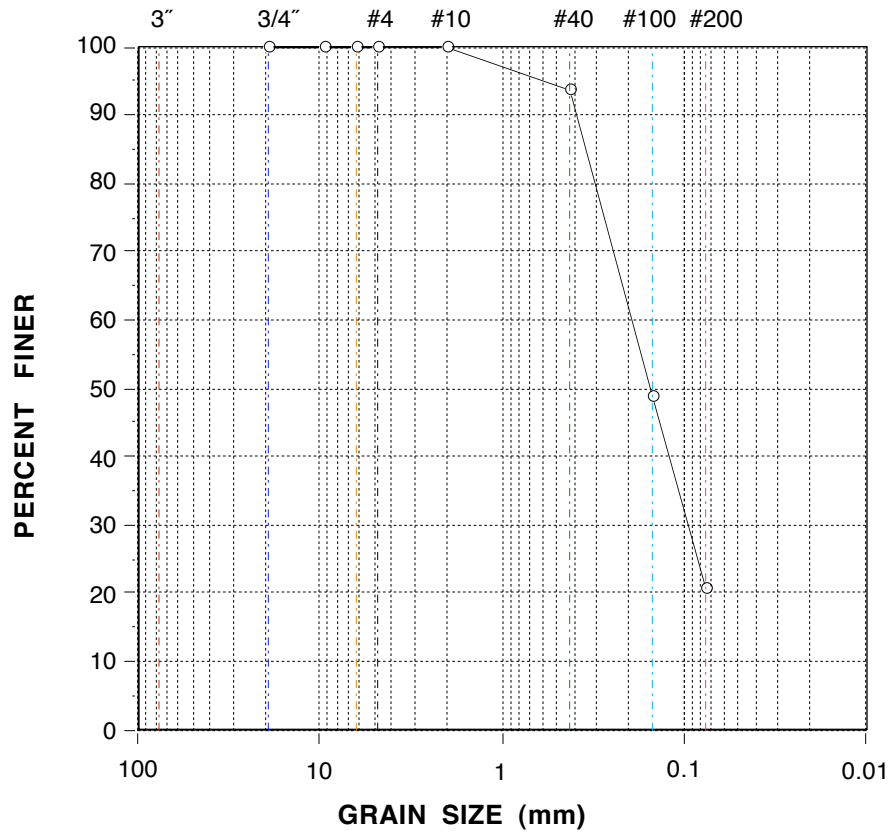
Grain Size Distribution

SAMPLE LOCATION: B2-6
SAMPLED DEPTH: 30'
SOIL TYPE: Silty Clayey Sand (SM/SC)

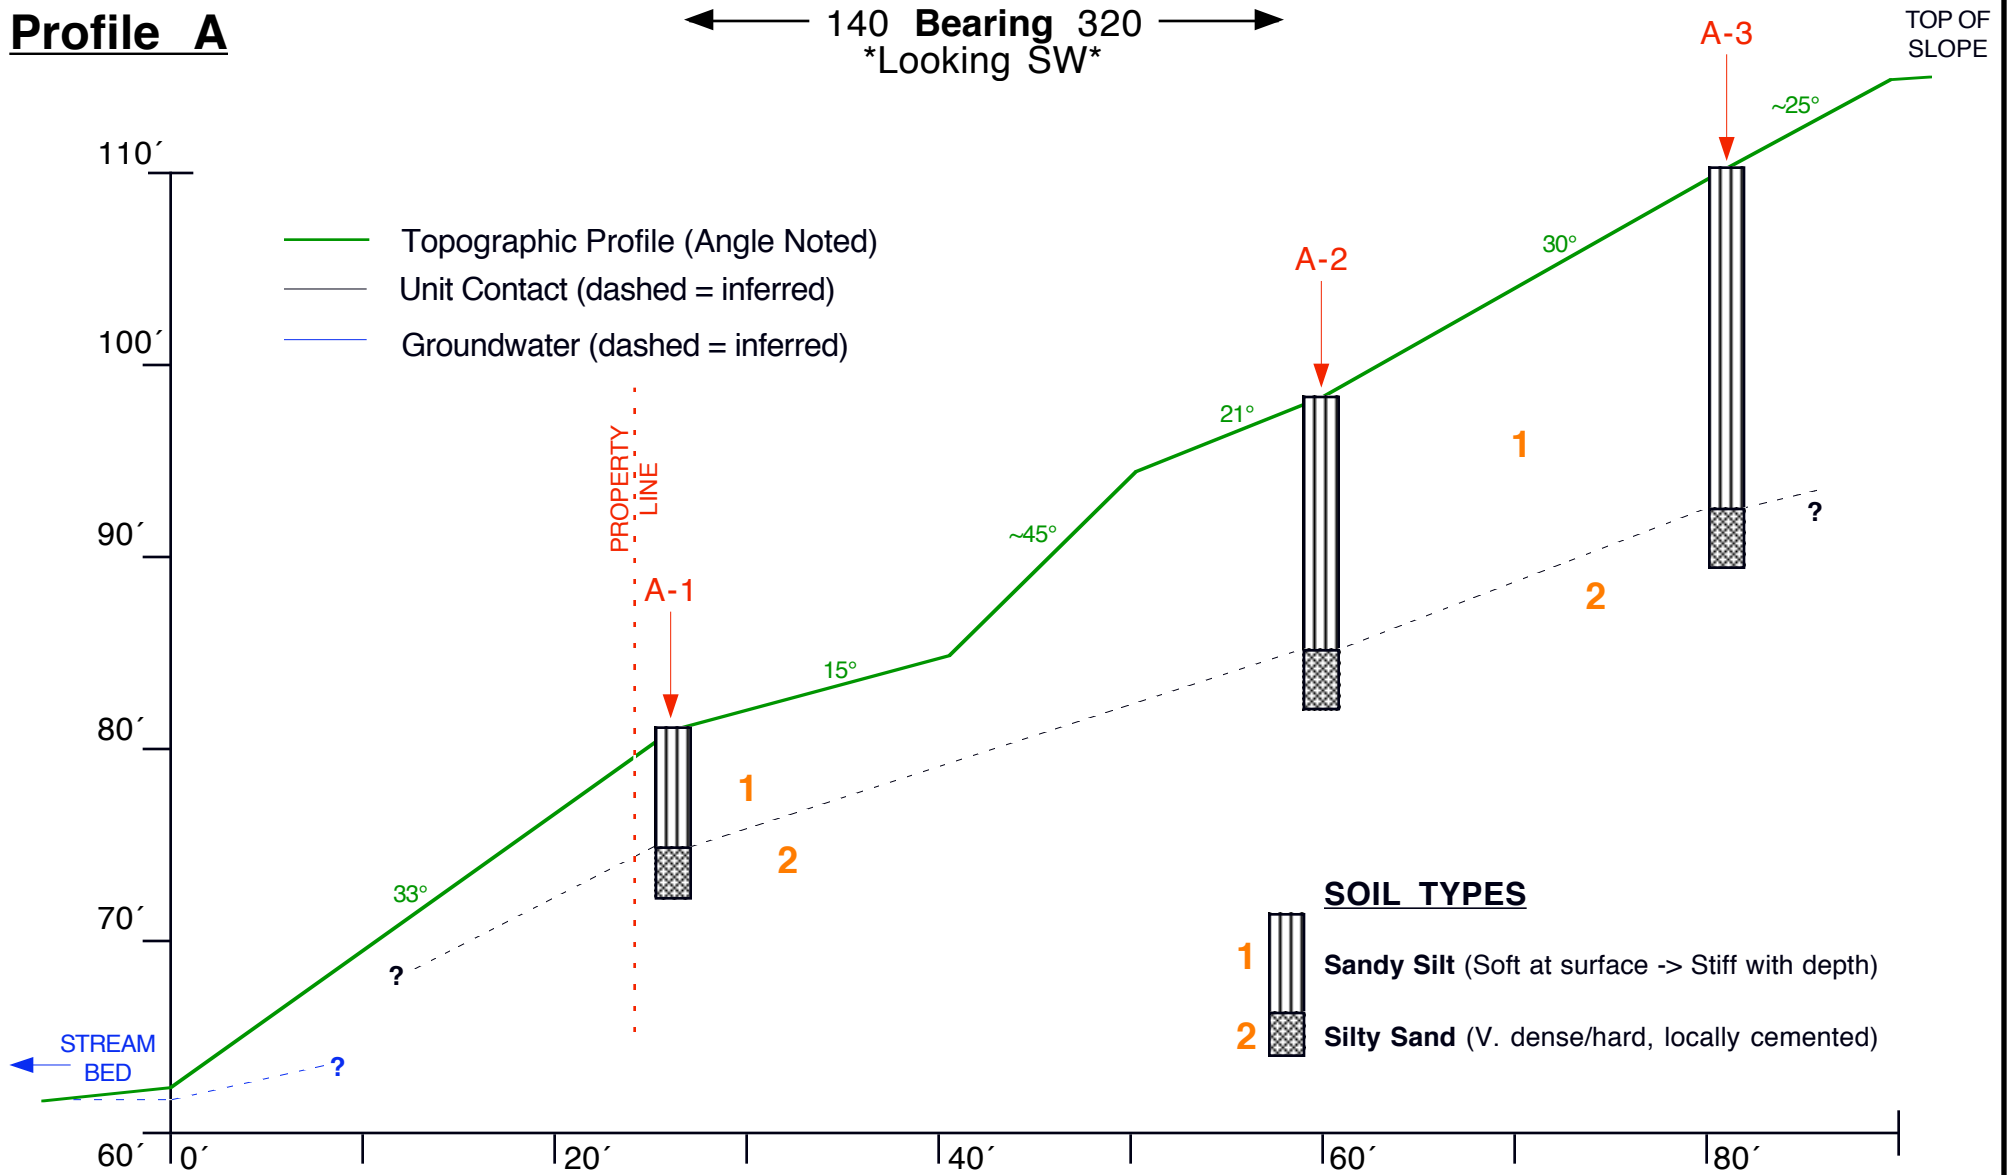
Profile A

← 140 Bearing 320 →
Looking SW

- Topographic Profile (Angle Noted)
- - - Unit Contact (dashed = inferred)
- - - Groundwater (dashed = inferred)

- SOIL TYPES**
- 1** **Sandy Silt** (Soft at surface -> Stiff with depth)
 - 2** **Silty Sand** (V. dense/hard, locally cemented)
