Geotechnical Engineering Report  
Proposed Commercial Development  
2315 Inter Ave  
Puyallup, Washington  
PN: 2105200140  
Doc ID: CIMCO.InterAve.RG

**Site Location Map**  
 Proposed Commercial Development  
 2315 Inter Avenue  
 Puyallup, Washington  
 PN: 2105200140

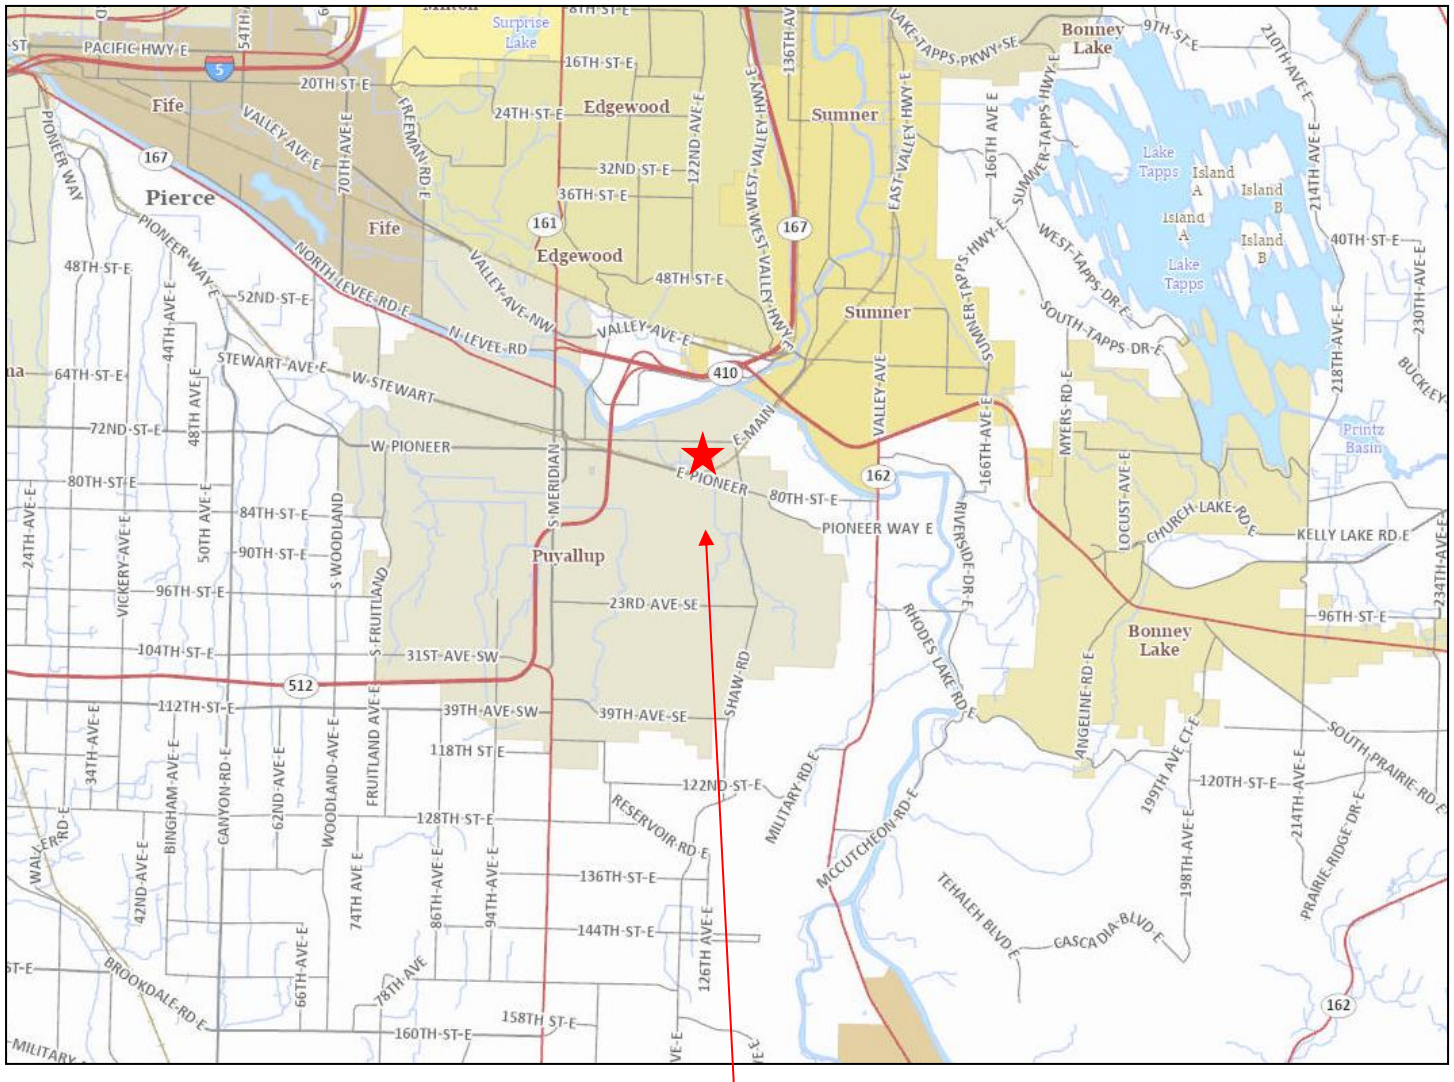
Figure 1

**Approximate Site Location**

This *Geotechnical Engineering Report* summarizes our site observations, subsurface explorations, laboratory testing and engineering analyses and provides geotechnical recommendations and design criteria for the proposed commercial development to be constructed at 2315 Inter Avenue in Puyallup, Washington. We prepared a *Soils Report* for the property on April 8, 2022 to address stormwater requirement per the City of Puyallup (the City). We understand that the structural engineer is requesting geotechnical recommendations per the 2018 International Building Code (IBC). The approximate site location is shown on the attached Site Location Map, Figure 1.

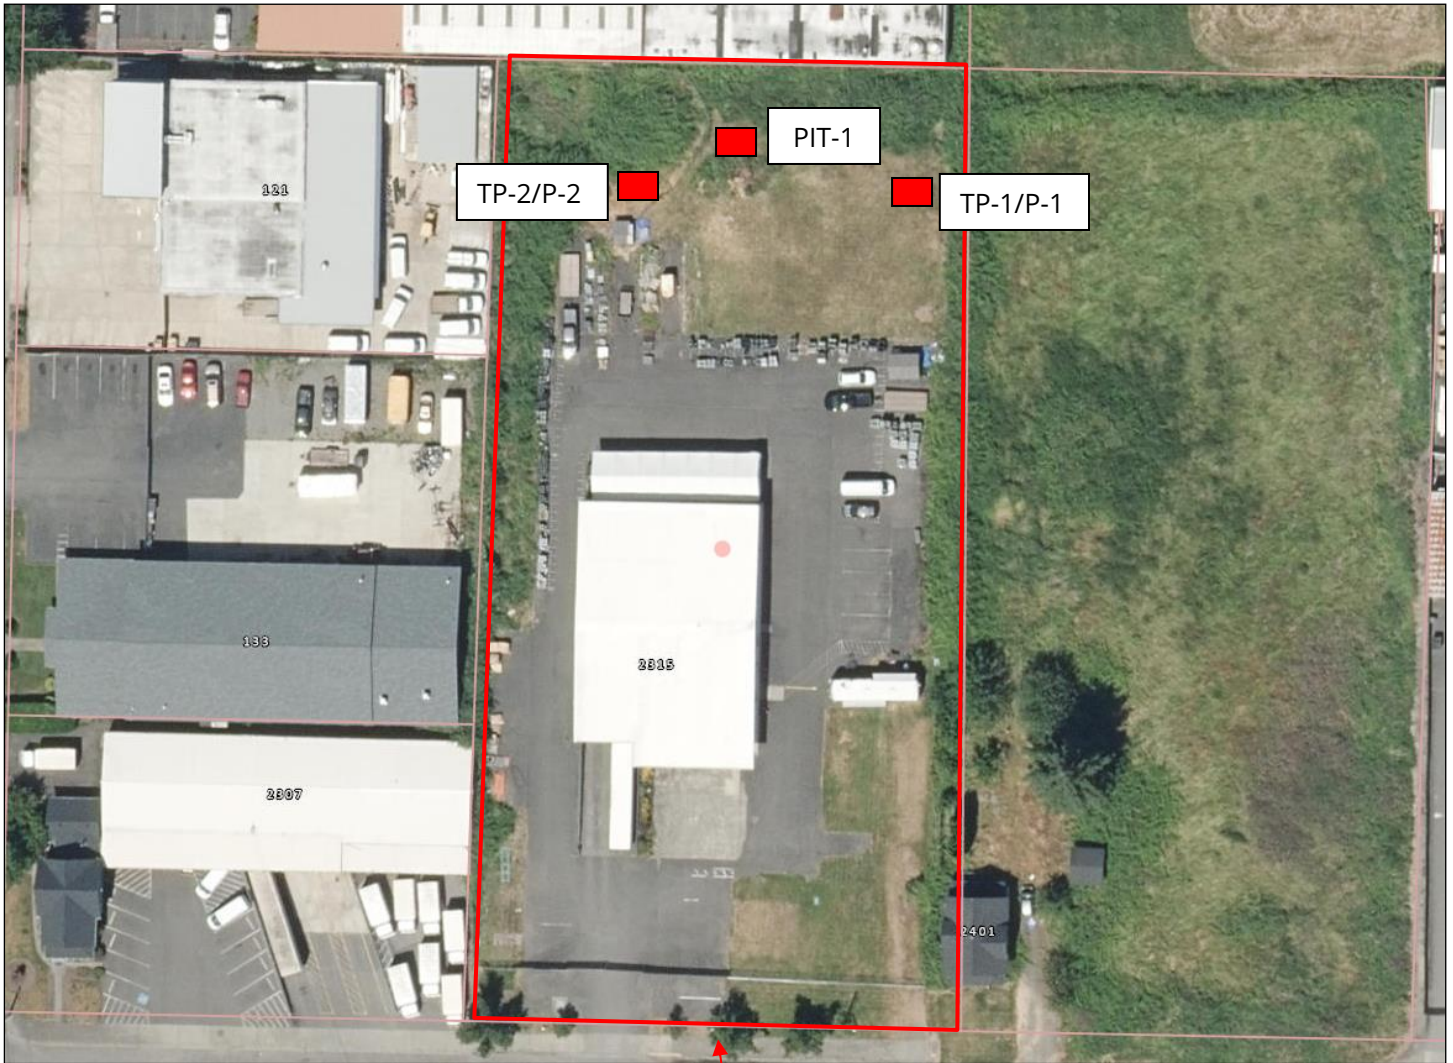
Doc ID: CIMCO.InterAve.F	March 2023	Figure 2
--------------------------	------------	----------

■ Number and approximate location of test pit/Pilot Infiltration Test

**Site & Exploration Map**  
 Proposed Commercial Development  
 2315 Inter Avenue  
 Puyallup, Washington  
 PN: 2105200140

The site generally flat with less than 2 feet of topographic relief. The vegetation in the area of the proposed development had been generally cleared and consisted of grasses, brambles, and other low lying native and invasive species. No areas of surficial erosion, seeps, or springs were observed at the time of our reconnaissance. Standing water was not observed in the existing pond/depressions on the northwest and portions of the site at the time of our December 2021 site visit. The existing site topography is shown on the Site Exploration Map, Figure 2.

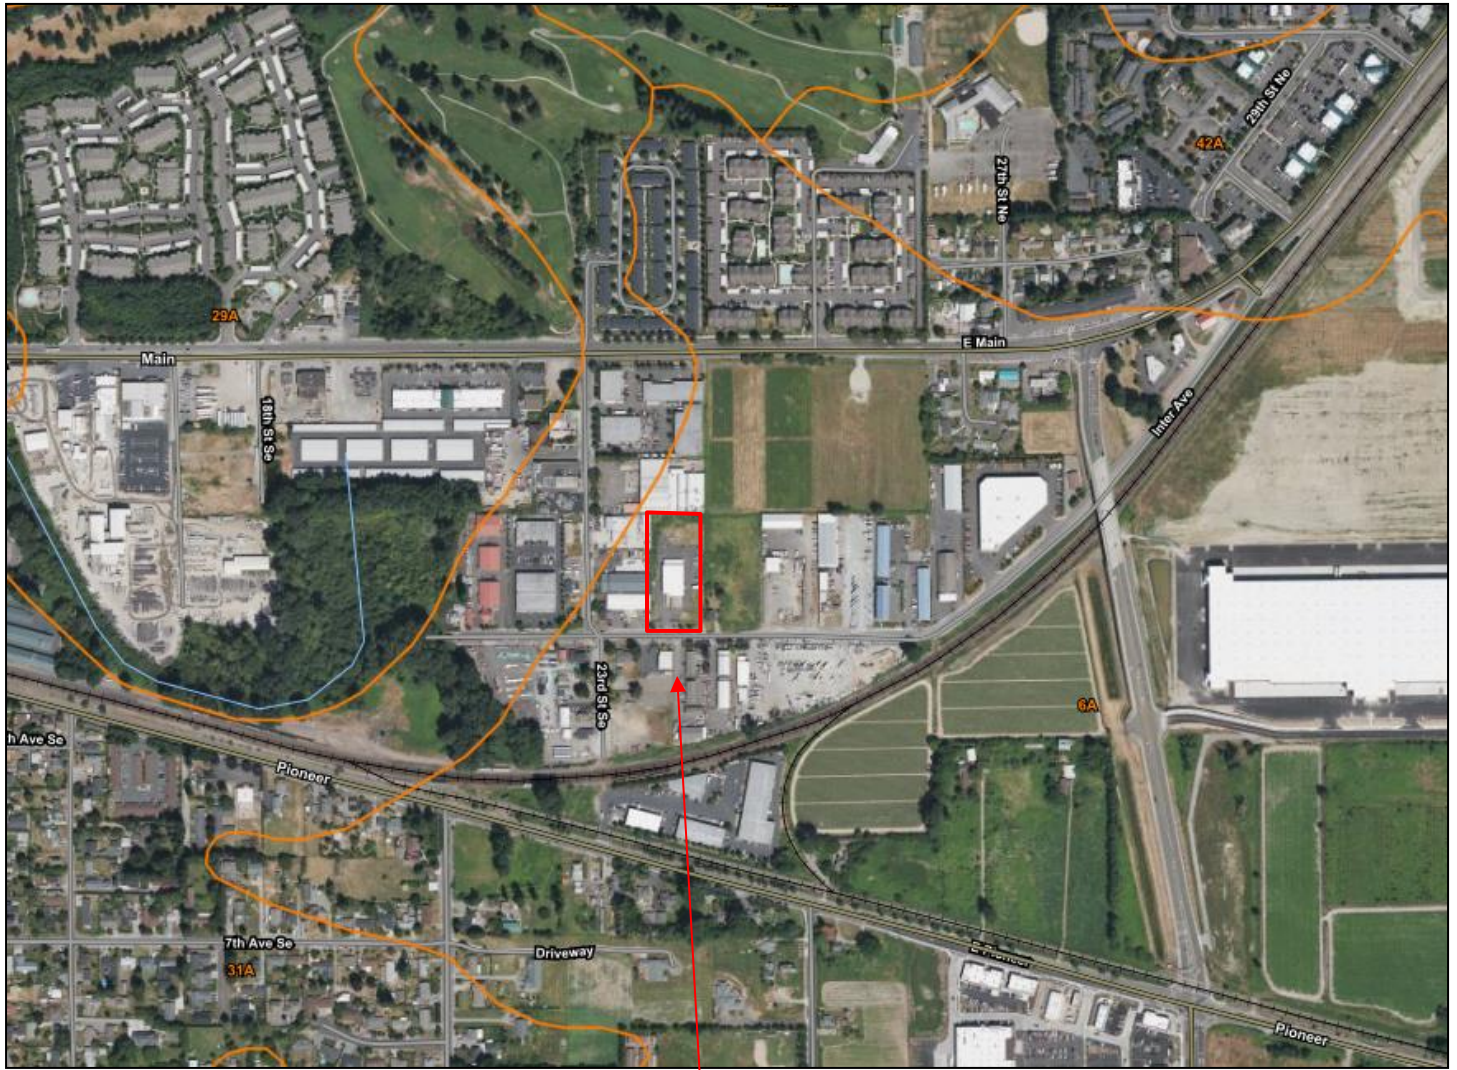
Figure 3

Map created from Web Soil Survey (<http://websoilsurvey.sc.egov.usda.gov/App/WebSoilSurvey.aspx>)

**NRCS Soils Map**  
 Proposed Commercial Development  
 2315 Inter Avenue  
 Puyallup, Washington  
 PN: 2105200140

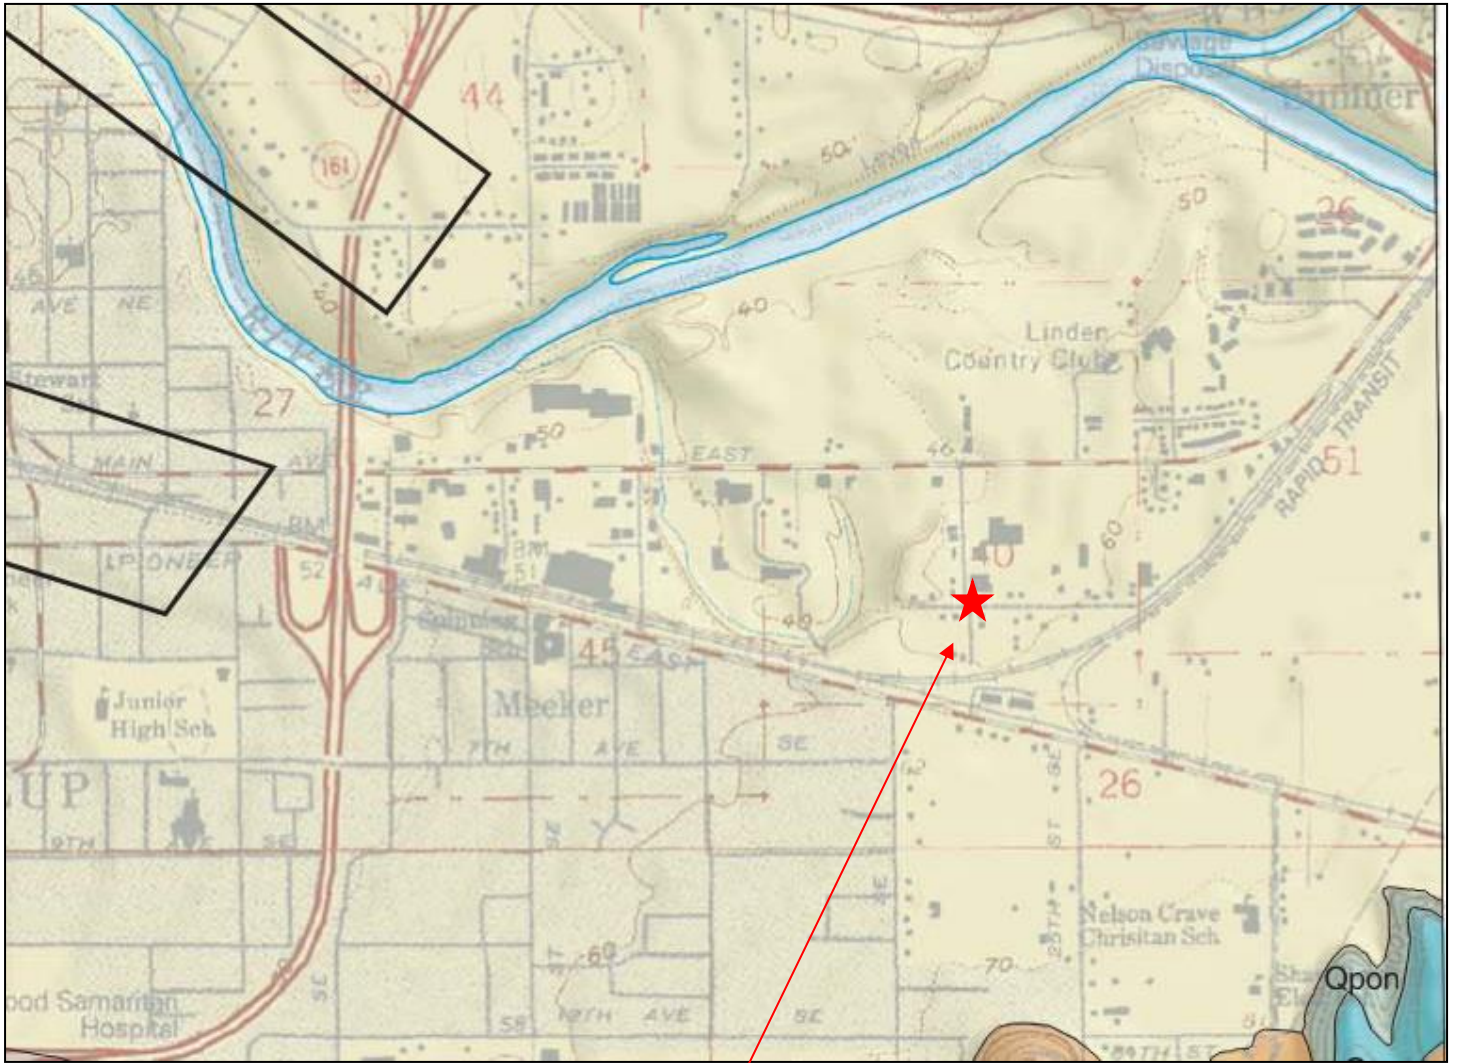
Figure 4

An excerpt from the draft the *Geologic Map of the Puyallup 7.5-minute Quadrangle, Washington* by Kathy G. Troost (in review)

### Geologic Map

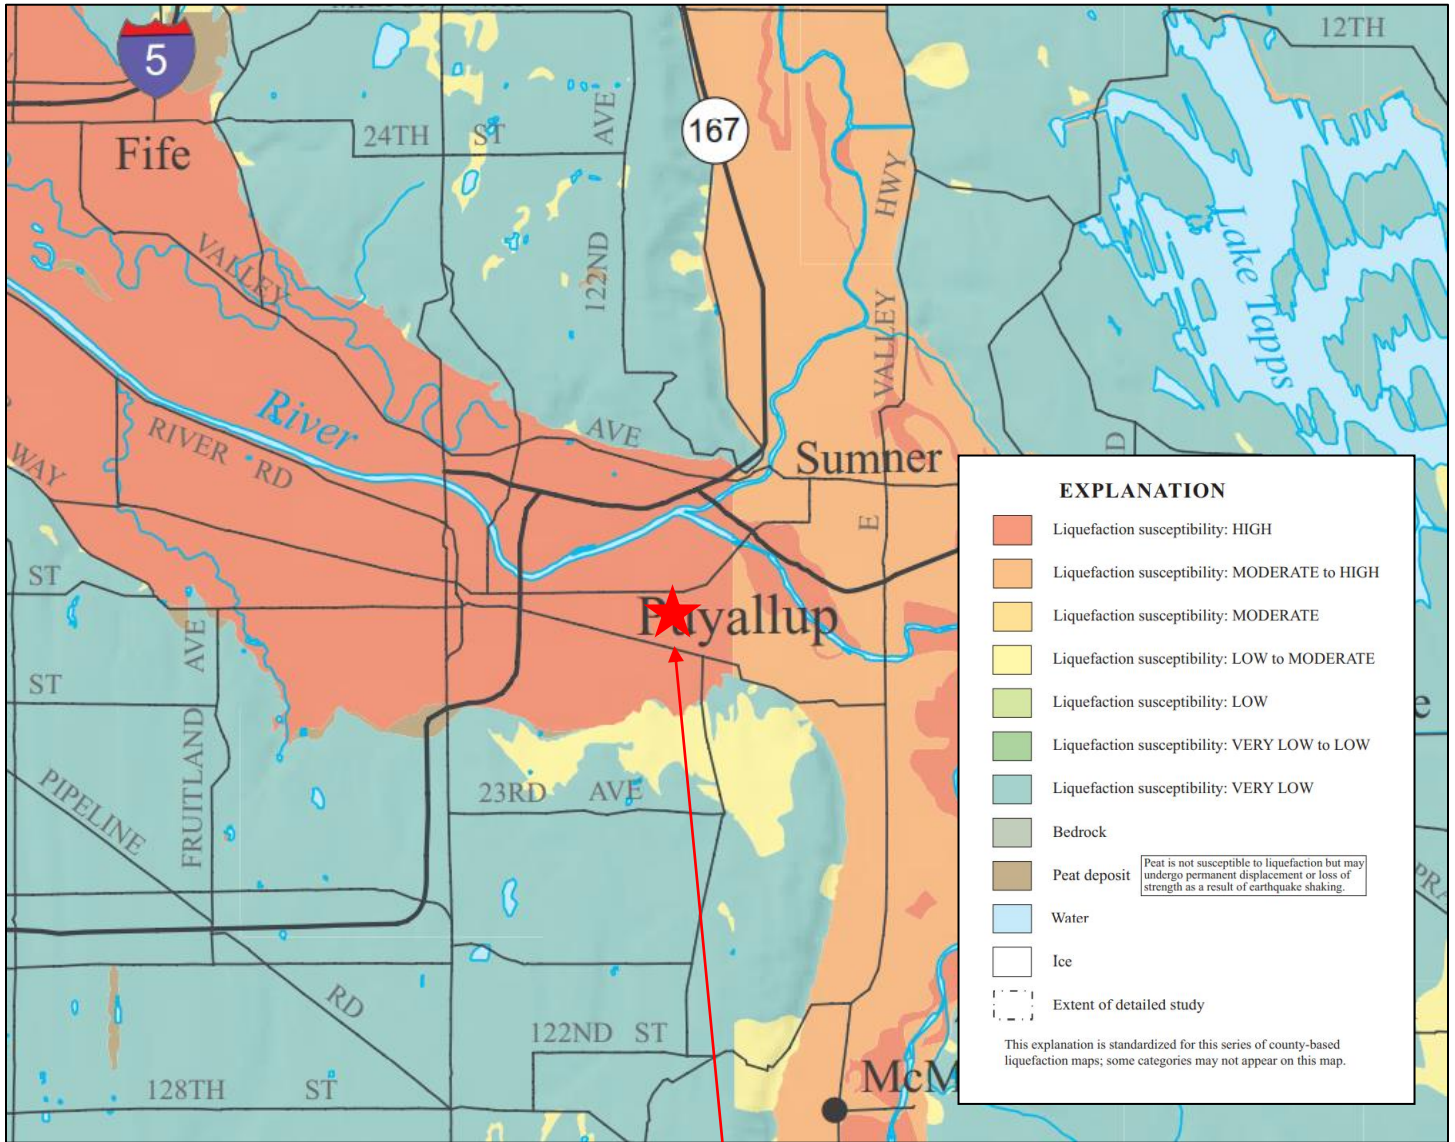
Figure 5

Map created from the Liquefaction Susceptibility Map of Pierce County, Washington by Stephen P. Palmer, Sammantha L. Magsino, Eric L. Bilderback, James L. Poelstra, Derek S. Folger, and Rebecca A. Niggemann (September 2004)

Earthquake-induced geologic hazards may include liquefaction, lateral spreading, slope instability, and ground surface fault rupture. Liquefaction is a phenomenon where there is a reduction or complete loss of soil strength due to an increase in pore water pressure in soils. The increase in pore water pressure is induced by seismic vibrations. Liquefaction primarily affects geologically recent deposits of loose, uniformly graded, fine-grained sands and granular silts that are below the groundwater table. The site is mapped as having a "High" liquefaction susceptibility by the *Liquefaction Susceptibility Map of Pierce County, Washington* (2004); an excerpt of this map is included as Figure 5.

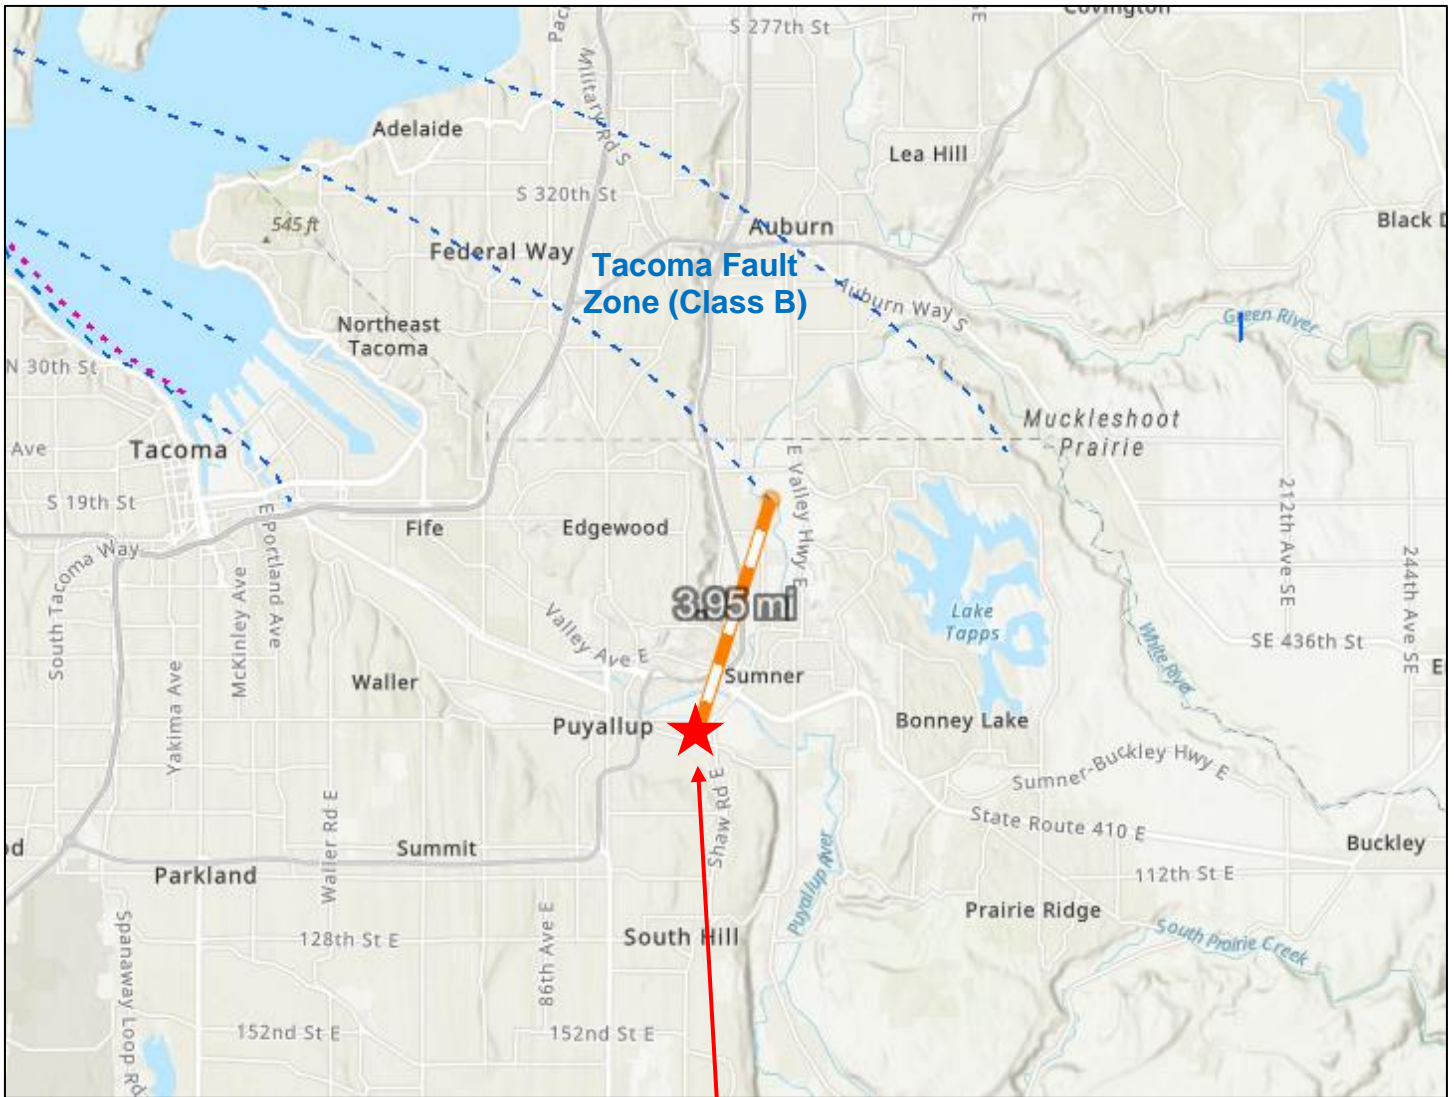
Figure 6

Map created from the Washington Geologic Information Portal ([geologyportal.dnr.wa.gov](http://geologyportal.dnr.wa.gov))

## Fault Hazards Map

The ground surface at the project site is generally level and the offsite slopes to the west are mapped as bedrock; therefore, in our opinion, the potential for earthquake-induced slope instability on the site is low. According to the Department of Natural Resources Geologic Hazards Map (Geologic Information Portal), the site is located about 4 miles south of the Tacoma Fault Zone. The USGS Interactive Fault Map for the general area is included as Figure 6. No evidence of ground fault rupture was observed in the subsurface explorations or out site reconnaissance. Therefore, in our opinion, the proposed structure should have no greater risk for ground fault rupture than other structures located in the area.

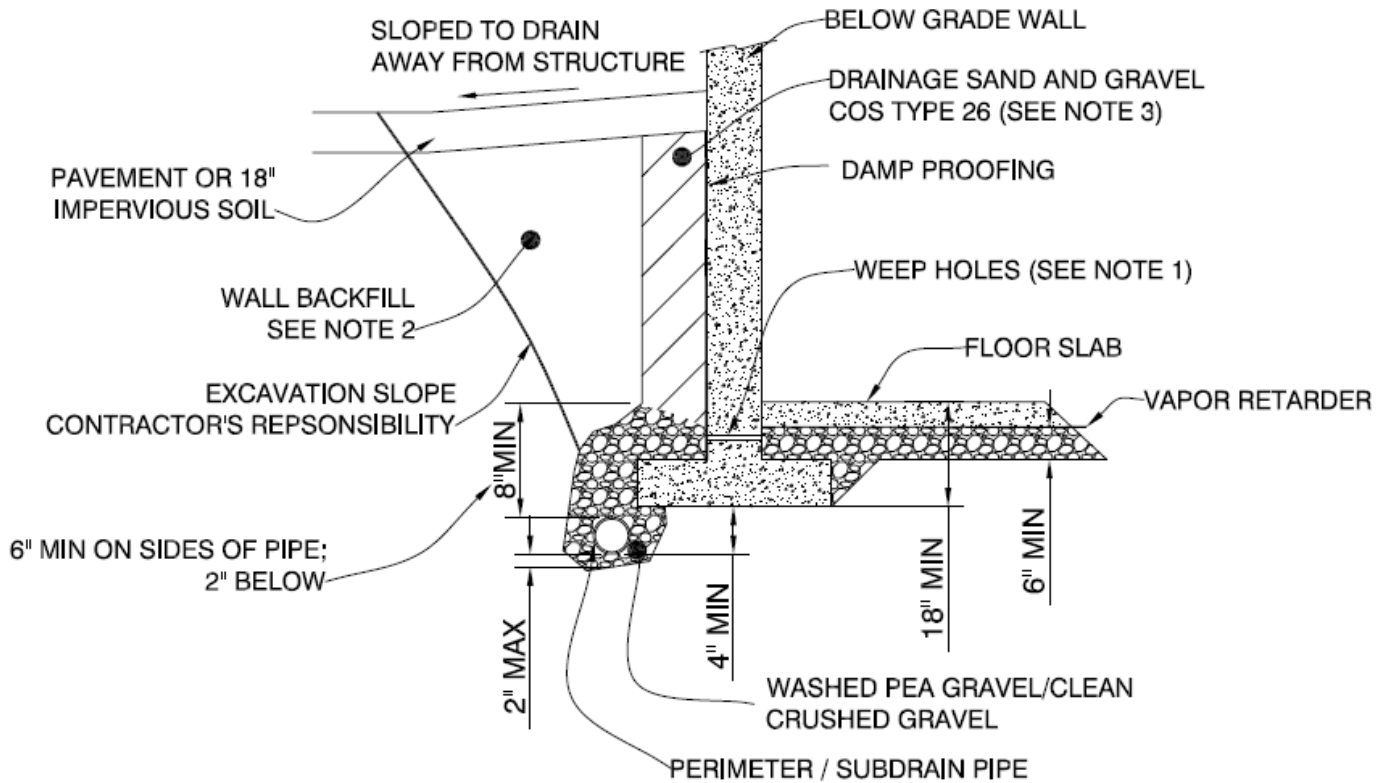
1. Washed pea gravel/crushed rock beneath floor slab could be hydraulically connected to perimeter/subdrain pipe. Use of 1" diameter weep holes as shown is one applicable method. Crushed gravel should consist of 3/4" minus. Washed pea gravel should consist of 3/8" to No. 8 standard sieve.

2. Wall backfill should meet WSDOT Gravel Backfill for walls Specification 9-03-12(2).
3. Drainage sand and gravel backfill within 18" of wall should be compacted with hand-operated equipment. Heavy equipment should not be used for backfill, as such equipment operated near the wall could increase lateral earth pressures and possibly damage the wall. The table below presents the drainage sand and gravel gradation.

We recommend that footing drains are installed for the residence in accordance with IBC 1805.4.2, and basement walls (if utilized) have a wall drain as describe above. The downspouts should not be connected to directly the footings drains until they are combined to tightline to the discharge point. Figure 7 shows typical wall drainage and backfilling details. If the basement cut extends below the adjacent municipal stormwater system, a sump and pump system may be required.

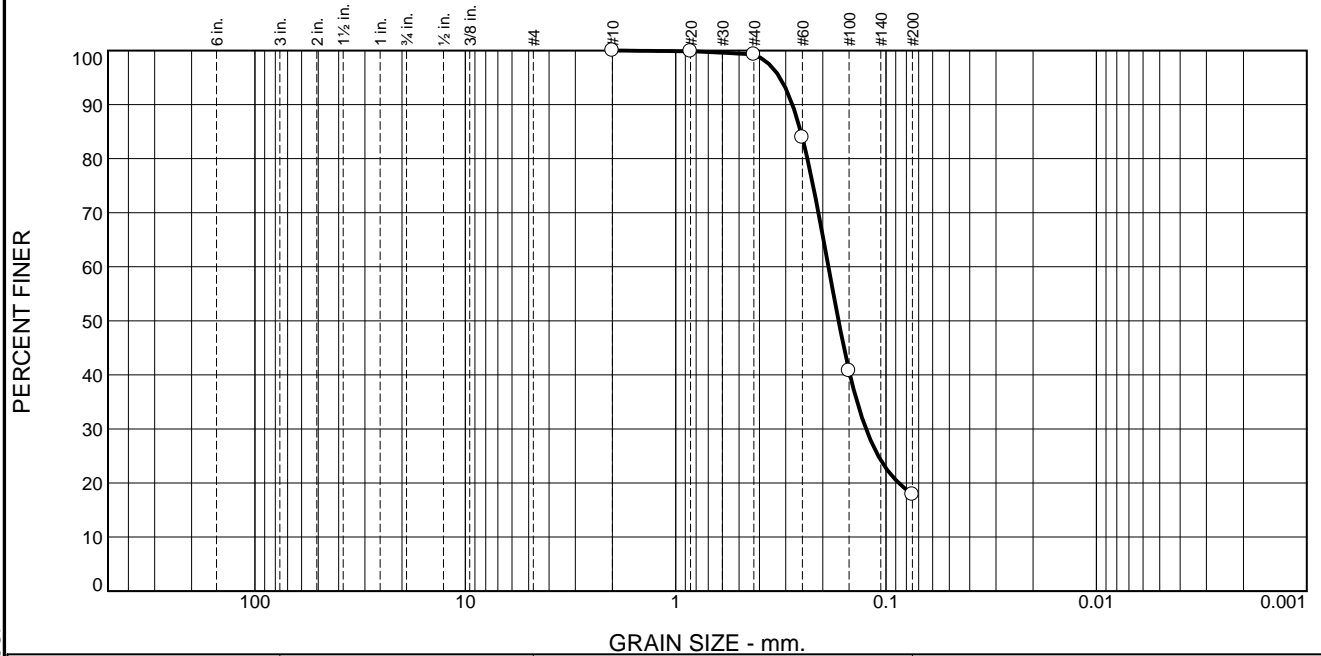
# Particle Size Distribution Report

% +3"	% Gravel		% Sand			% Fines	
	Coarse	Fine	Coarse	Medium	Fine	Silt	Clay
0.0	0.0	0.0	0.0	0.7	81.4	17.9

Test Results (ASTM D 6913 & ASTM D 1140)			
Opening Size	Percent Finer	Spec.* (Percent)	Pass? (X=Fail)
#10	100.0		
#20	99.9		
#40	99.3		
#60	83.9		
#100	40.8		
#200	17.9

Geotechnical laboratory tests were performed on select samples retrieved from the test pits to estimate index engineering properties of the soils encountered. Laboratory testing included visual soil classification per ASTM D2488 and ASTM D2489, moisture content determinations per ASTM D2216, and grain size analyses per ASTM D6913 standard procedures. The results of the laboratory tests are summarized below in Table 3 and graphical outputs are included in Appendix B.
