Reference: Geotechnical Engineering Investigation
East Town Crossing
Parcel Nos. 0420264053, 0420264054, 0420351066
SE Corner of E. Shaw Road and E. Pioneer Way
Puyallup, Washington 98371

**GEOTECHNICAL ENGINEERING INVESTIGATION
EAST TOWN CROSSING
PARCEL NOS. 0420264053, 0420264054, 0420351066
SE CORNER OF E. SHAW ROAD & E. PIONEER WAY
PUYALLUP, WASHINGTON**

**PROJECT NO. 062-19005
APRIL 11, 2019**

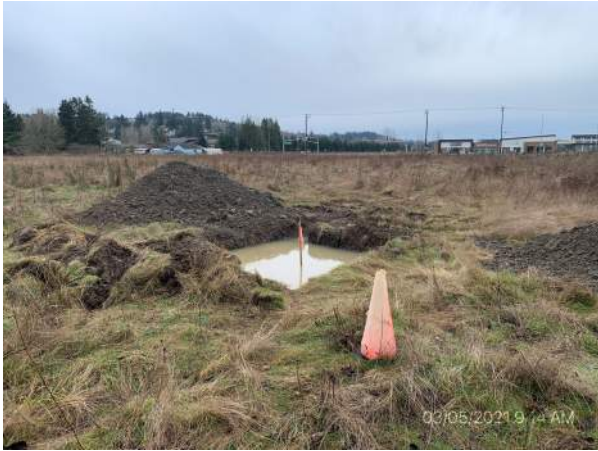
Water in Pit P-1 on March 5, 2021.

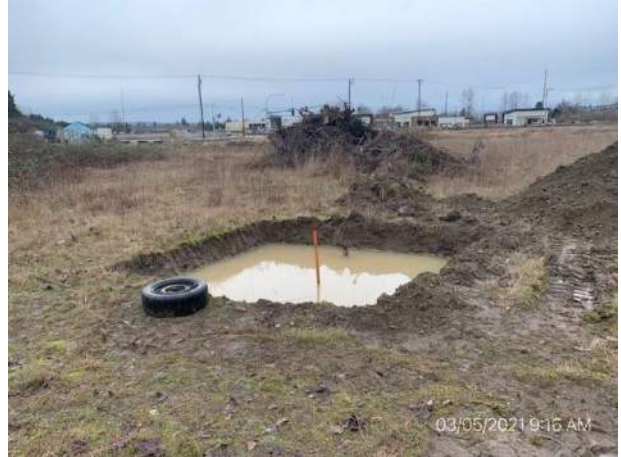
Water in Pit P-2 on March 5, 2021.

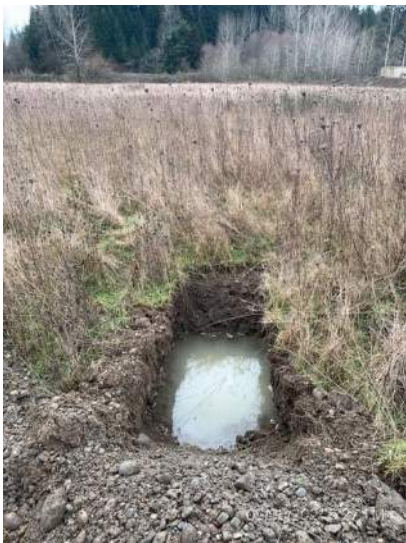
Water in Test Pit on March 5, 2021. Test pit was excavated in NE portion of site on March 4, 2021.
