*Subsurface Exploration, Geologic Hazard, Infiltration Feasibility,
and Preliminary Geotechnical Engineering Report*

PSD - SOUTH HILL SITE

Puyallup, Washington

Project No. 20210394E001

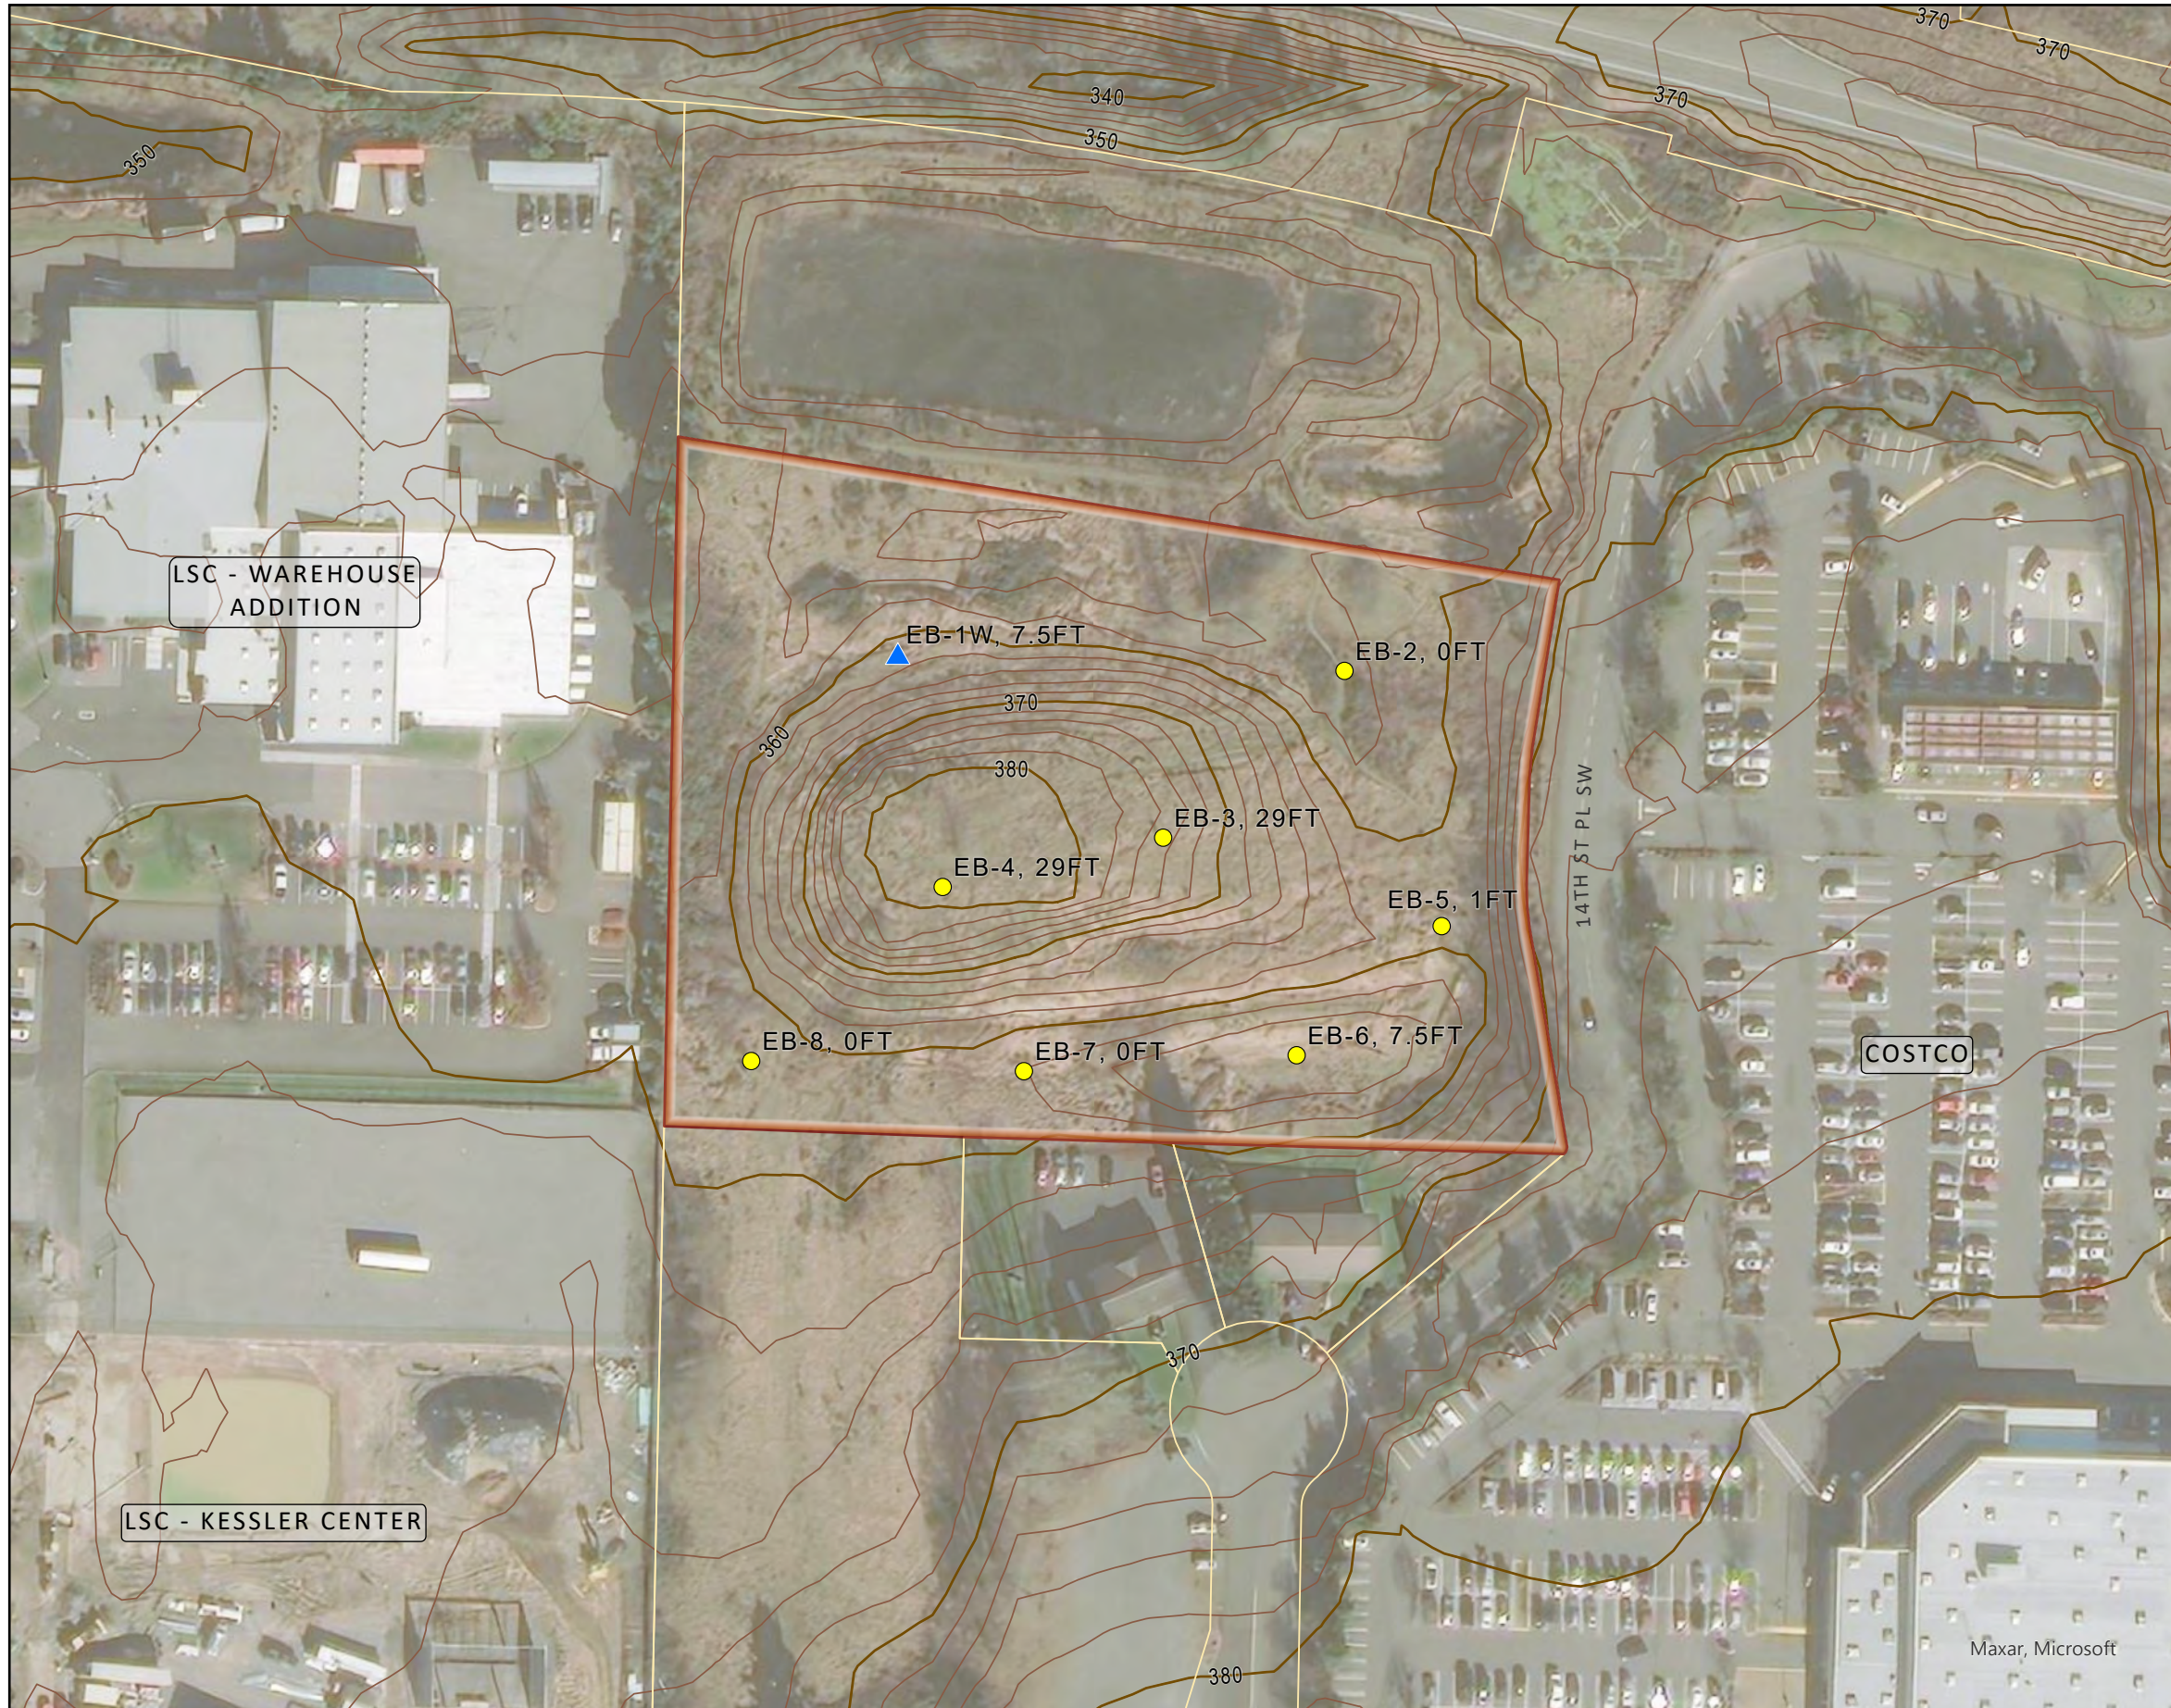
Our field explorations were conducted in October 2021 and included advancing eight exploration borings, one of which was completed as a groundwater monitoring well (EB-1W). The existing site conditions, and the approximate locations of subsurface explorations referenced in this study, are presented on the “Existing Site and Exploration Plan” (Figure 2). The various types of

Fill soils (those not naturally placed), were observed in borings EB-1W, EB-3, EB-4, EB-5, and EB-6. The observed fill thicknesses ranged between 1 foot (EB-5) and 29 feet (EB-3). Figure 2 includes the observed fill depths at each of the exploration locations. The fill generally consisted of loose to medium dense, moist, light brown to brown, fine to medium sand with variable silt content and variable gravel content. Organics (wood pieces) and faint organic odors were observed in the fill at the locations of borings EB-3 and EB-4. Existing fill may require remedial preparation below new pavement areas. Excavated existing fill material is potentially suitable for reuse in structural fill applications if such reuse is specifically allowed by project plans and specifications, if excessively organic and any other deleterious materials are removed, and if moisture content is adjusted (by aeration or cement amendment) to allow compaction to the specified level and to a firm and unyielding condition. Existing fill is not suitable for infiltration of stormwater and will be difficult to reuse during wet weather.

sediments, as well as the depths where the characteristics of the sediments changed, are indicated on the exploration logs presented in Appendix A. The depths indicated on the logs where conditions changed may represent gradational variations between sediment types. If changes occurred between sample intervals in our exploration borings, they were interpreted. Our explorations were approximately located in the field by measuring from known site features depicted on the aerial photograph used as a basis for Figure 2.
