## **Stormwater Site Plan – Phase 2**

East Town Crossing  
2902 E Pioneer  
Puyallup, WA 98372  
2230752.10

May 2024  
Revised January 2025

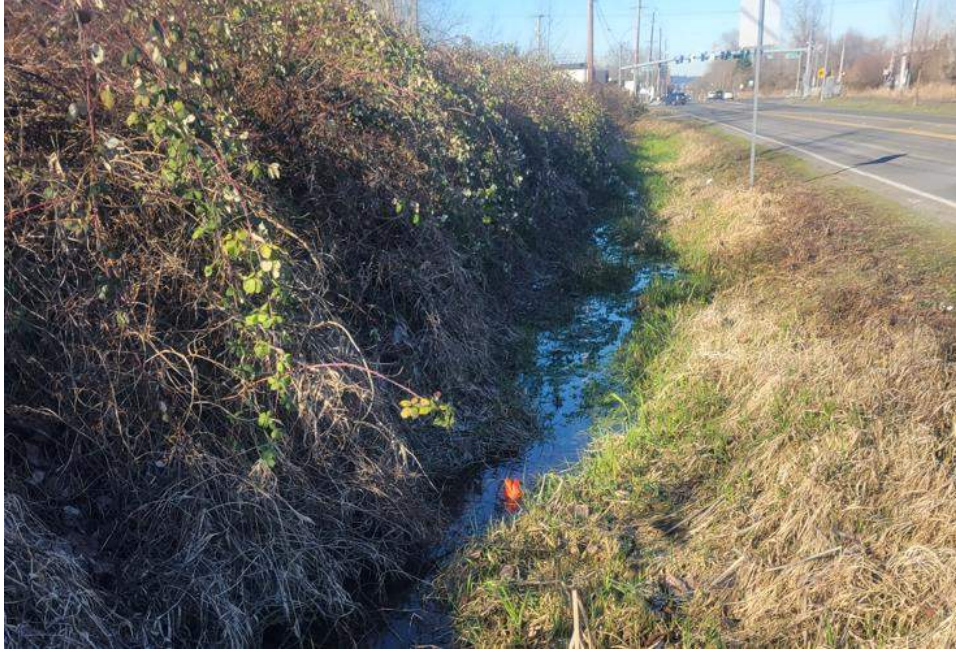
*Typical degraded conditions of Stream Z within ROW of East Pioneer Avenue*

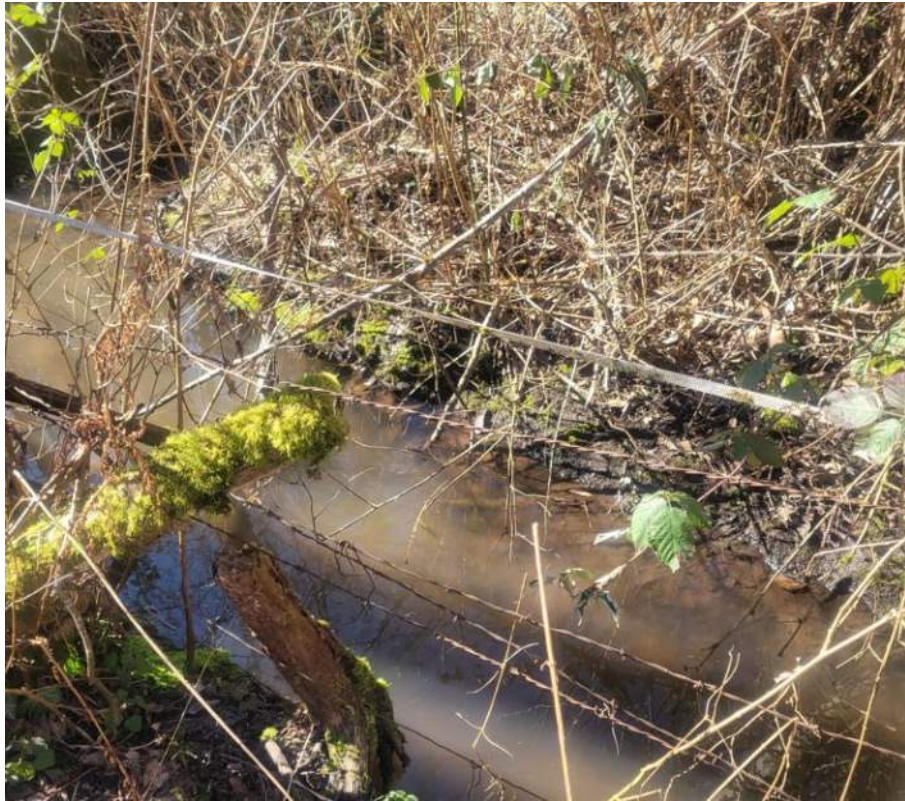
*Typical conditions of Stream Y*
