## Meridian Firs Apartments Deck Repair

Scope of Work

2923 S. MERIDIAN ST (BLDG F)

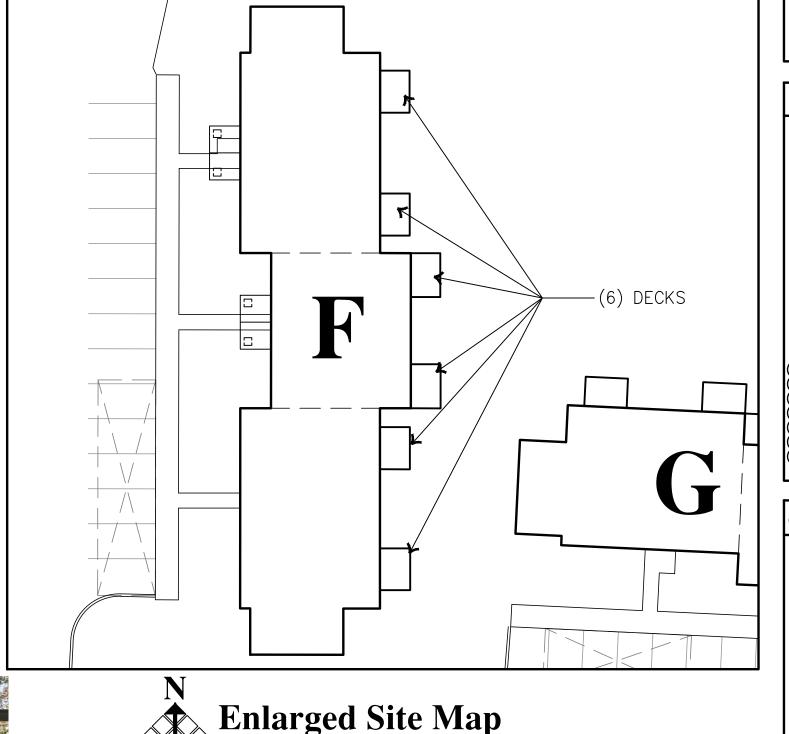
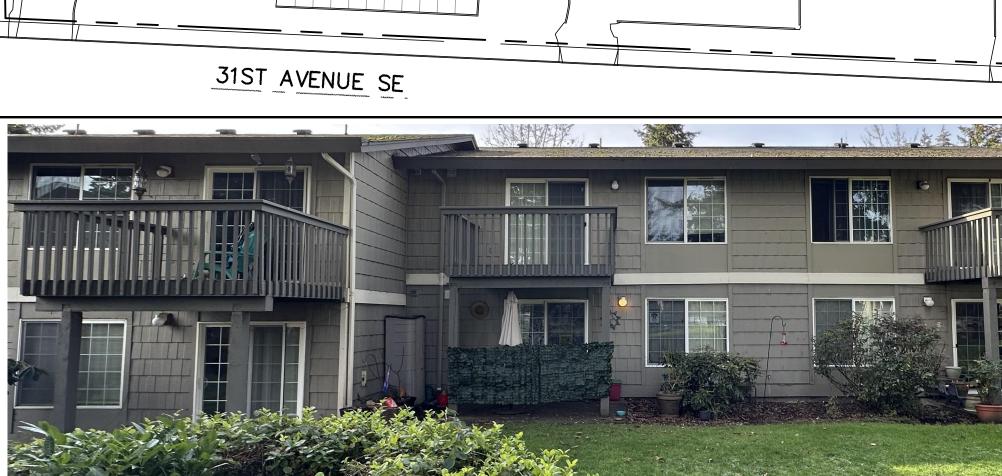
**Photos of Existing Conditions**

**Enlarged Site Map**  $\sim$ EXISTING CONDITIONS AT DECKS: - NO DECK REPAIR/REPLACEMENT OR
