Deck Repair

City of Puyallup

**Project Statistics** CODE COMPLIANCE: 2021 INTERNATIONAL EXIST BLDG CODE 2923 S. MERIDIAN ST (BLDG G) SITE ADDRESS: PUYALLUP, WA 0419032096 R-2 OCCUPANCY MULTI-FAMILY 2 STORY APARTMENTS NUMBER OF DECKS: 4 DECKS

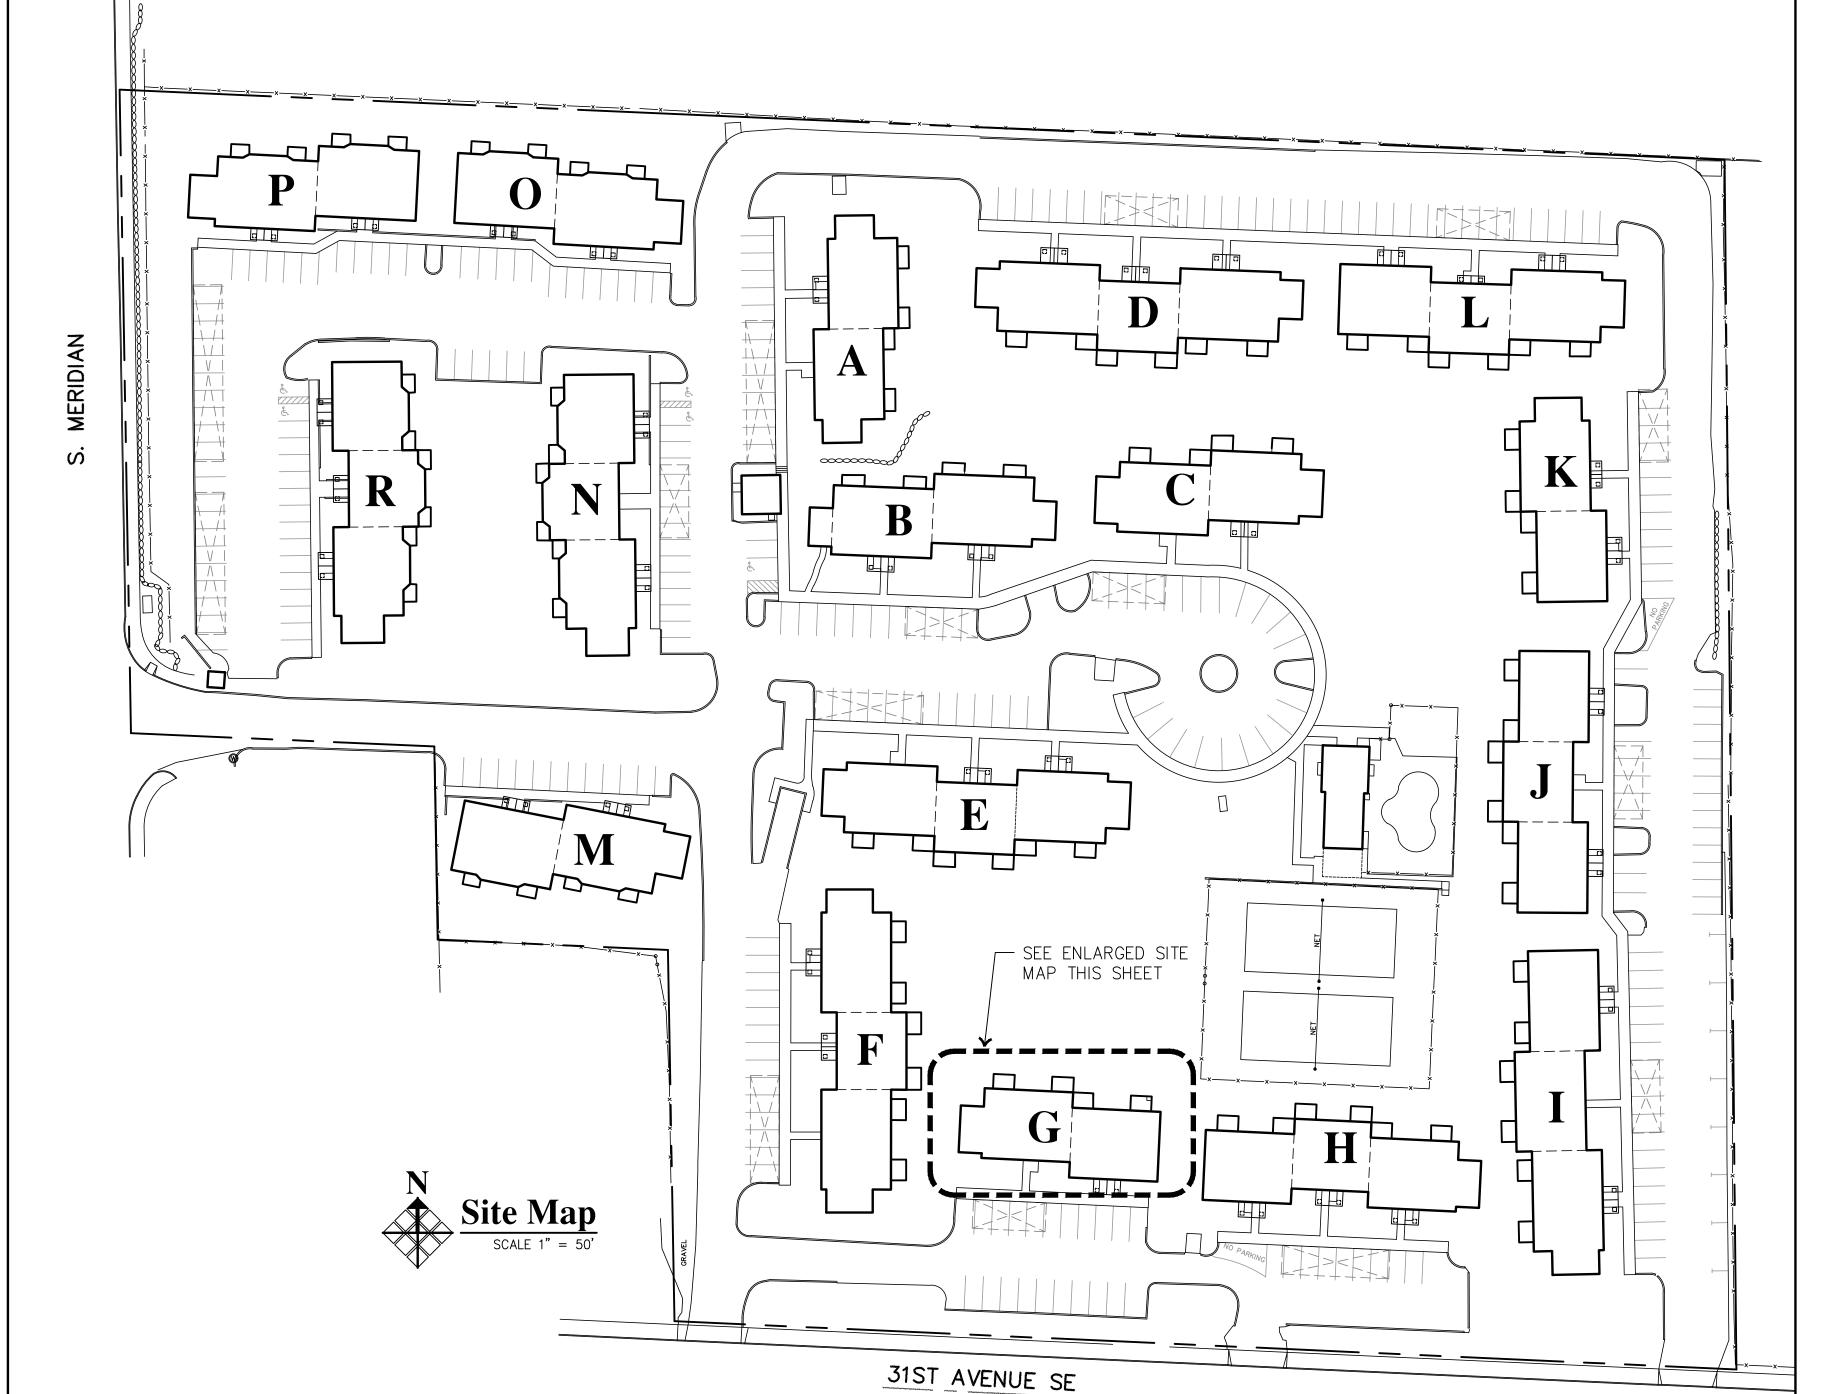
- DECKING REPLACEMENT COMPLETE - HORIZONTAL RAILING COMPLETE ON - RAILINGS NOT PAINTED - NO DECK REPAIR/REPLACEMENT OR CONSTRUCTION HAS BEEN STARTED **Photos of Existing Conditions**

REMOVE CORNER OF EXISTING CONCRETE PATIOS AS NEEDED POUR NEW CONCRETE FOOTINGS PER DETAILS AT NEW POST LOCATIONS WHERE CALLED OUT.

ADD NEW BEAM & POSTS PER DETAILS WHERE CALLED OUT.

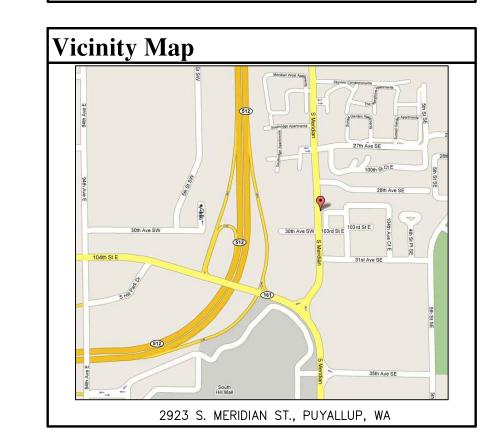
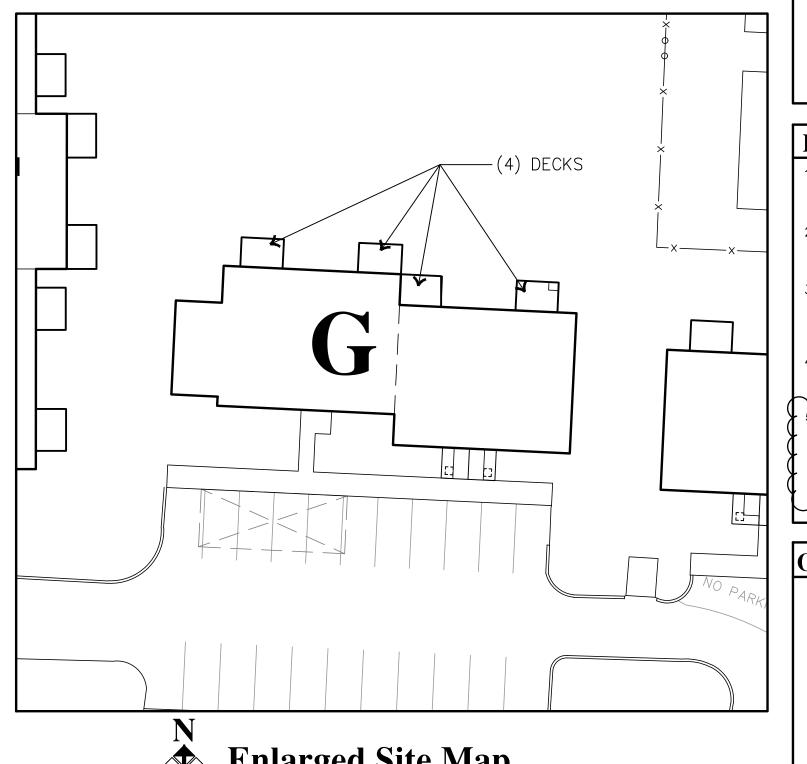
EXISTING CONDITIONS AT DECKS:
