Deck Repair

PUYALLUP, WA

Scope of Work

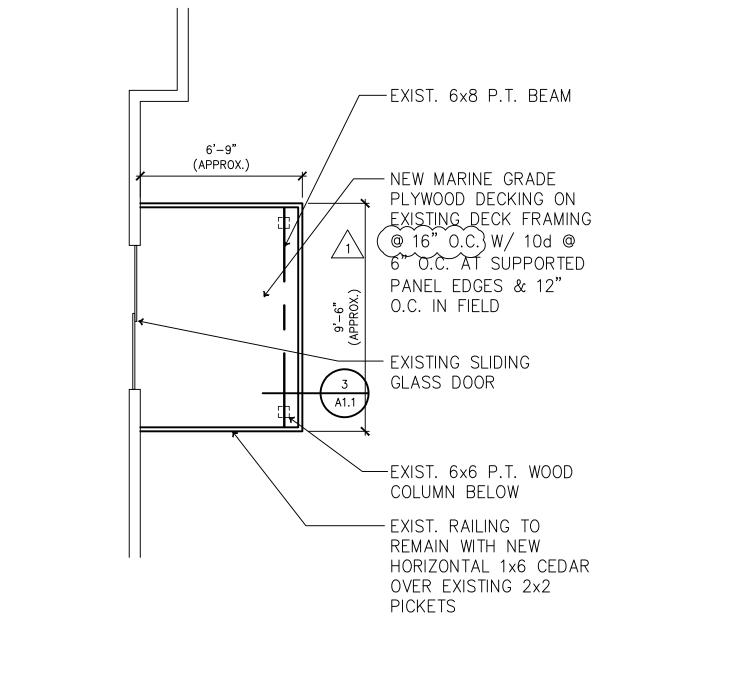
Typical Deck Elevation SCALE: 1/4" = 1' - 0"

IMPORTANT RAILING NOTE: THE CONTRACTOR SHALL EXAMINE AND DETERMINE THE CONDITION OF EXISTING 2x2 PICKETS AND REPLACE DAMAGED PICKETS WITH NEW OF LIKE KIND AND ATTACHMENT METHOD.

+ EXISTING 2x2 PICKETS

- REPLACE AS

NEW 3/4" MARINE

GRADE ROUGH TOP

SHEATHING '

EXISTING P.T

BEAM TO COLUMN BRACKET

EXISTING TOP RAILING

CAP TO REMAIN -

EXISTING

CANTILEVERED

DECK FRAMING-

/---NEW HORIZONTAL 1x6

CAP - PAINT TO

EXIST 6x8 P.T. BEAM

-EXISTING POST ON

SIMPSON ELEVATED POST

CEDAR OVER EXISTING

2x2 PICKETS WITH TOP

PER IBC SECTION 1015.4 OPENING LIMITATIONS: REQUIRED GUARDS SHALL NOT HAVE OPENINGS THAT ALLOW PASSAGE OF A SPHERE 4 INCHES (102 MM) IN DIAMETER FROM THE WALKING SURFACE TO THE REQUIRED GUARD HEIGHT.
