Geotechnical Engineering Report Proposed Multi-Family Development

202 – 27<sup>th</sup> Avenue Southeast Puyallup, Washington

Doc ID: Timberlane.BradleyHeights.RG

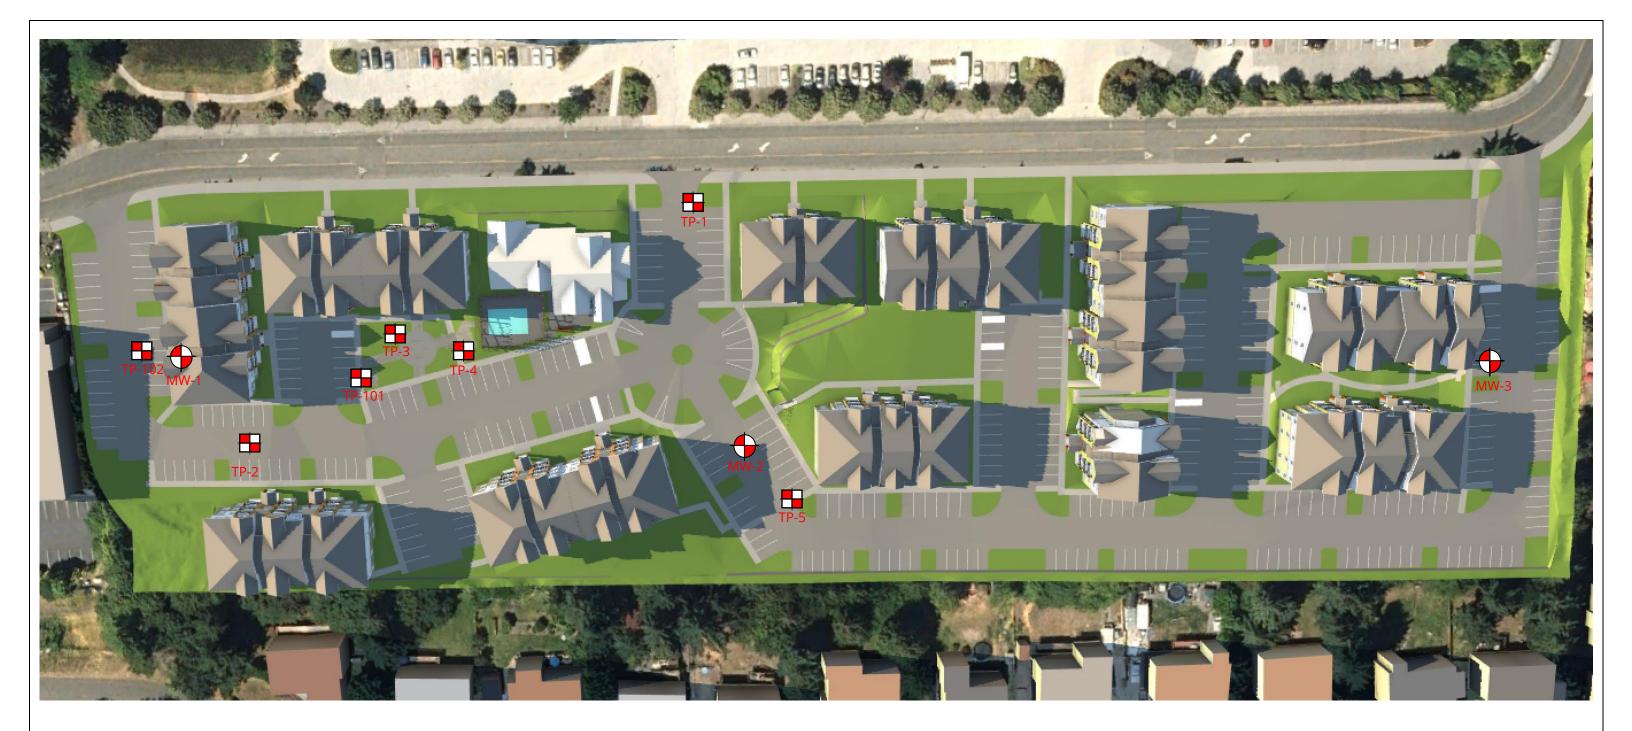
Figure 2

Conceptual site plan provided by Azure Green Consultants

Our understanding of the project is based on our discussions with you, a review of the *Conceptual Site Plan* provided to us by Azure Green Consultants (attached as our Figure 2), our subsurface explorations, including those completed during our most recent December 22, 2021 site visit, and our experience in the general area.
