## **Stormwater Site Plan – Phase 2**

East Town Crossing  
2902 E Pioneer  
Puyallup, WA 98372  
2230752.10

May 2024  
Revised January 2025

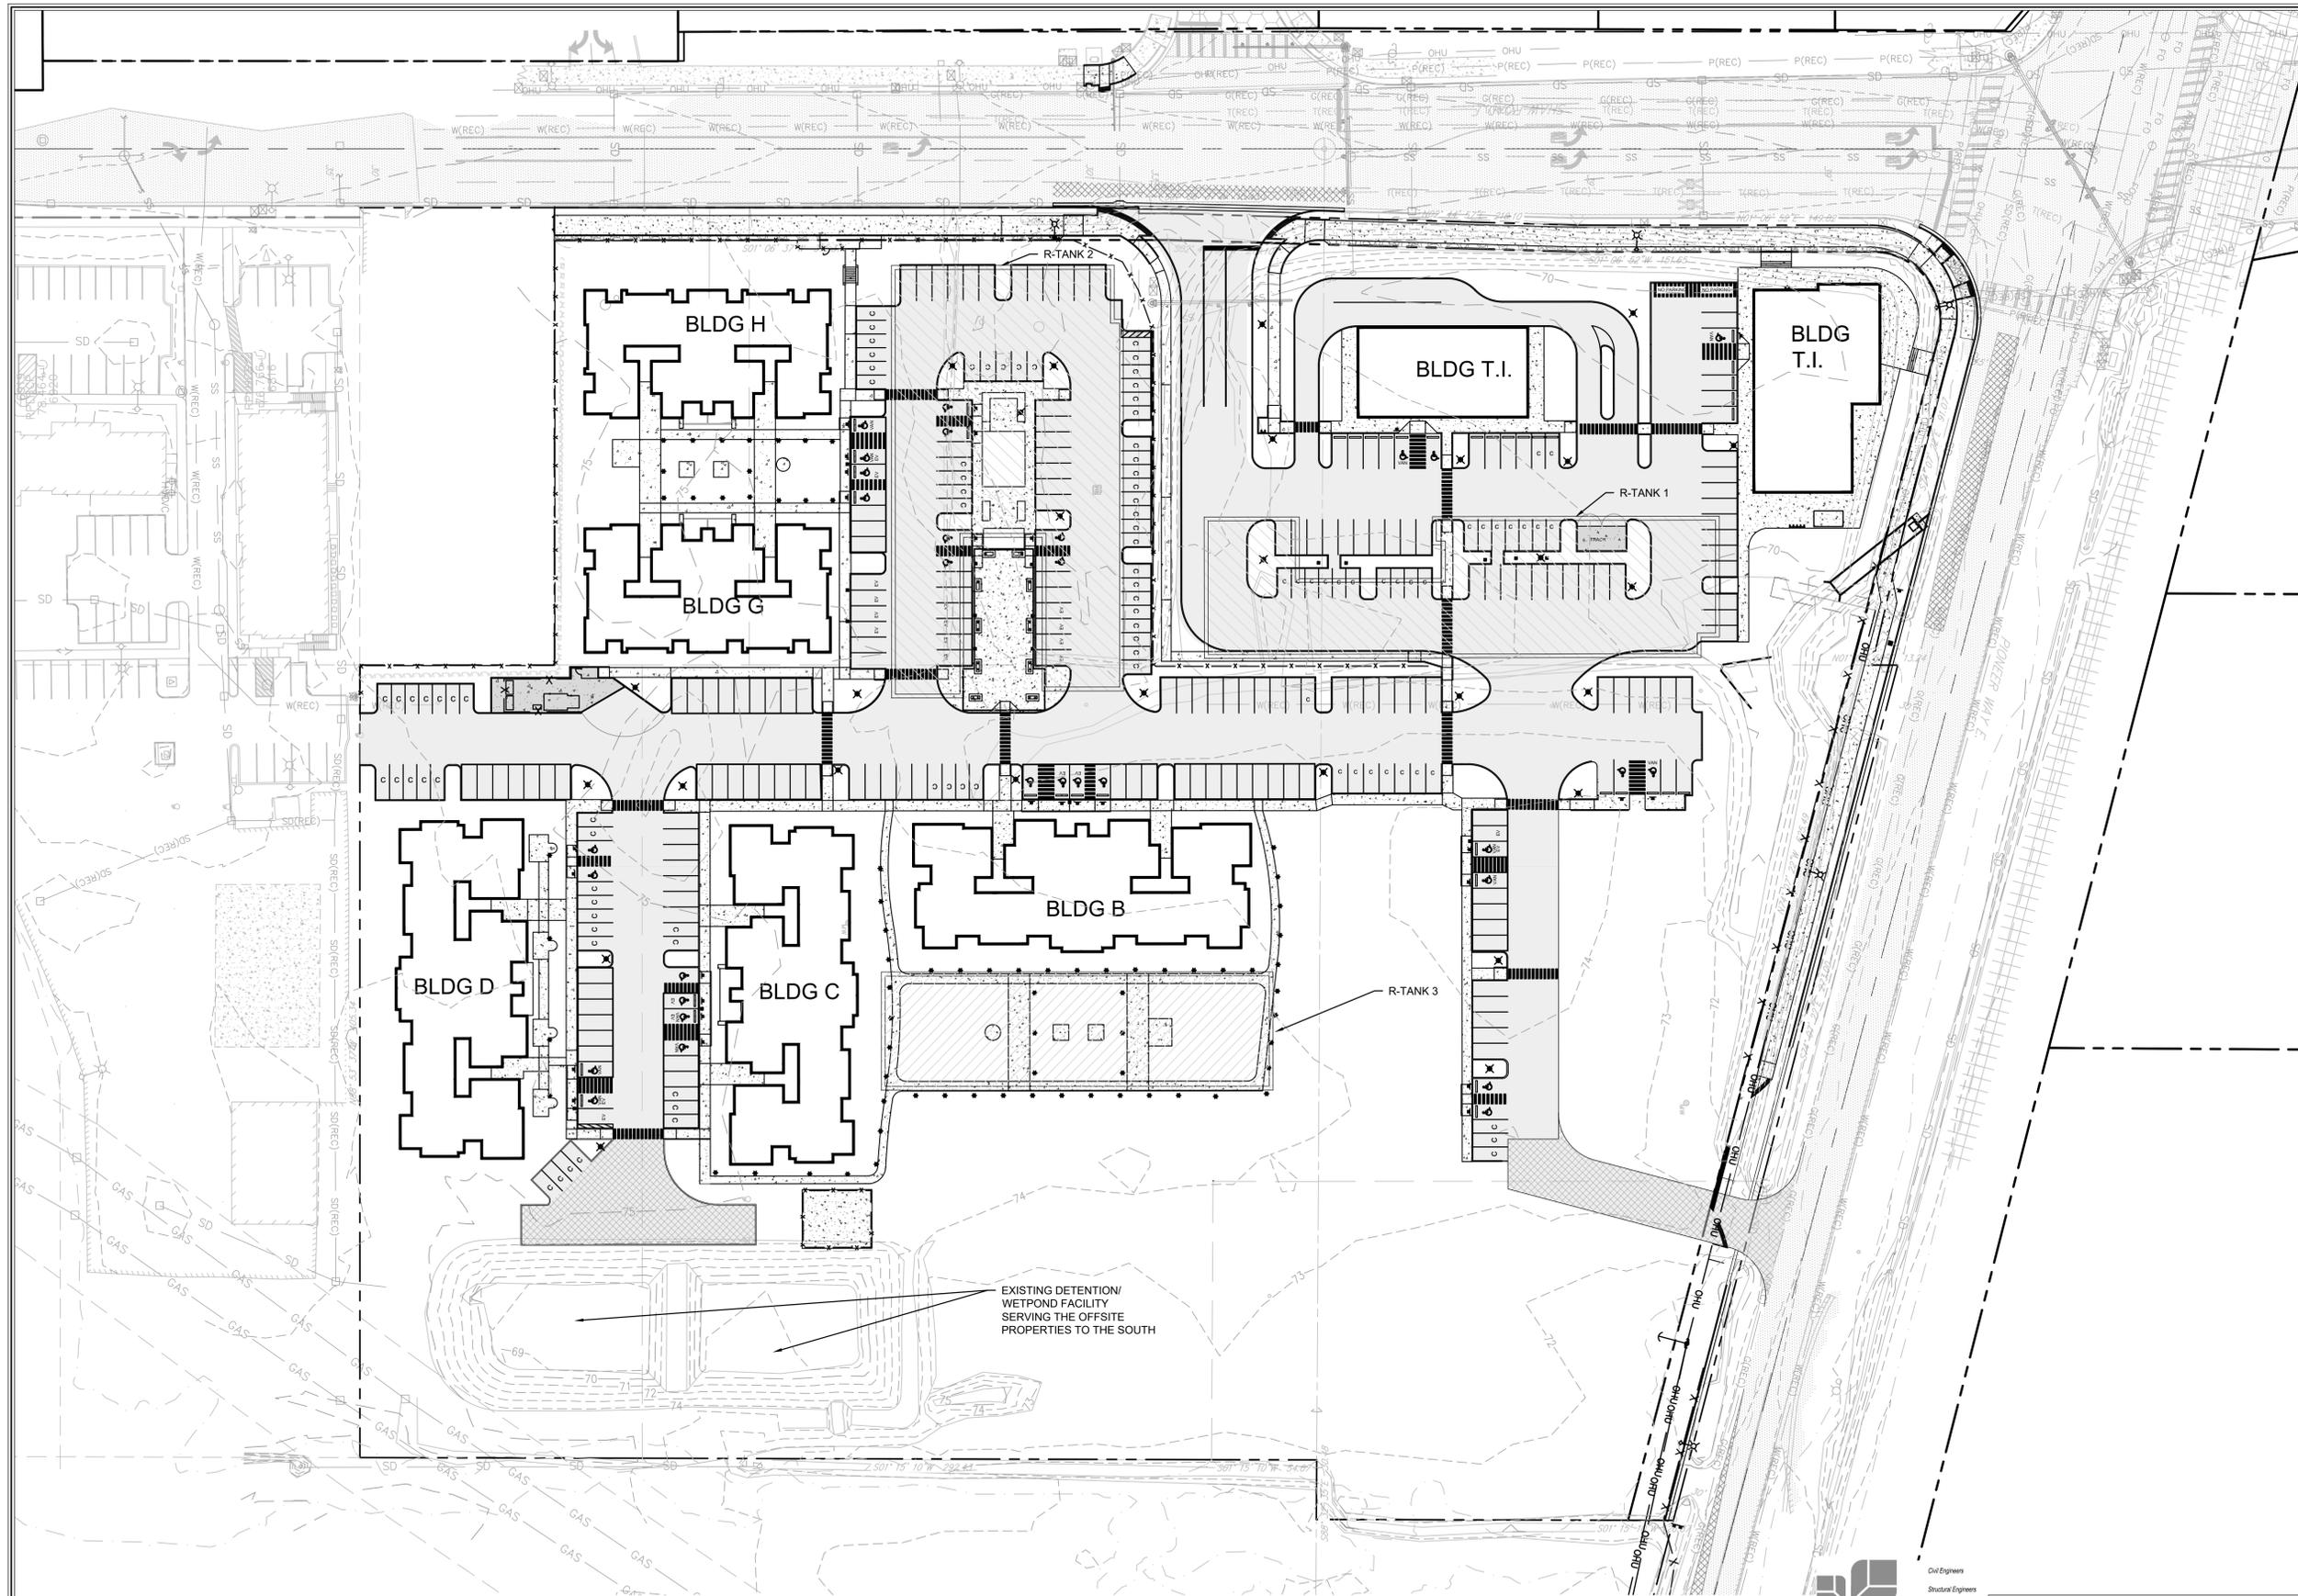
**A-2**

**EXISTING CONDITIONS MAP**  
**EAST TOWN CROSSING PHASE 2**

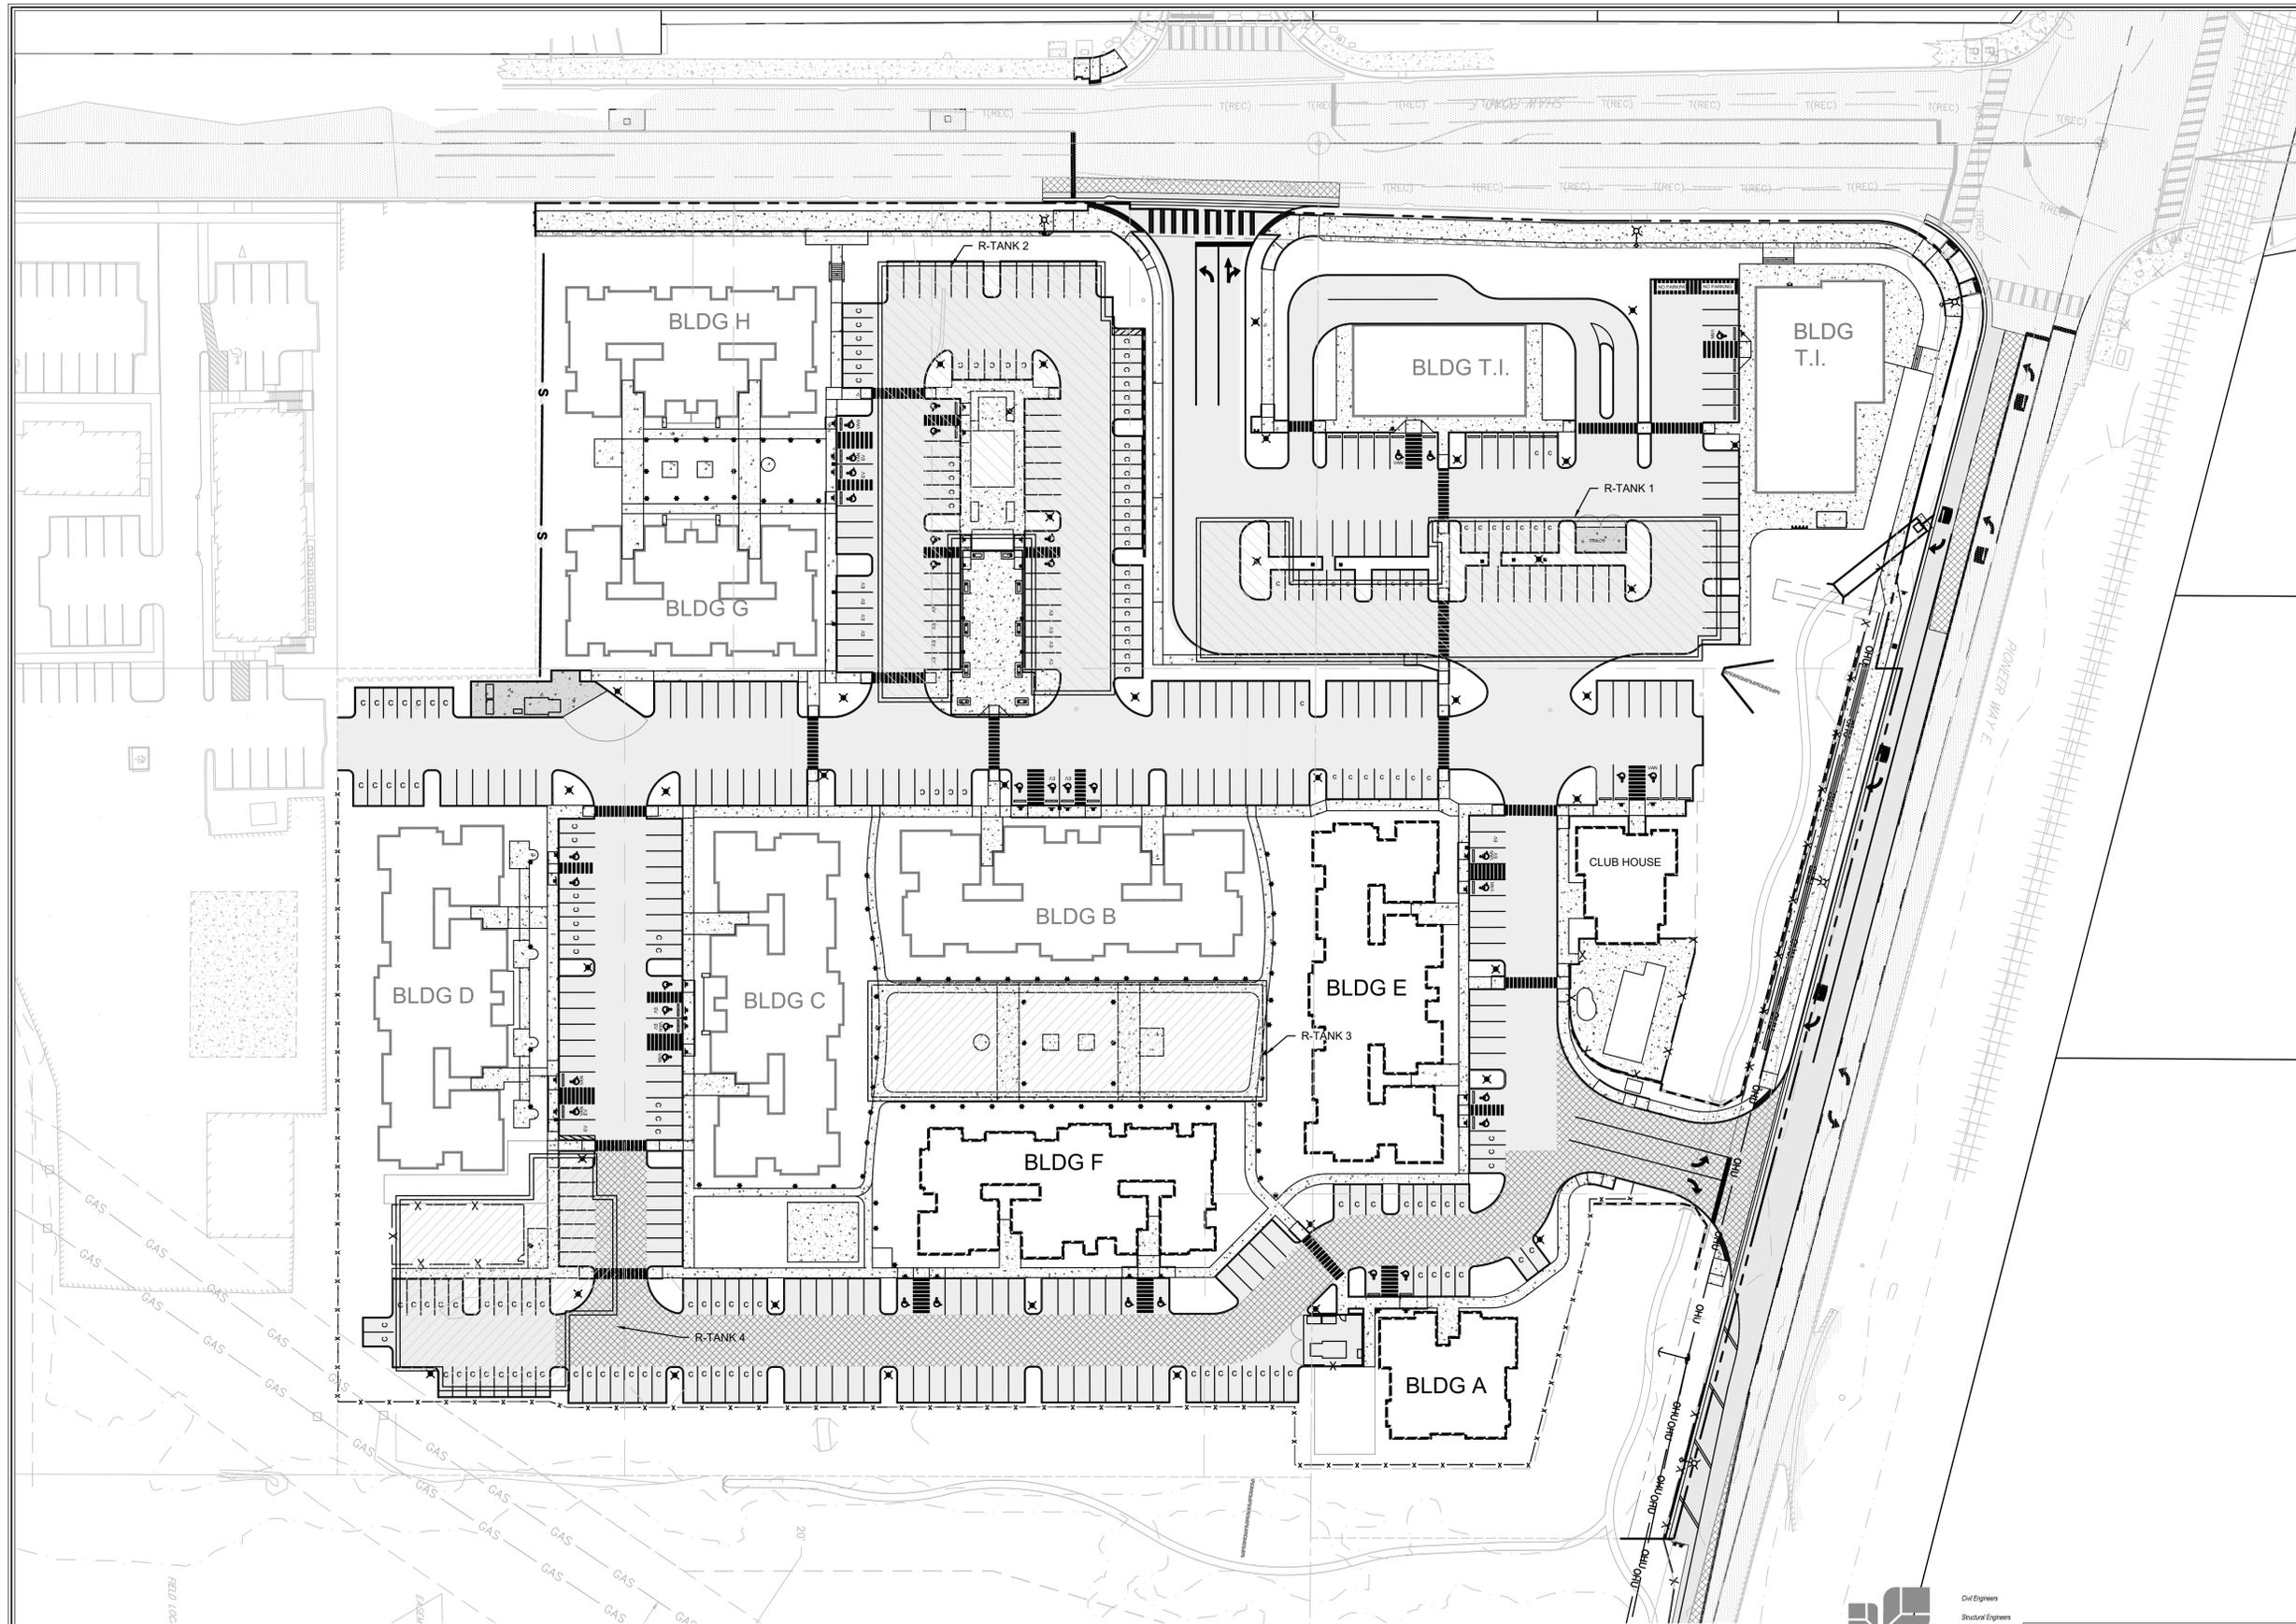
A-3

DEVELOPED CONDITIONS MAP  
 EAST TOWN CROSSING PHASE 2

See Appendix A, Exhibit A-3, for the Developed Conditions Map.

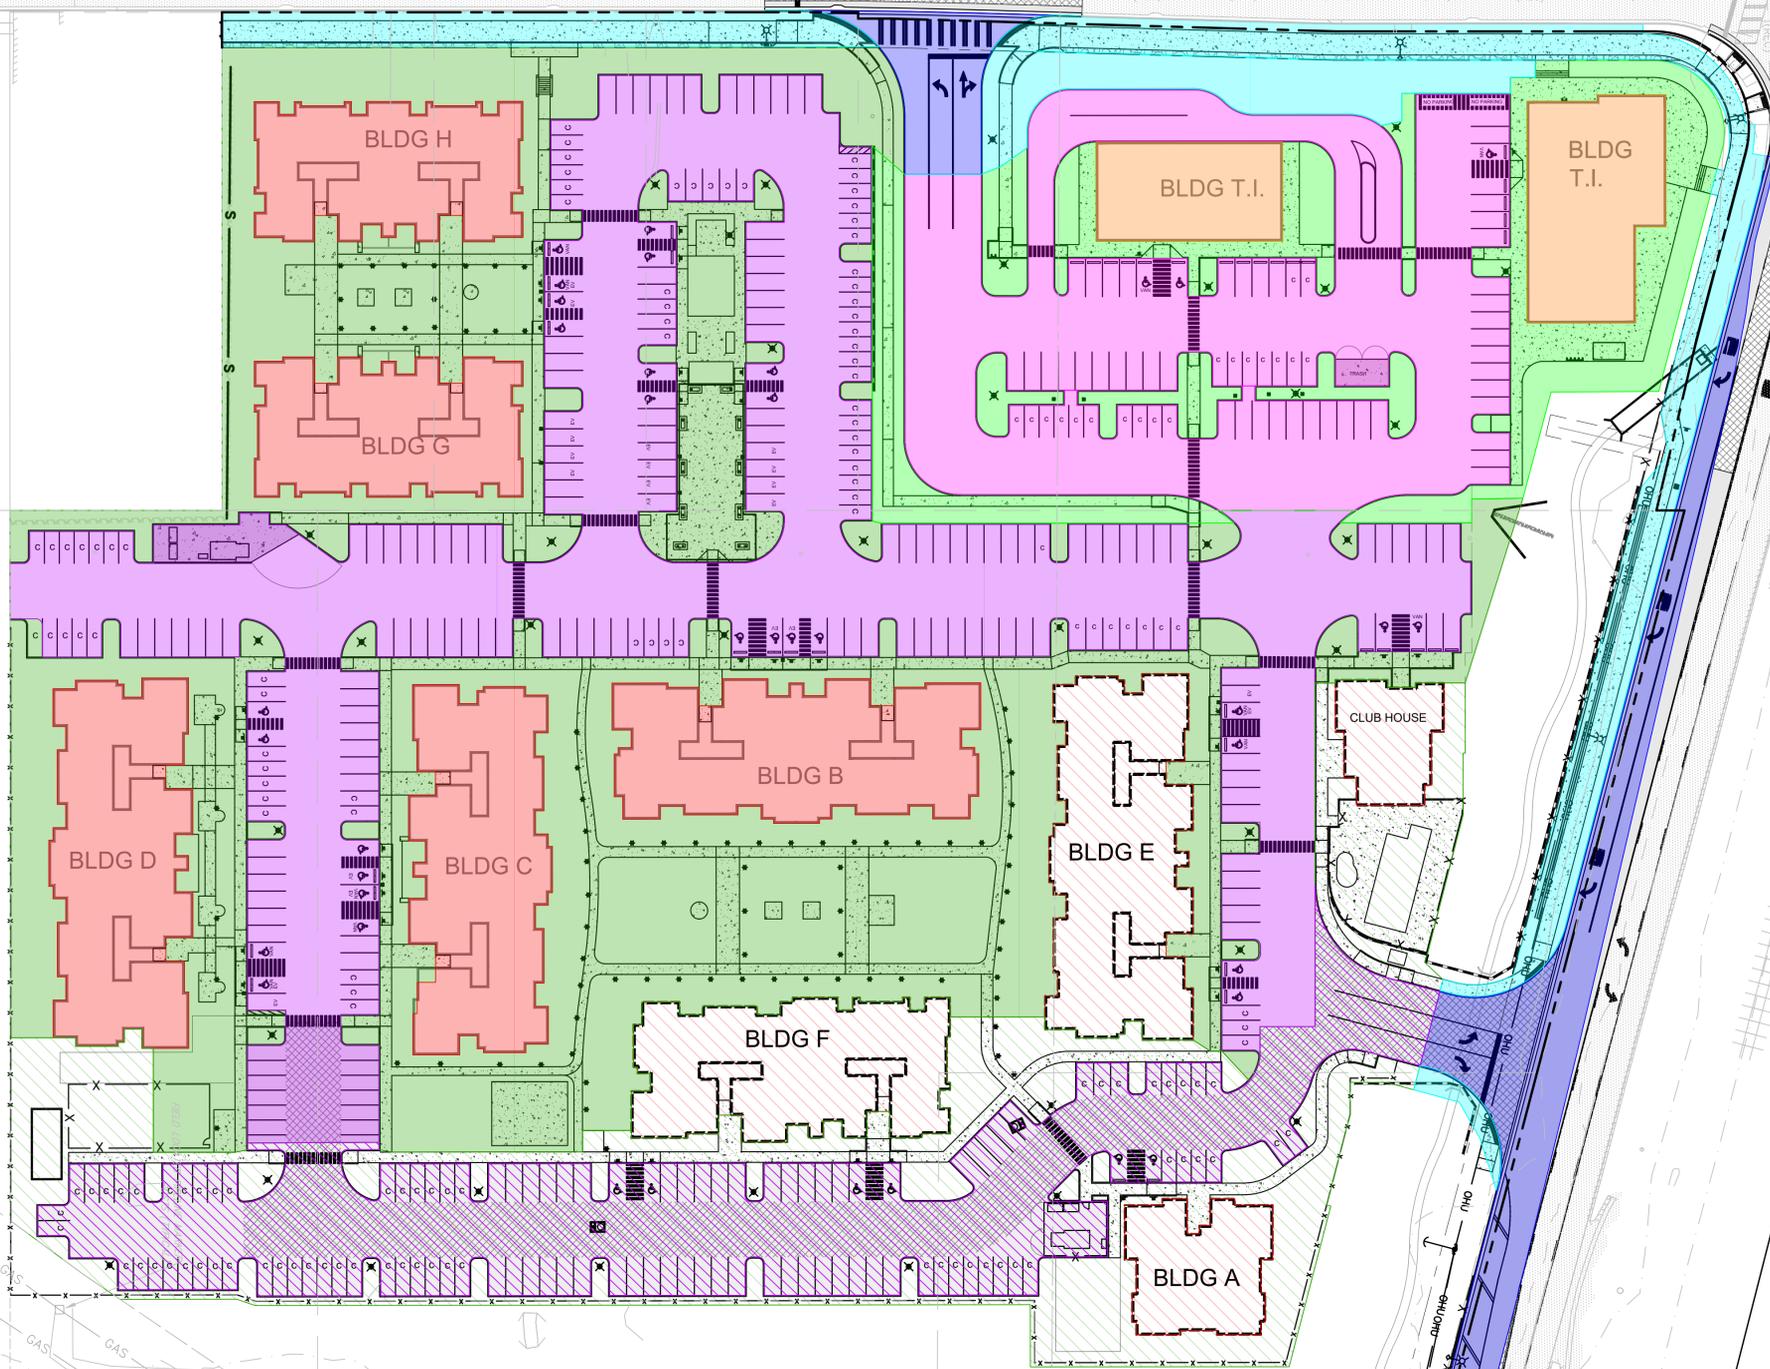
**SURFACE AREA BREAKDOWN:**

**DEVELOPED CONDITIONS BASIN MAP**

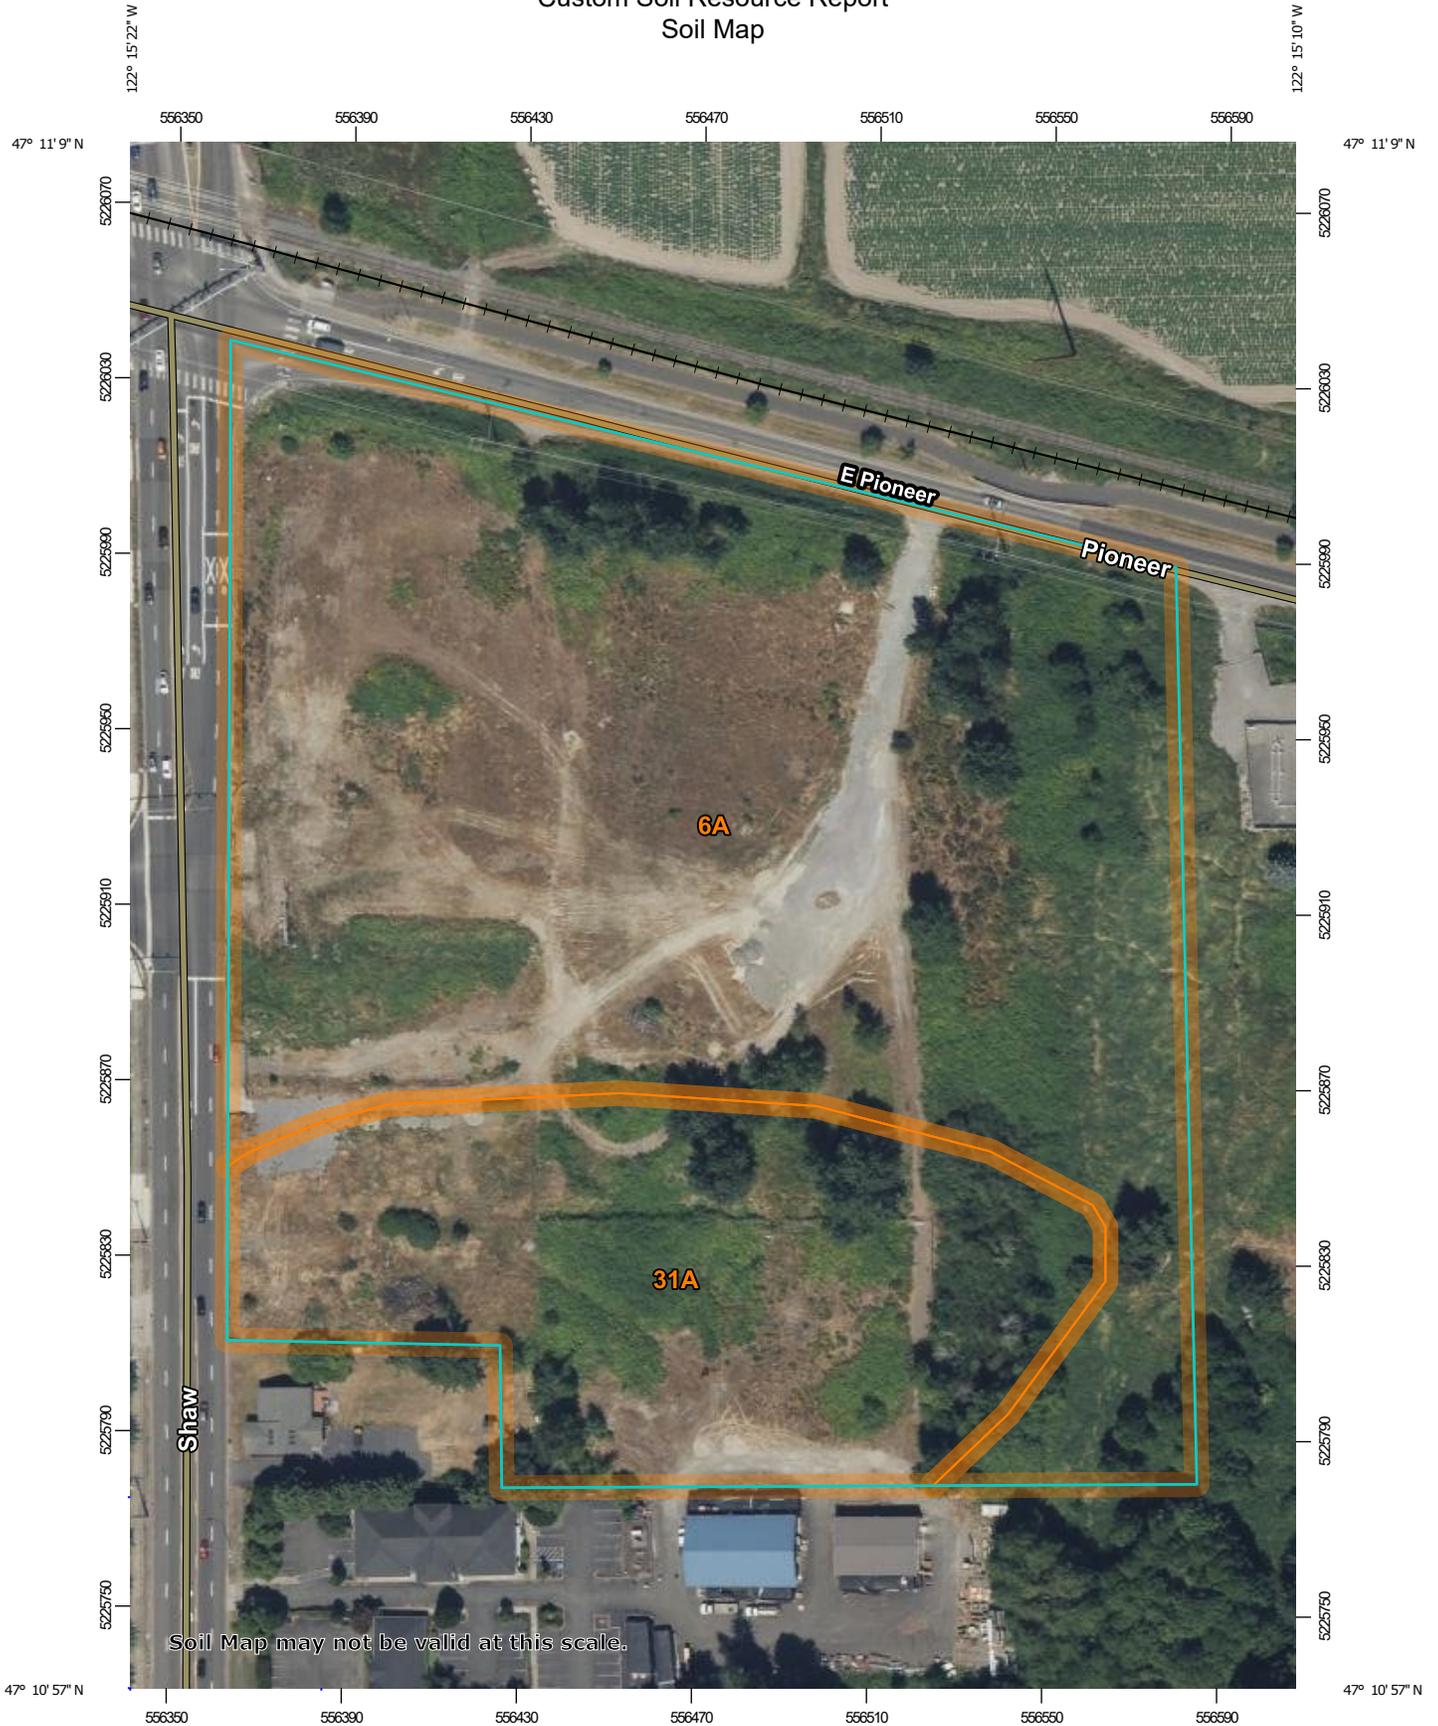
# Custom Soil Resource Report Soil Map

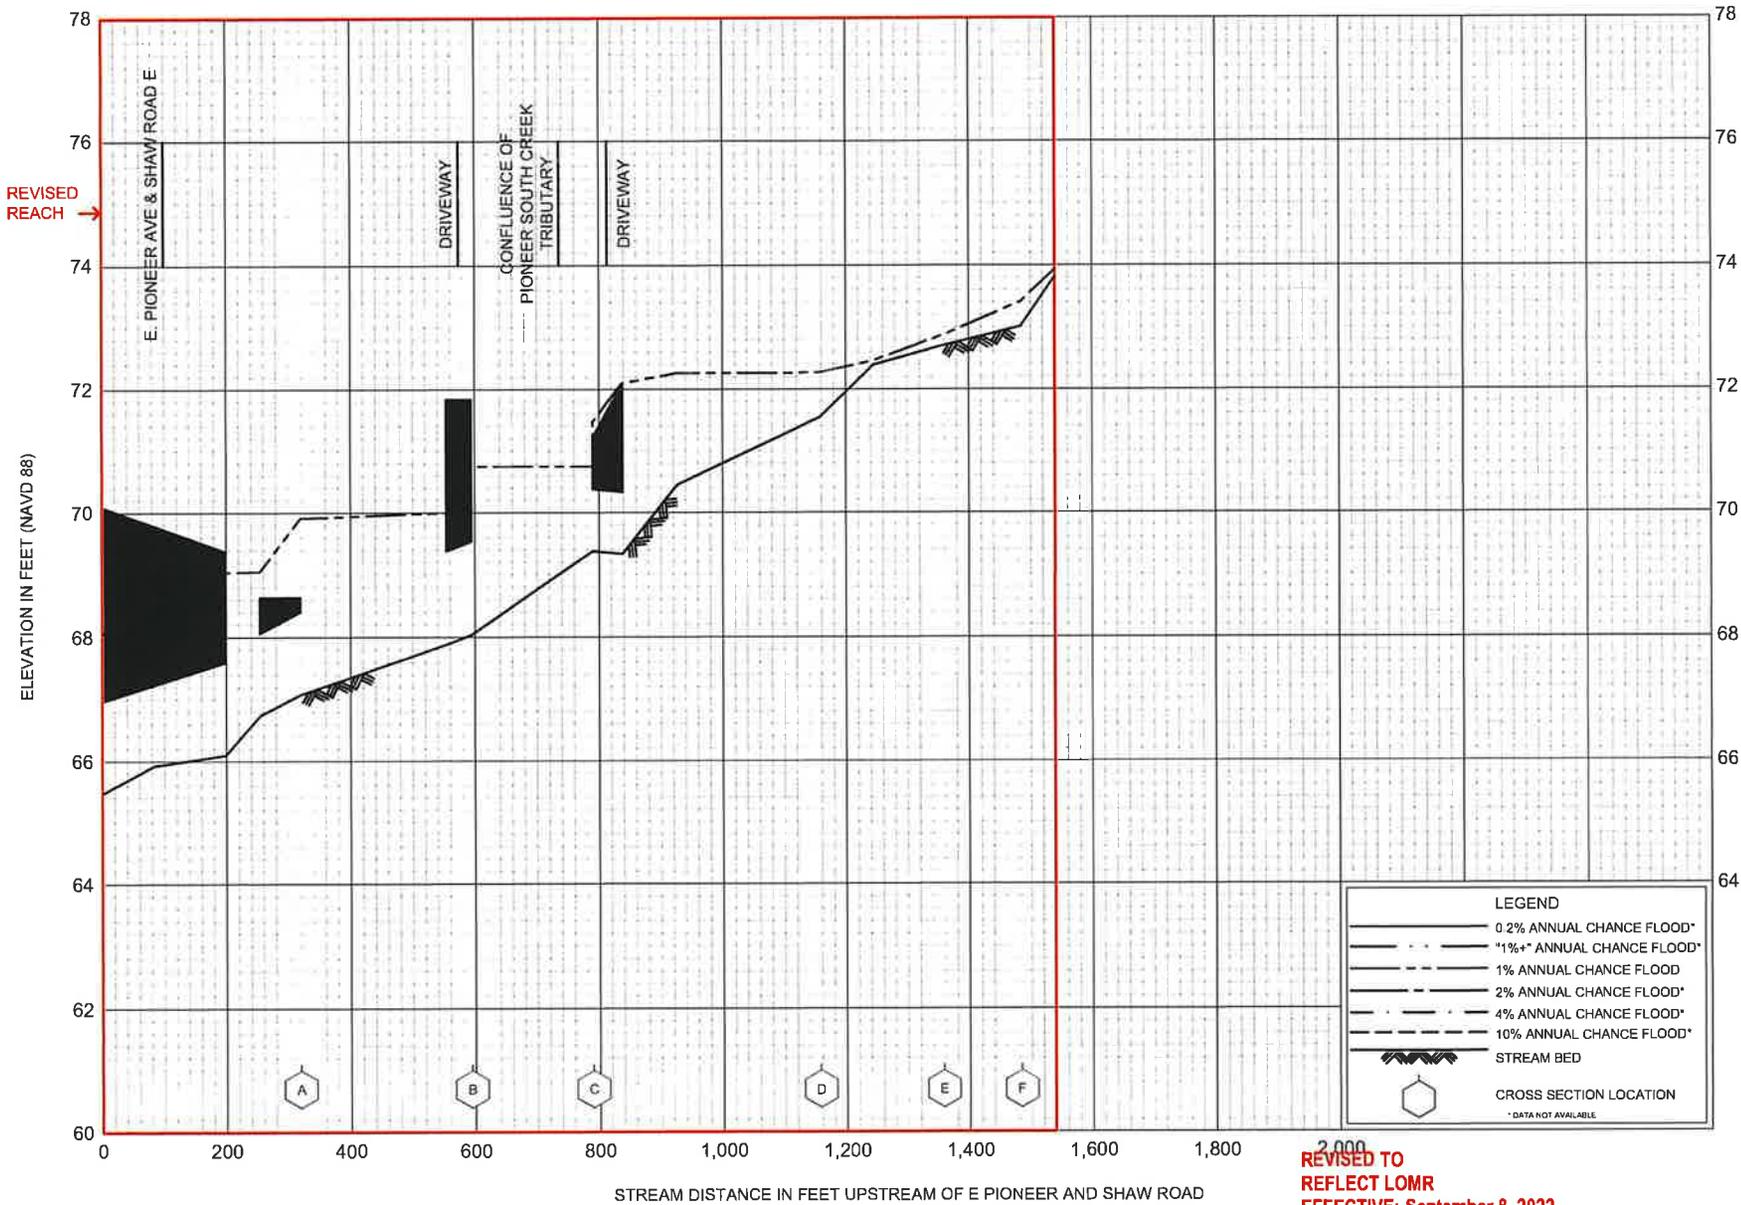
FLOOD PROFILES  
PIONEER SOUTH CREEK

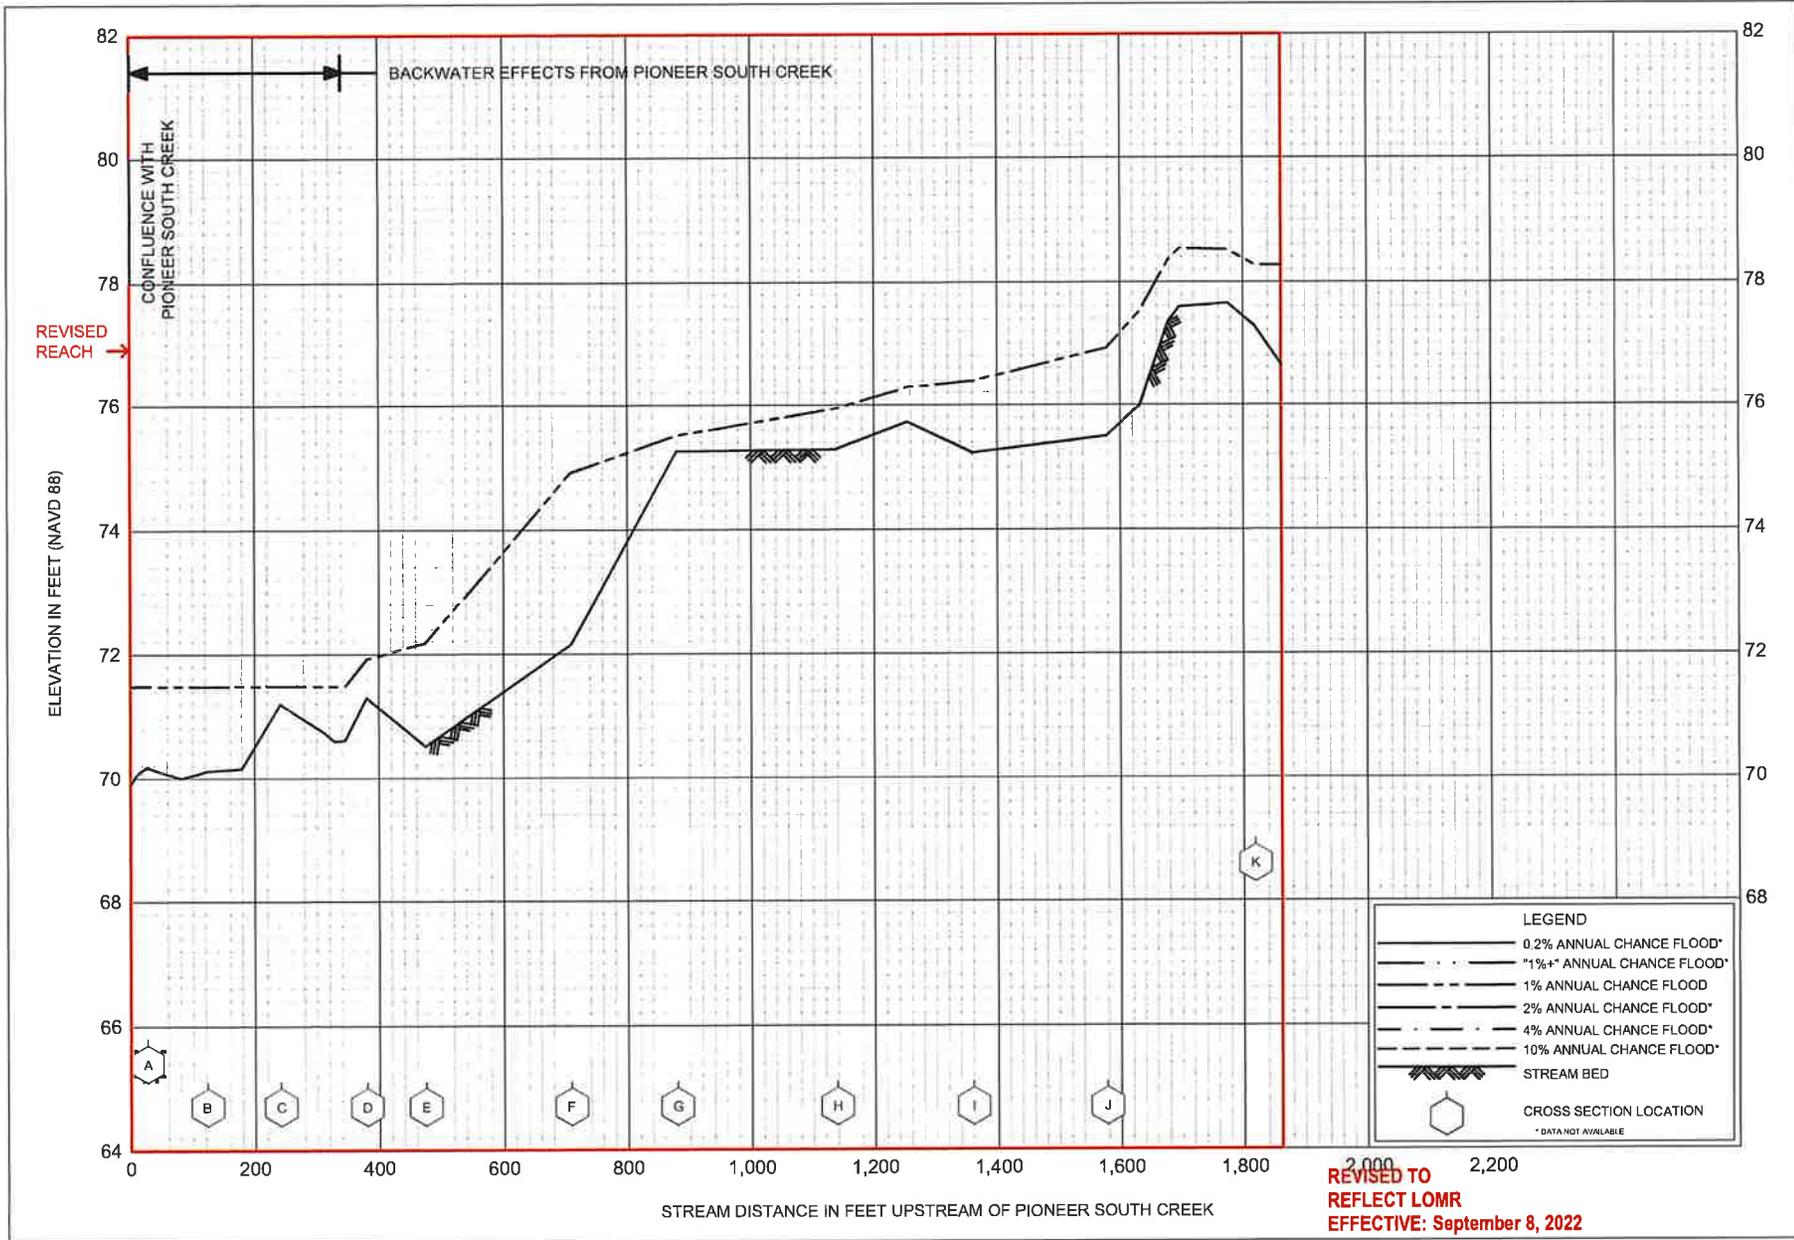
FLOOD PROFILES  
PIONEER SOUTH CREEK TRIBUTARY

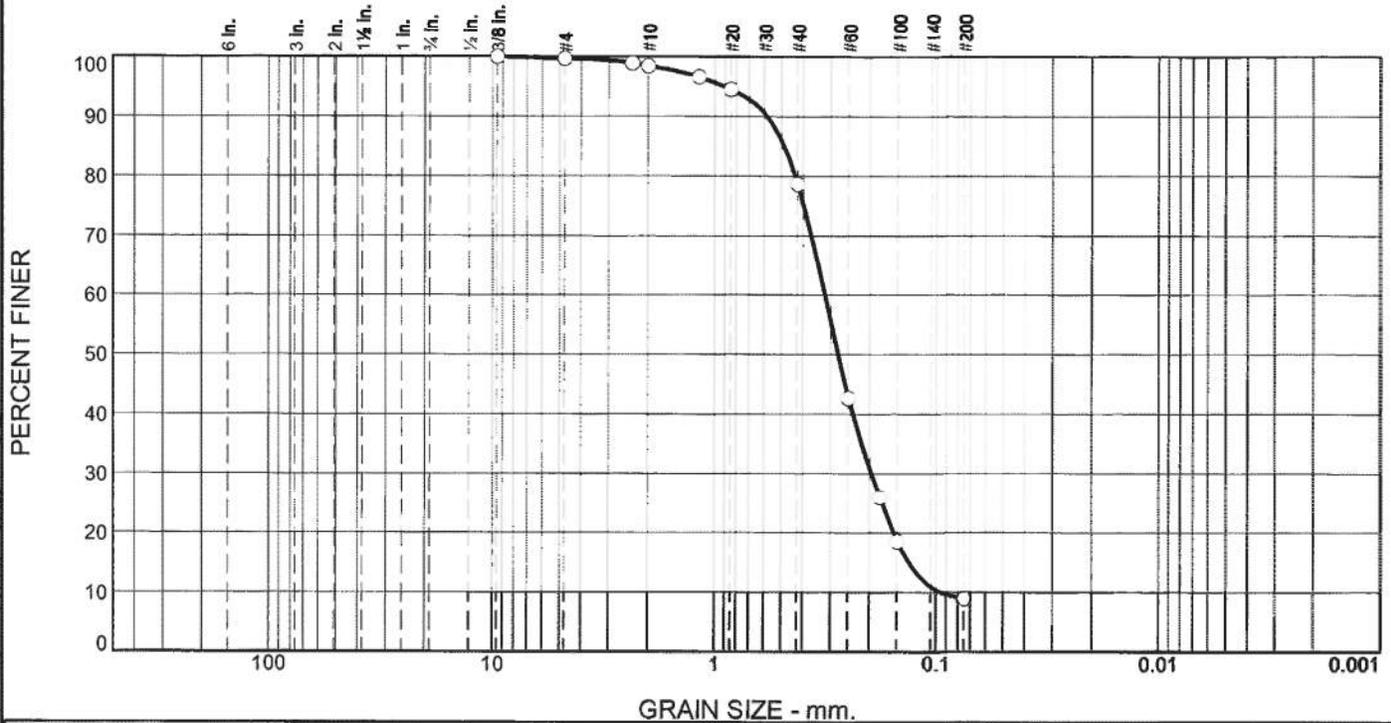
# Particle Size Distribution Report

% +3"	% Gravel		% Sand			% Fines
	Coarse	Fine	Coarse	Medium	Fine	
0.0	0.0	0.3	1.2	19.8	69.8	8.9

Test Results (C-136 & C-117)			
Opening Size	Percent Finer	Spec.* (Percent)	Pass? (X=Fail)
.375	100.0		
#4	99.7		
#8	98.9		
#10	98.5		
#16	96.6		
#20	94.5		
#40	78.7		
#60	42.7		
#80	26.0		
#100	18.5		
#200	8.9

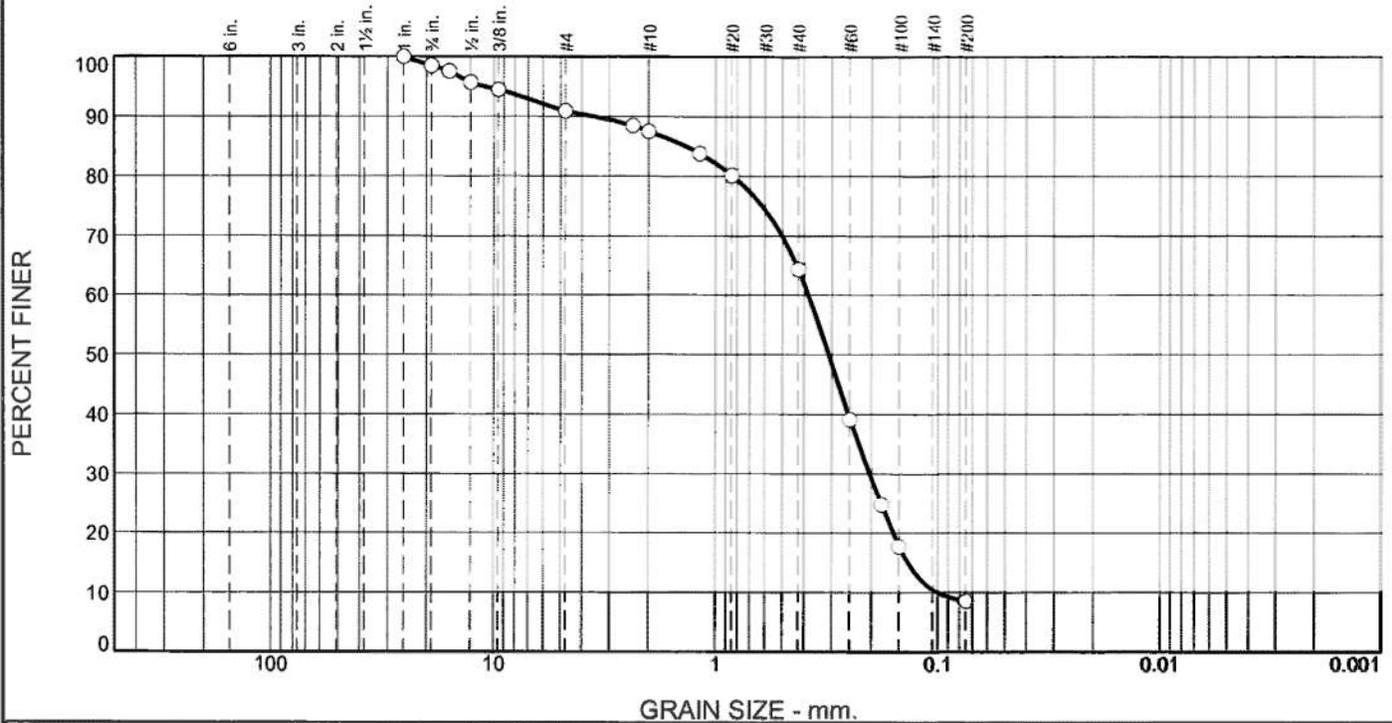
# Particle Size Distribution Report

% +3"	% Gravel		% Sand			% Fines
	Coarse	Fine	Coarse	Medium	Fine	
0.0	1.4	7.6	3.5	23.3	55.7	8.5

Test Results (C-136 & C-117)			
Opening Size	Percent Finer	Spec.* (Percent)	Pass? (X=Fail)
1	100.0		
.75	98.6		
.625	97.6		
.5	95.7		
.375	94.5		
#4	91.0		
#8	88.5		
#10	87.5		
#16	83.8		
#20	80.2		
#40	64.2		
#60	39.1		
#80	24.7		
#100	17.7		
#200	8.5

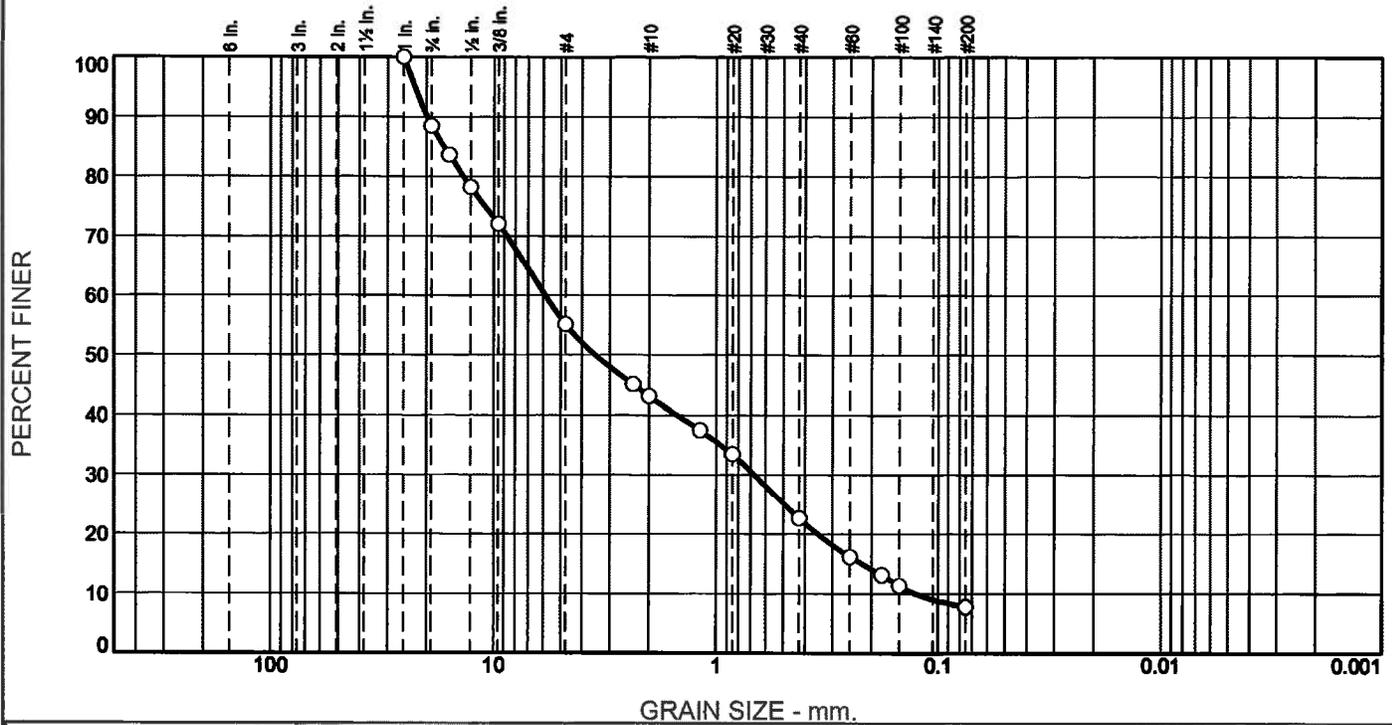
# Particle Size Distribution Report

% +3"	% Gravel		% Sand			% Fines
	Coarse	Fine	Coarse	Medium	Fine	
0.0	11.5	33.3	12.0	20.5	14.9	7.8

Test Results (C-136 & C-117)			
Opening Size	Percent Finer	Spec.* (Percent)	Pass? (X=Fail)
1	100.0		
.75	88.5		
.625	83.7		
.5	78.3		
.375	72.1		
#4	55.2		
#8	45.1		
#10	43.2		
#16	37.5		
#20	33.5		
#40	22.7		
#60	16.2		
#80	13.2		
#100	11.4		
#200	7.8

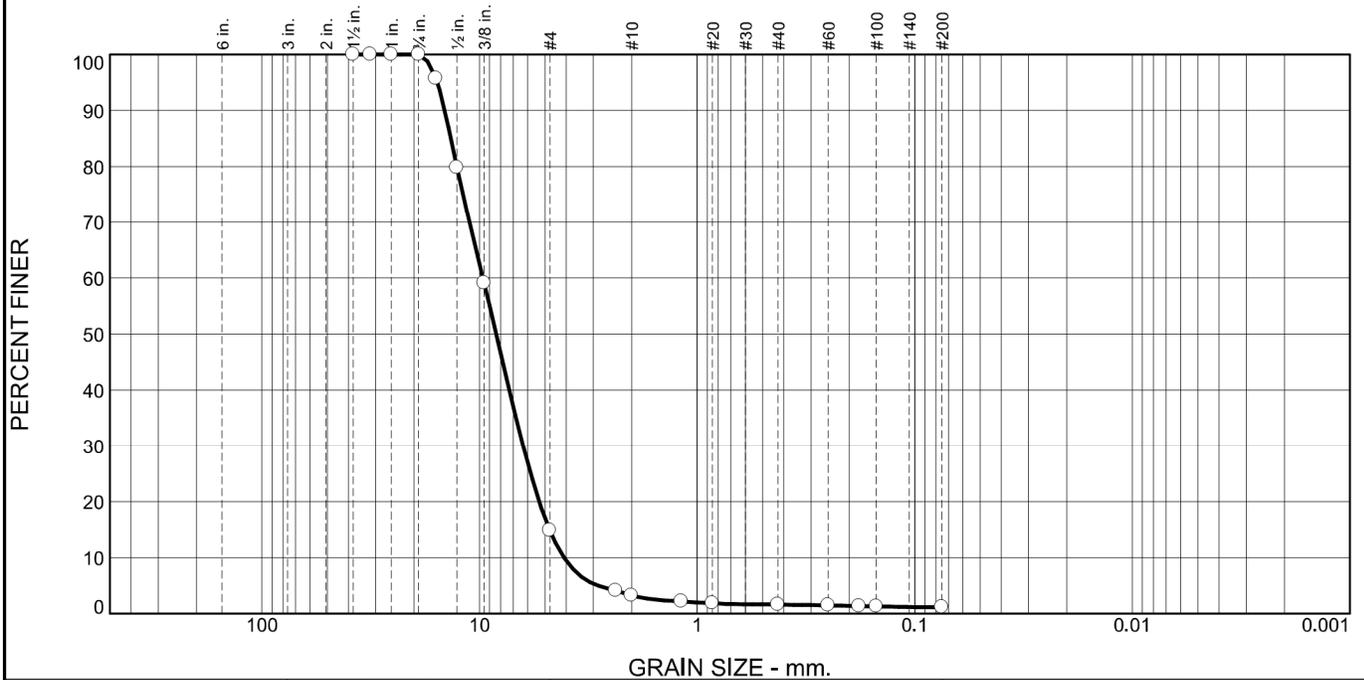
# Particle Size Distribution Report

% +3"	% Gravel		% Sand			% Fines	
	Coarse	Fine	Coarse	Medium	Fine	Silt	Clay
0	0	85	12	1	1	1

Test Results (C-136 & C-117)			
Opening Size	Percent Finer	Spec.* (Percent)	Pass? (X=Fail)
1.5	100		
1.25	100		
1	100		
.75	100		
.625	96		
.5	80		
.375	59		
#4	15		
#8	4		
#10	3		
#16	2		
#20	2		
#40	2		
#60	1		
#80	1		
#100	1		
#200	1.2

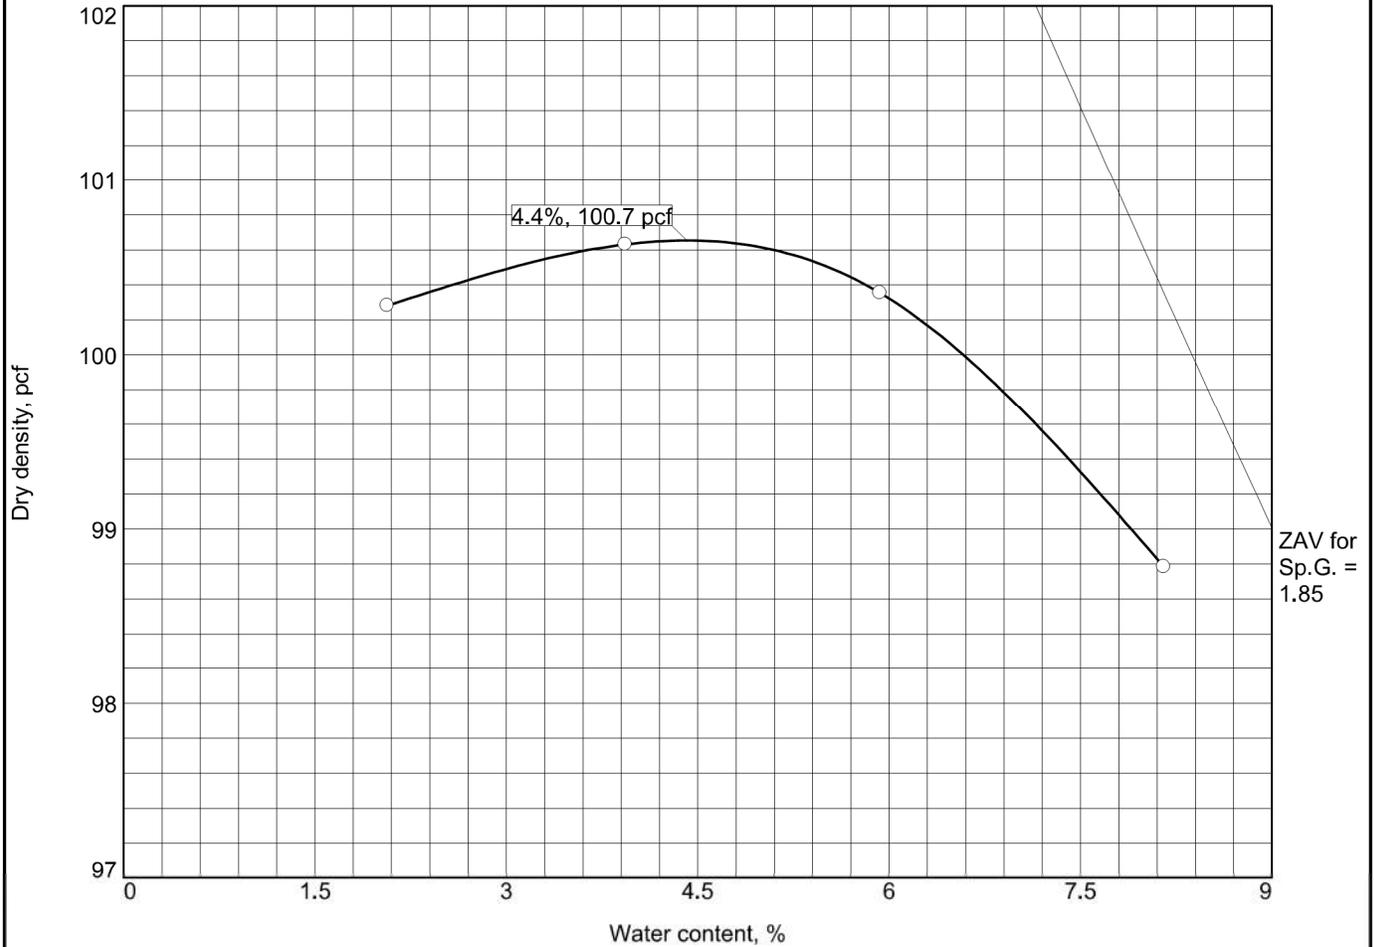
# COMPACTION TEST REPORT

Test specification: ASTM D 1557 Method C Modified

Elev/ Depth	Classification		Nat. Moist.	Sp.G.	LL	PI	% > 3/4 in.	% < No.200
	USCS	AASHTO						
	GP	A-1-a		1.85	NV	NP	0	1.2
