## **Stormwater Site Plan – Phase 2**

East Town Crossing  
2902 E Pioneer  
Puyallup, WA 98372  
2230752.10

May 2024  
Revised January 2025

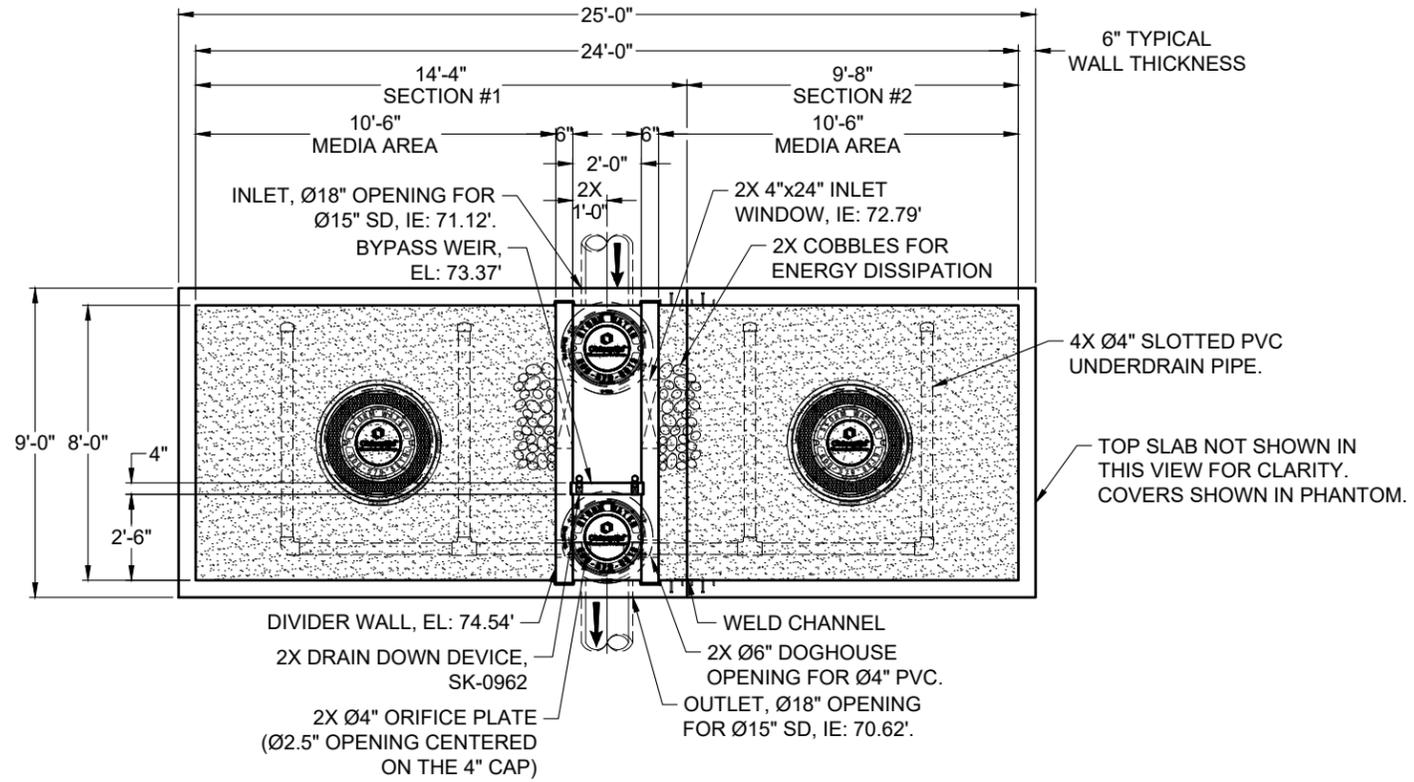
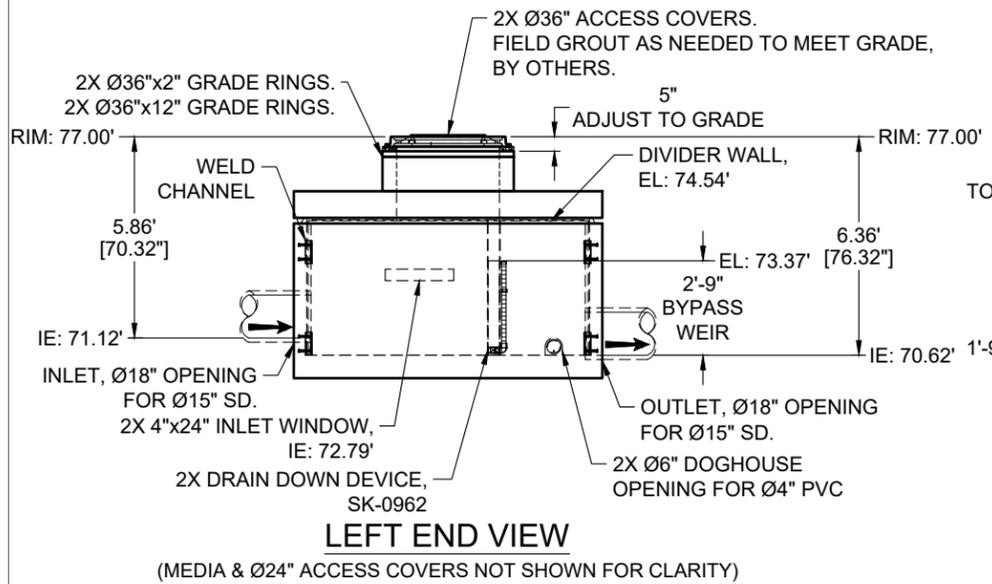
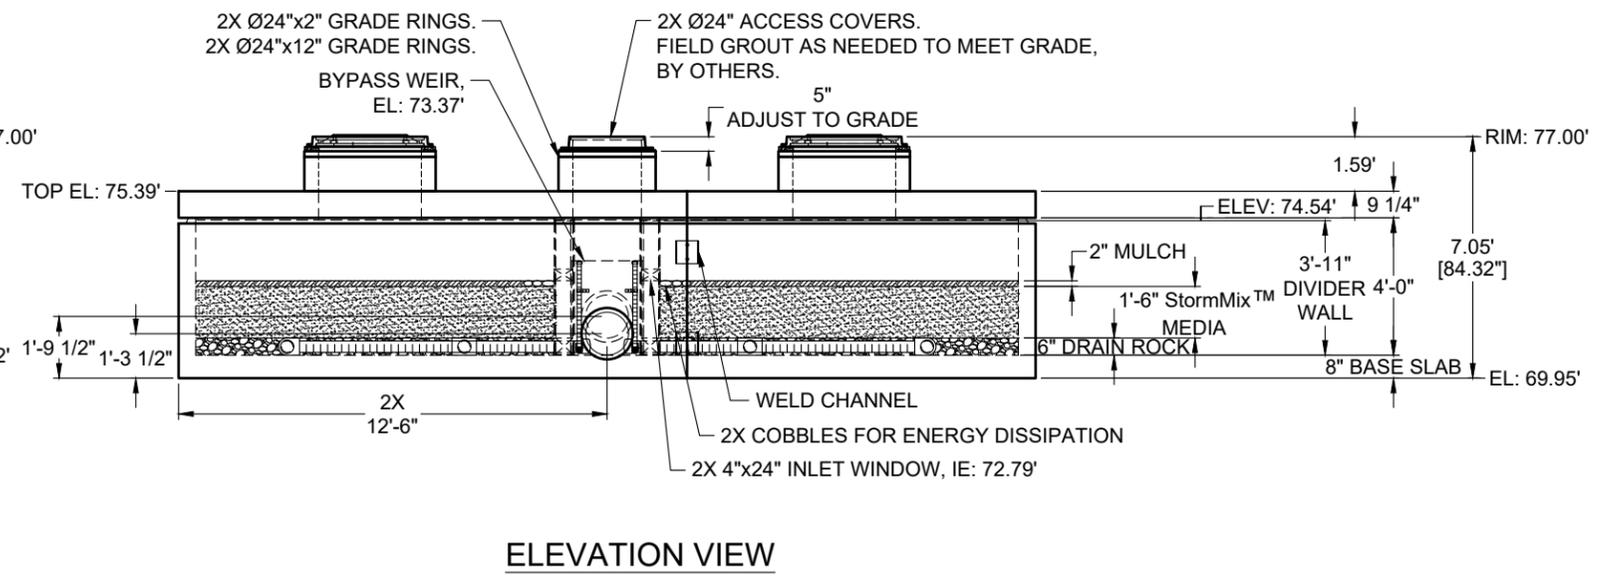
- NOTES:**
- DESIGN LOADINGS:
    - AASHTO HS-20-44 (WITH IMPACT)
    - DESIGN SOIL COVER: 5'-0" MAXIMUM
    - ASSUMED WATER TABLE: BELOW BASE OF PRECAST (ENGINEER-OF-RECORD TO CONFIRM SITE WATER TABLE ELEVATION)

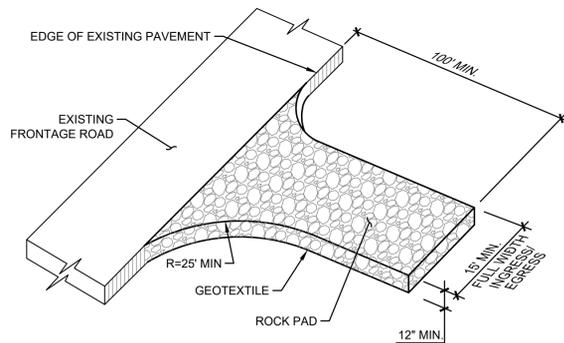
- ROCK PAD MATERIAL SHALL BE QUARRY SPALLS PER WSDOT STANDARD SPECIFICATION 9-13.1(5) AND MAY BE TOP-DRESSED WITH 1"-3" ROCK.
- THE ROCK PAD SHALL BE AT LEAST 12 INCHES THICK AND 100 FEET LONG. WIDTH SHALL BE THE FULL WIDTH OF THE VEHICLE INGRESS AND EGRESS AREA.

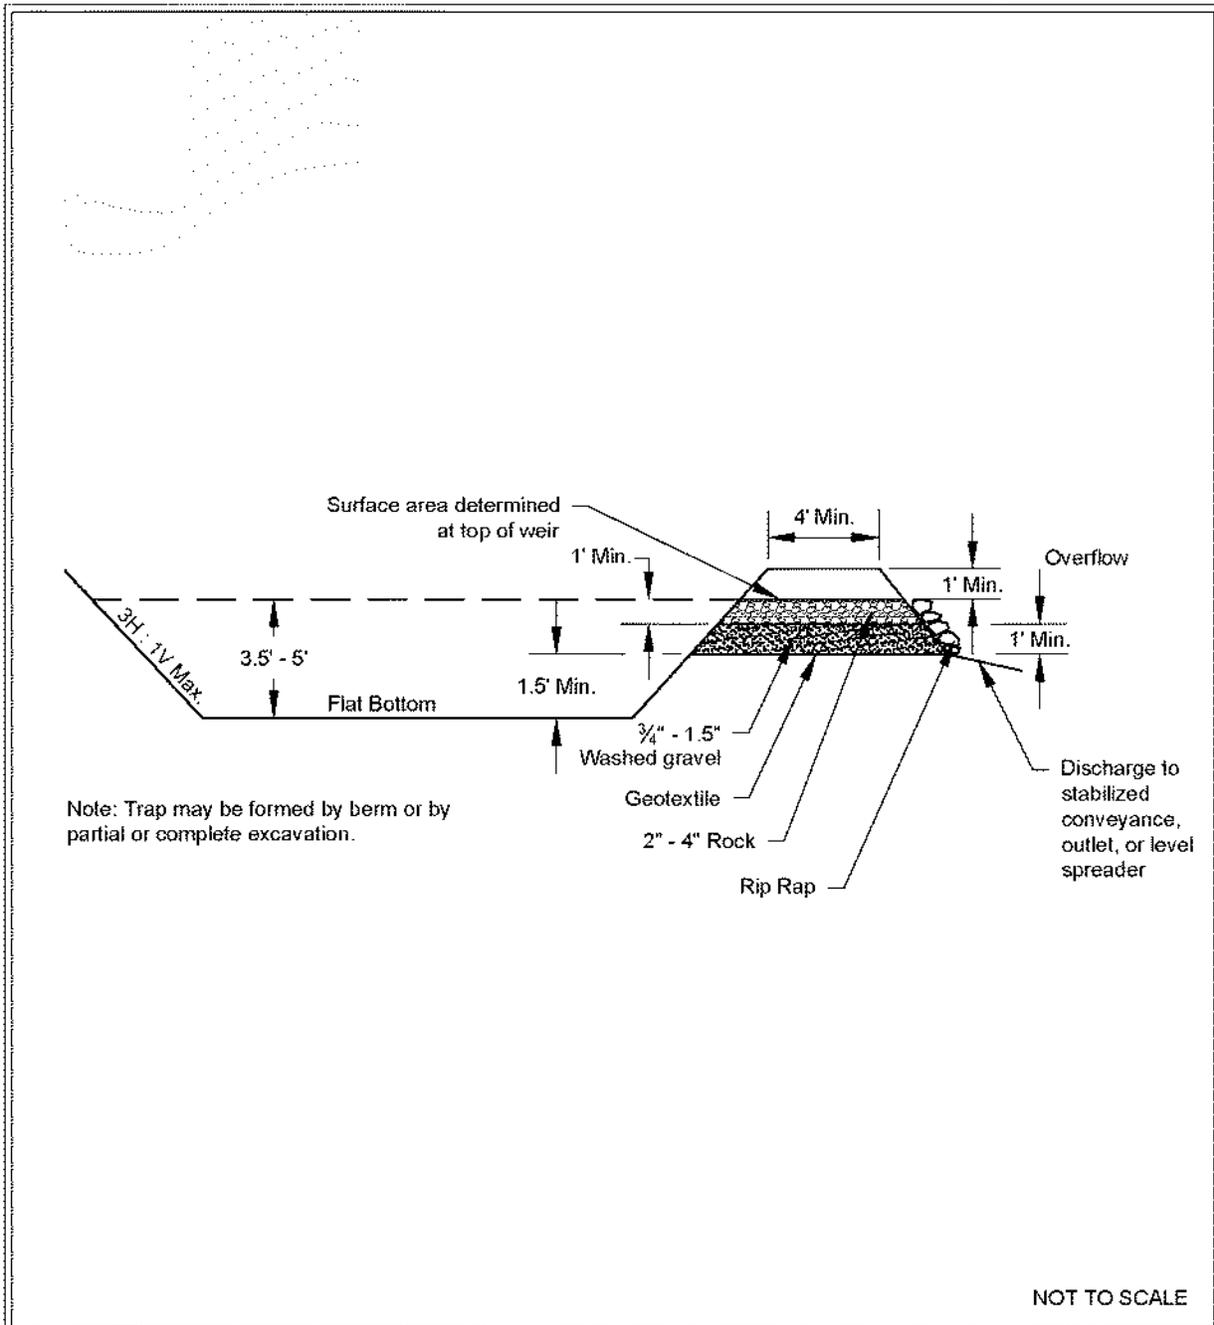
**Figure II-3.26: Cross Section of Sediment Trap**
