Reference: Geotechnical Engineering Investigation
East Town Crossing
Parcel Nos. 0420264053, 0420264054, 0420351066
SE Corner of E. Shaw Road and E. Pioneer Way
Puyallup, Washington 98371

**GEOTECHNICAL ENGINEERING INVESTIGATION
EAST TOWN CROSSING
PARCEL NOS. 0420264053, 0420264054, 0420351066
SE CORNER OF E. SHAW ROAD & E. PIONEER WAY
PUYALLUP, WASHINGTON**

**PROJECT NO. 062-19005
APRIL 11, 2019**

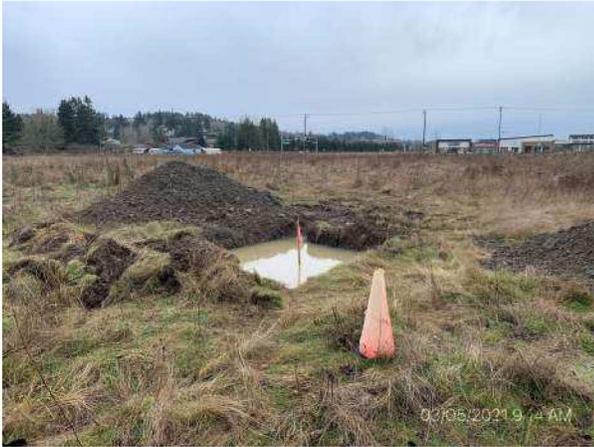
Water in Pit P-1 on March 5, 2021.

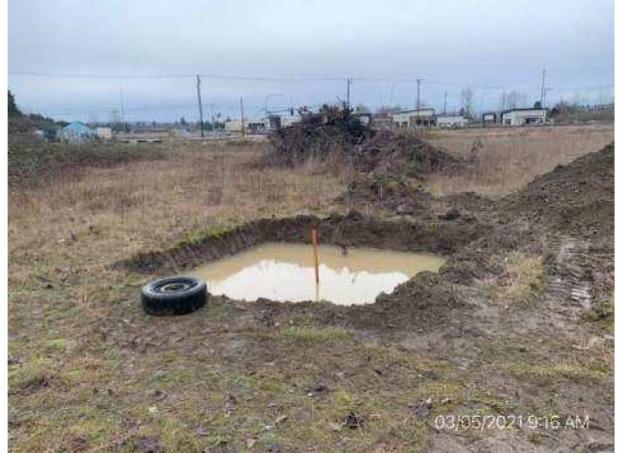
Water in Pit P-2 on March 5, 2021.

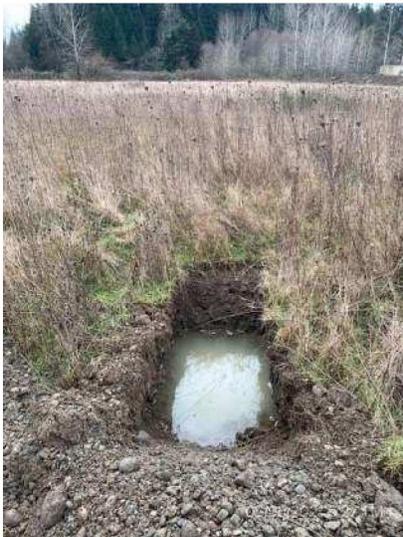
Figure 2 - Photos (March 5, 2021)

Water in Test Pit on March 5, 2021. Test pit was excavated in NE portion of site on March 4, 2021.
