**Puyallup School District  
Kessler Center**

**Stormwater Site Plan**

**Revised: June 2020  
Revised: March 2020  
Date: December 2019**

**S&H Job Number 18,328**

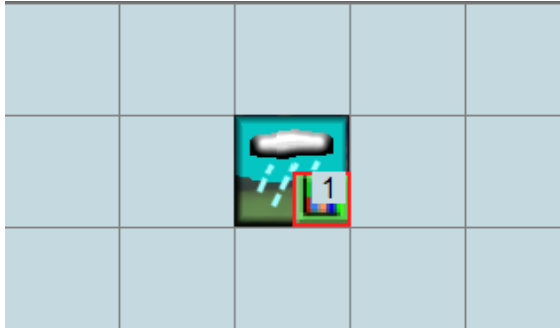
Basin 1 Predeveloped

Predeveloped Conditions:

Available Pervious	Acres	Available Impervious	Acres
<input checked="" type="checkbox"/> C, Forest, Flat	5.87

The modeled infiltration trench is designed with a 5-foot width by 10-foot height and includes two 30-inch perforated pipes (stacked vertically). This over-sized trench section is used due to the large depth to the infiltrative layer. The infiltration trench basin area can be seen in Figure 13.

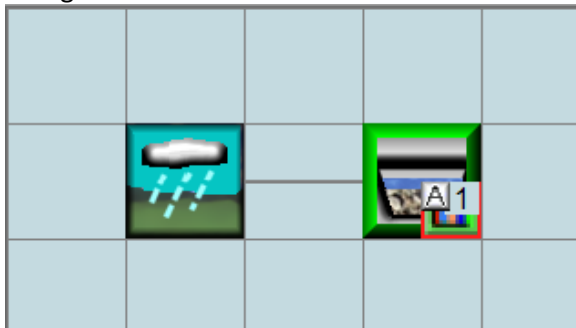
Basin 1 Mitigated

Mitigated Conditions:

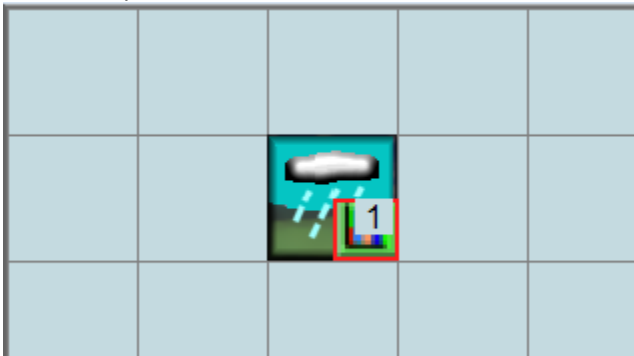
Basin 1 Predeveloped

Predeveloped Conditions:

Available Pervious	Acres	Available Impervious	Acres
<input checked="" type="checkbox"/> C, Forest, Flat	5.4

The bioretention basin area can be seen in Figure 14.

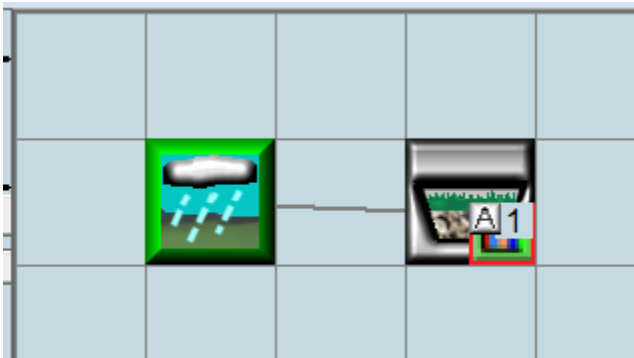
Basin 1 Mitigated

Mitigated Conditions:

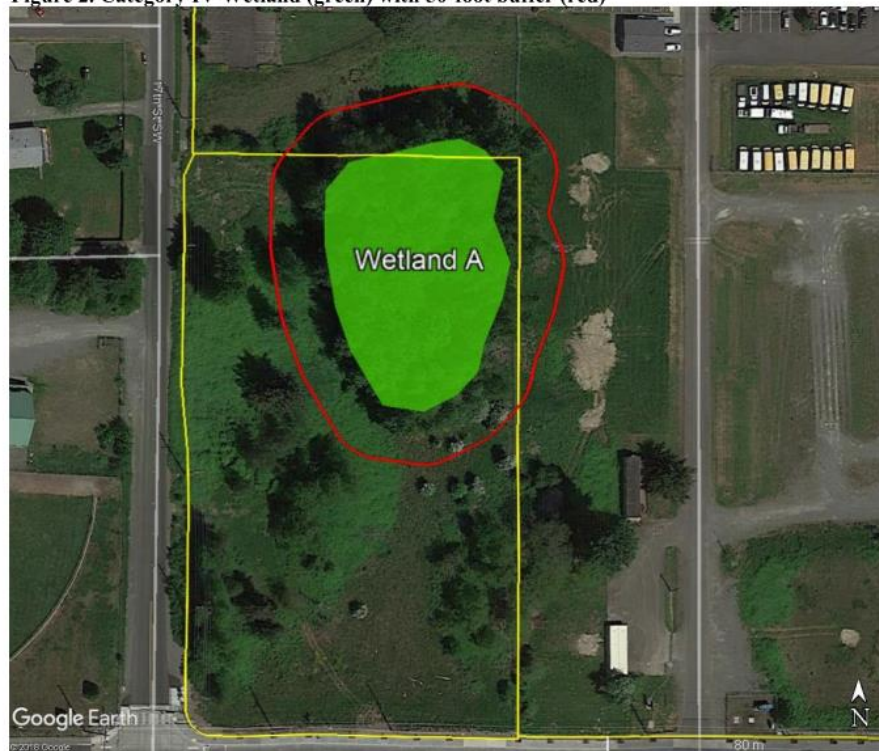
**Figure 2. Category IV Wetland (green) with 50-foot buffer (red)**

A Grette Associates biologist visited the subject property on April 17, 2019 to verify the boundaries and rating of the existing wetland near the project site. Grette Associates staff also inspected the surrounding 300 feet to identify and rate wetlands that may be present outside of the area of the project site. Wetland A was originally delineated and rated in 2017 by Habitat Technologies. Wetland A was originally rated as a Category IV wetland. Grette Associates rated Wetland A as a Category IV wetland based on the requirements in PMC 21.06.910. A summary of the critical areas identified during the site assessment is provided below in Table 1. A critical areas map is provided in Appendix A.
