## **Geotechnical Engineering Services Report**

Pierce College Puyallup – STEM Building Design Study  
Puyallup, Washington

**File No. 21342-002-00**

**January 21, 2021**

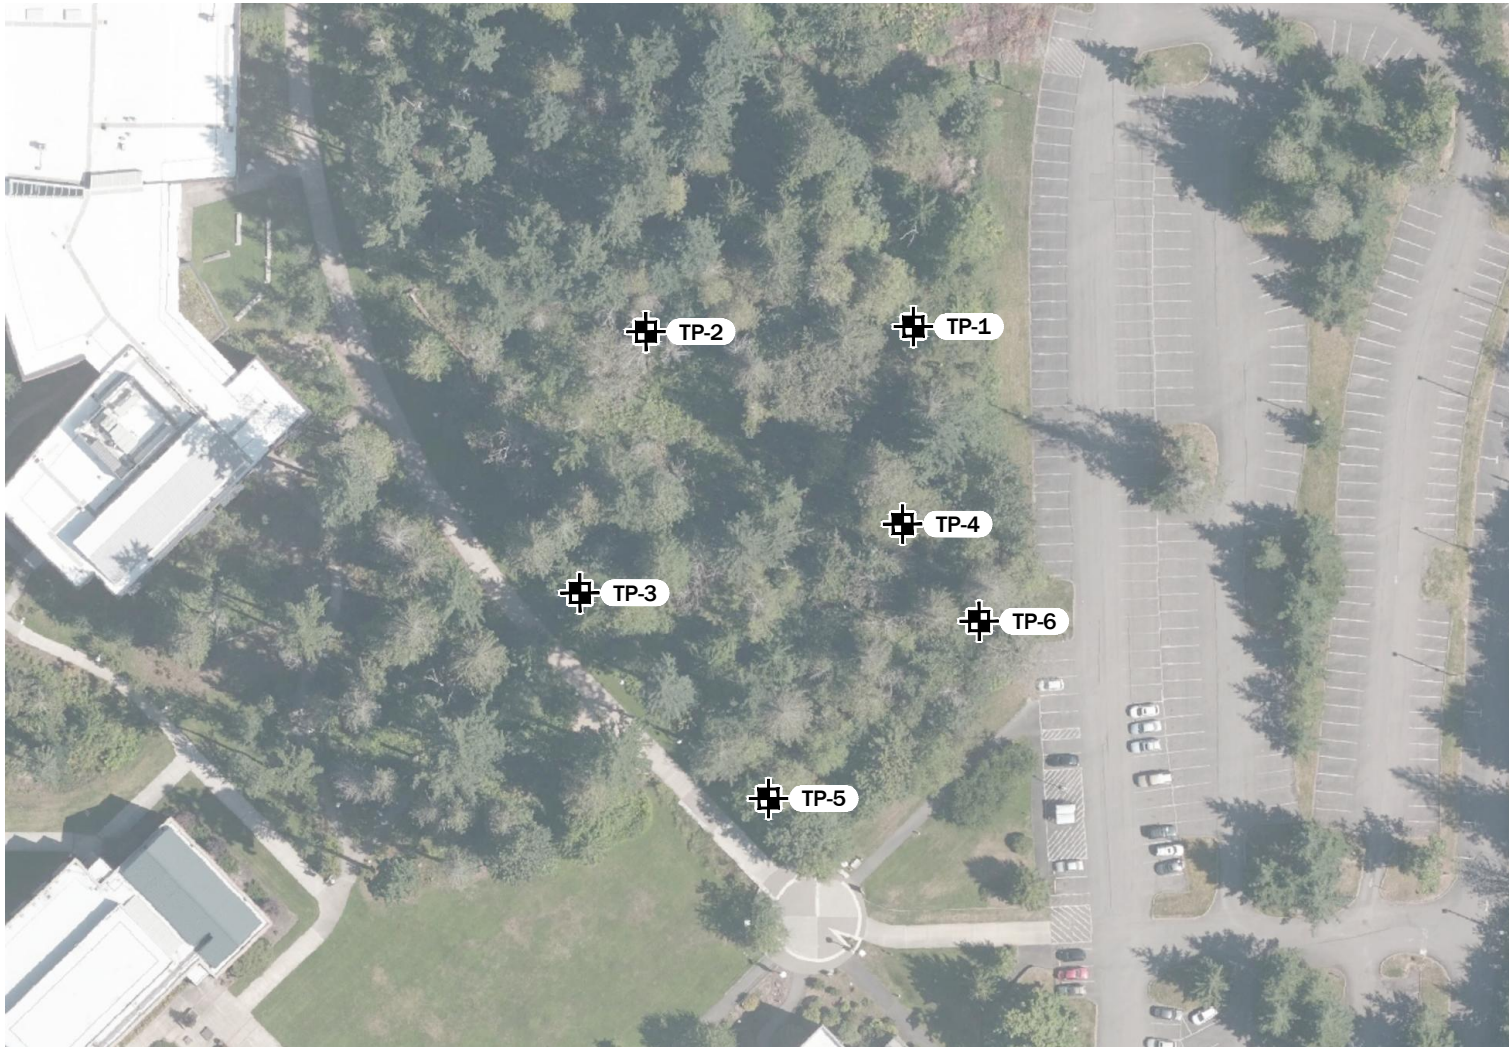
**Legend**  
TP-1

We explored subsurface conditions at the site by excavating six test pits (TP-1 through TP-6) at the approximate locations shown on the attached Site Plan, Figure 2. A description of our subsurface exploration program and summary exploration logs are provided in Appendix A.
