## **Supplemental Geotechnical Report**

### **Small Scale Pit Infiltration Test**

**Parcel No. 4389000160, 0170, 0180**

**LS&E Job No. 13298**

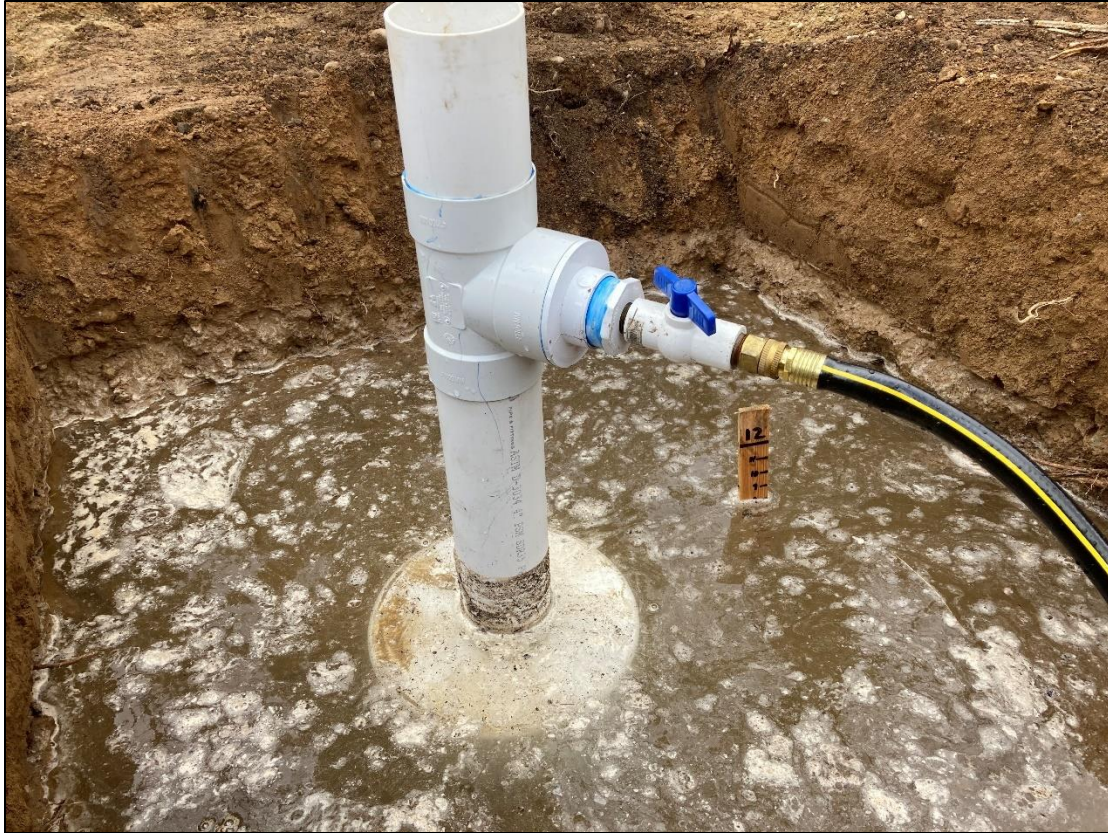
**Figure 2: Infiltration Test in Progress**

A Licensed Geologist and representative from our firm oversaw the preparation of the site and conducted the test. An excavation measuring 4-feet wide by 4-feet long (16 square feet) advanced approximately 6 inches into the underlying outwash deposit. The spoils were set back from the excavation. A water table review port was placed into a deep excavation near, and just down-gradient from, the pit.
