**Geotechnical Engineering Services
Addendum Report No. 1**

Pierce College Puyallup
STEM Building Design Services
Puyallup, Washington

File No. 21342-002-01

June 29, 2022

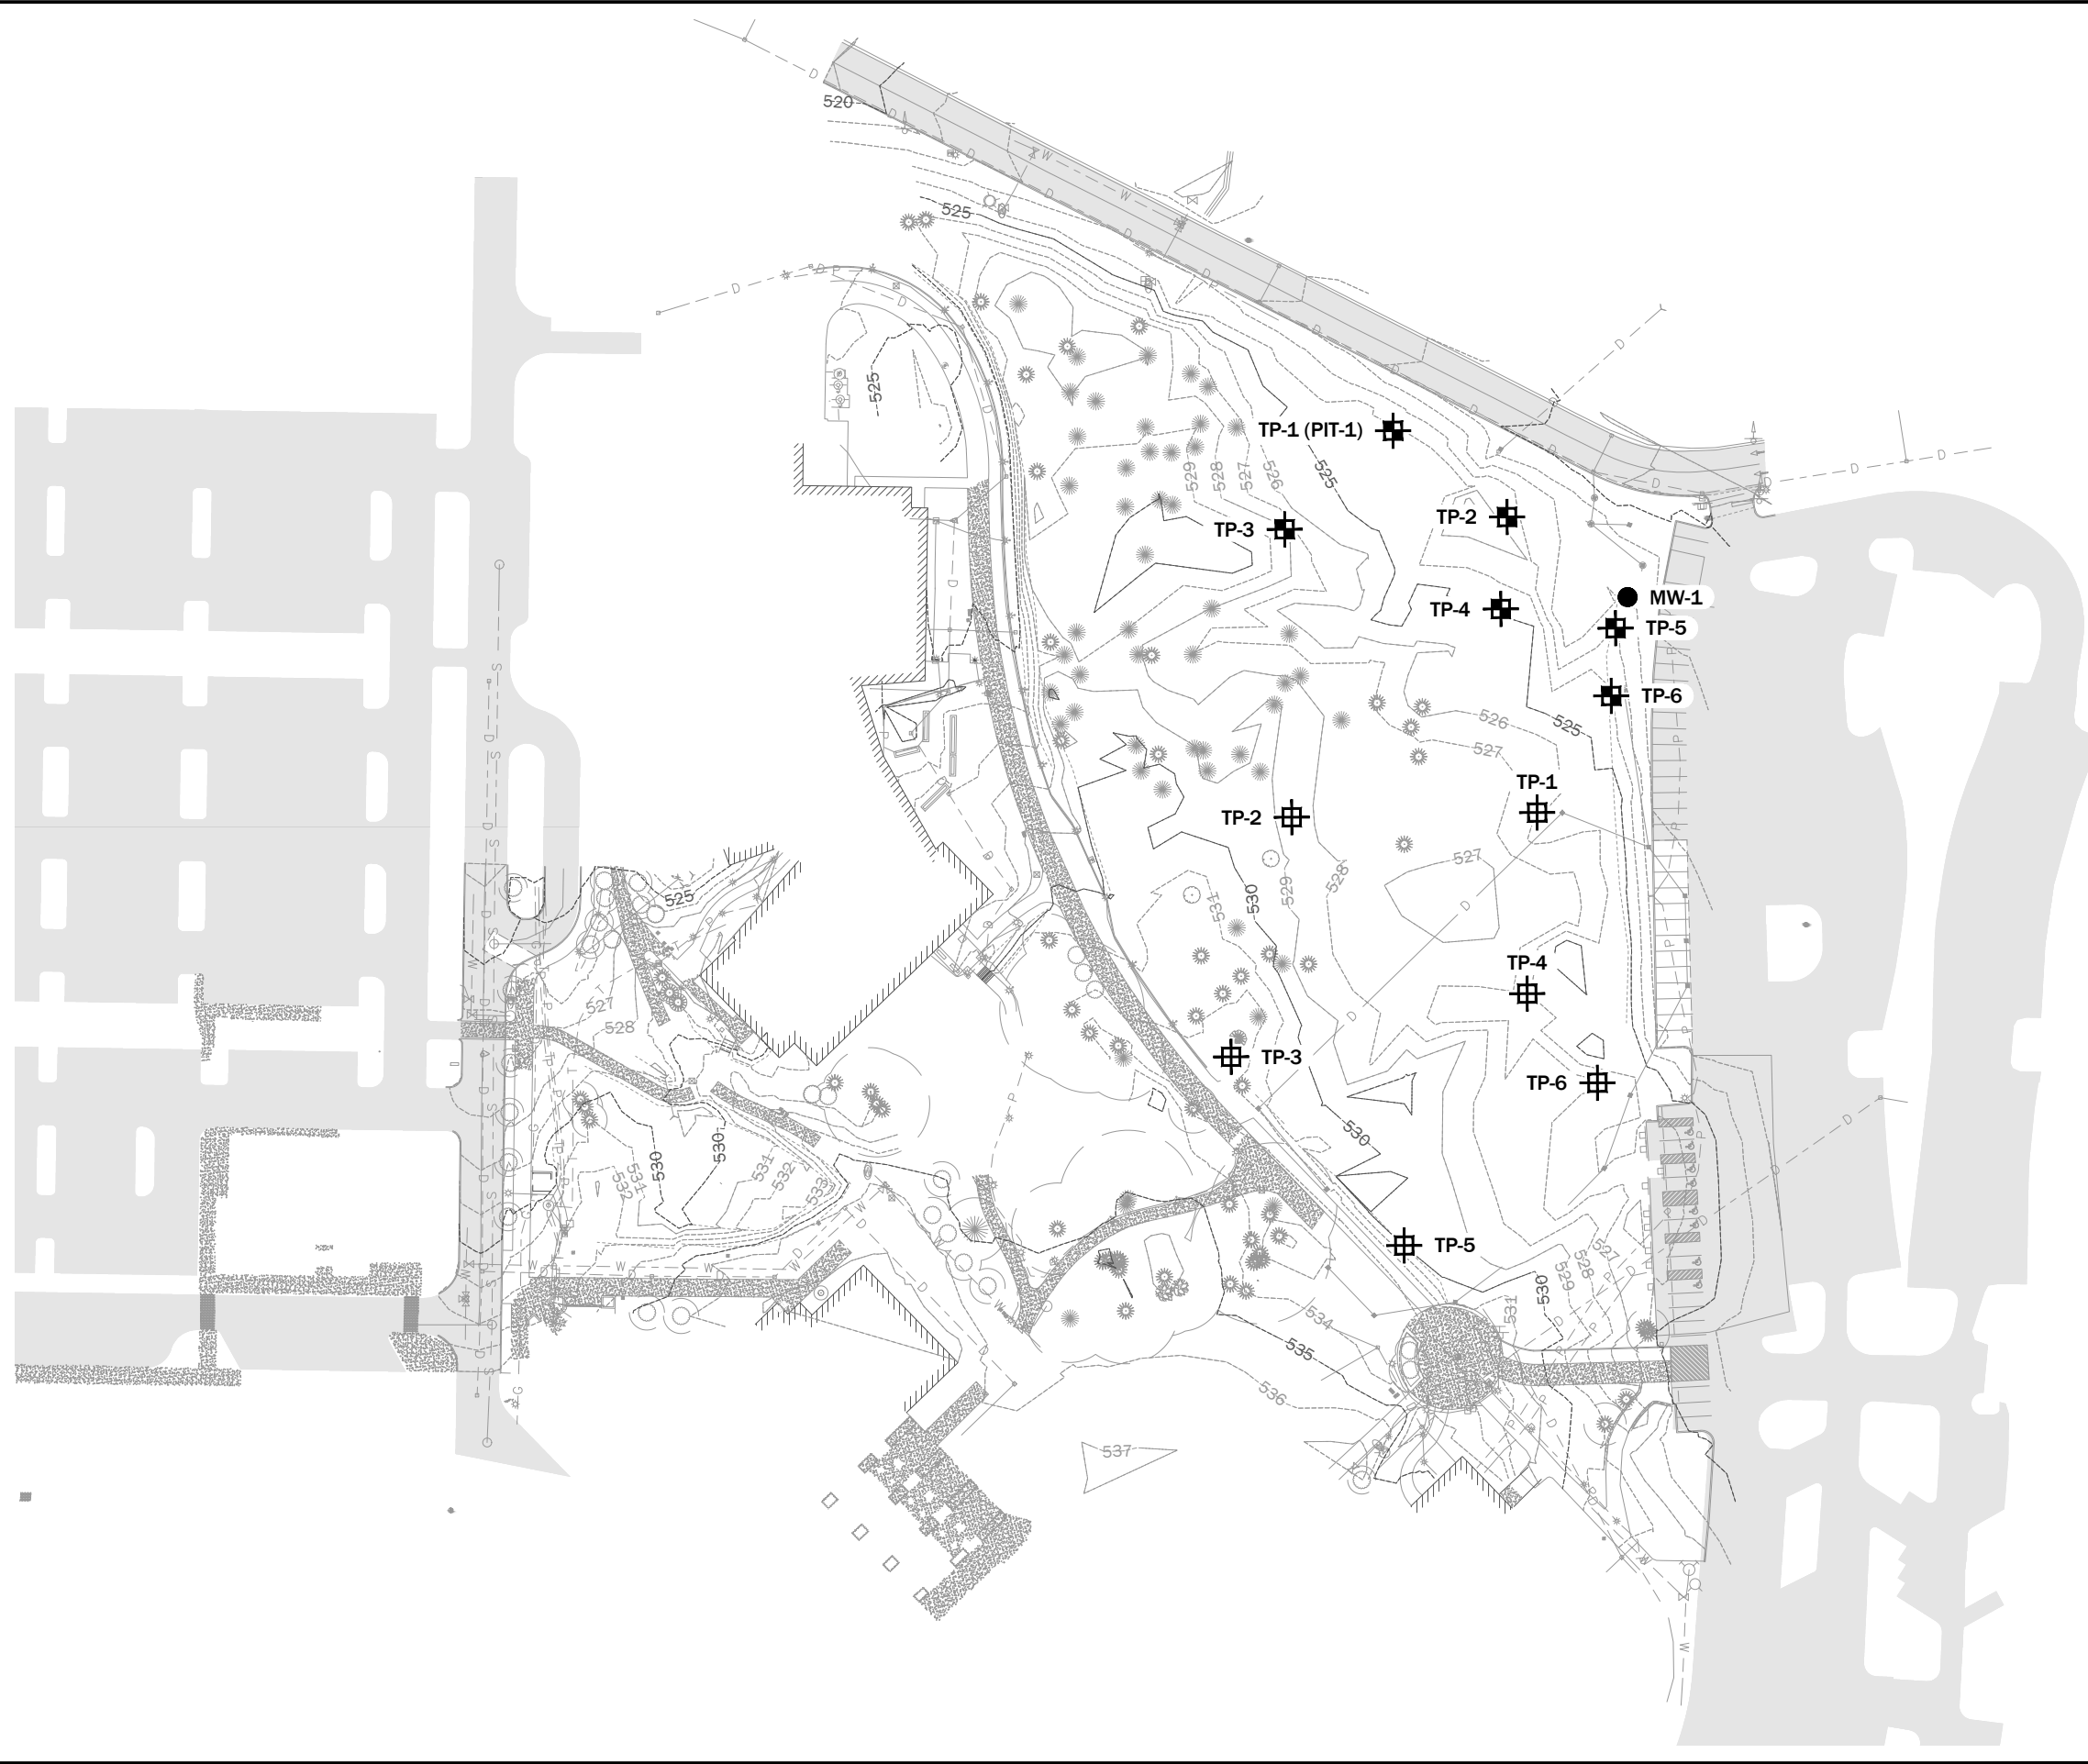
Site Plan	
Pierce College Puyallup - STEM Building Design Services Puyallup, Washington

We explored subsurface conditions at the project site by advancing one boring (MW-1) on March 9, 2022, and six test pit excavations (TP-1 (PIT-1) through TP-6) between April 5 and 6, 2022. The approximate locations of the boring and test pits are shown on the attached Site Plan, Figure 2. A groundwater monitoring well was constructed in the boring after drilling was complete. One small-scale pilot infiltration test (PIT) was completed in TP-1 (PIT-1) at approximately 12 feet below the ground surface (bgs). The test results and methodology for the PIT are discussed in further detail in the “Stormwater Infiltration” section of this report. A description of our subsurface exploration program and summary exploration logs for this study are provided in Appendix A.

Figure 2 also displays the locations of test pit explorations completed as part of our January 2021 Report. We provide this as additional reference when reviewing our January 2021 Report in concert with this report. The subsurface exploration procedures, interpreted conditions, and test pits logs are presented in our January 2021 Report.

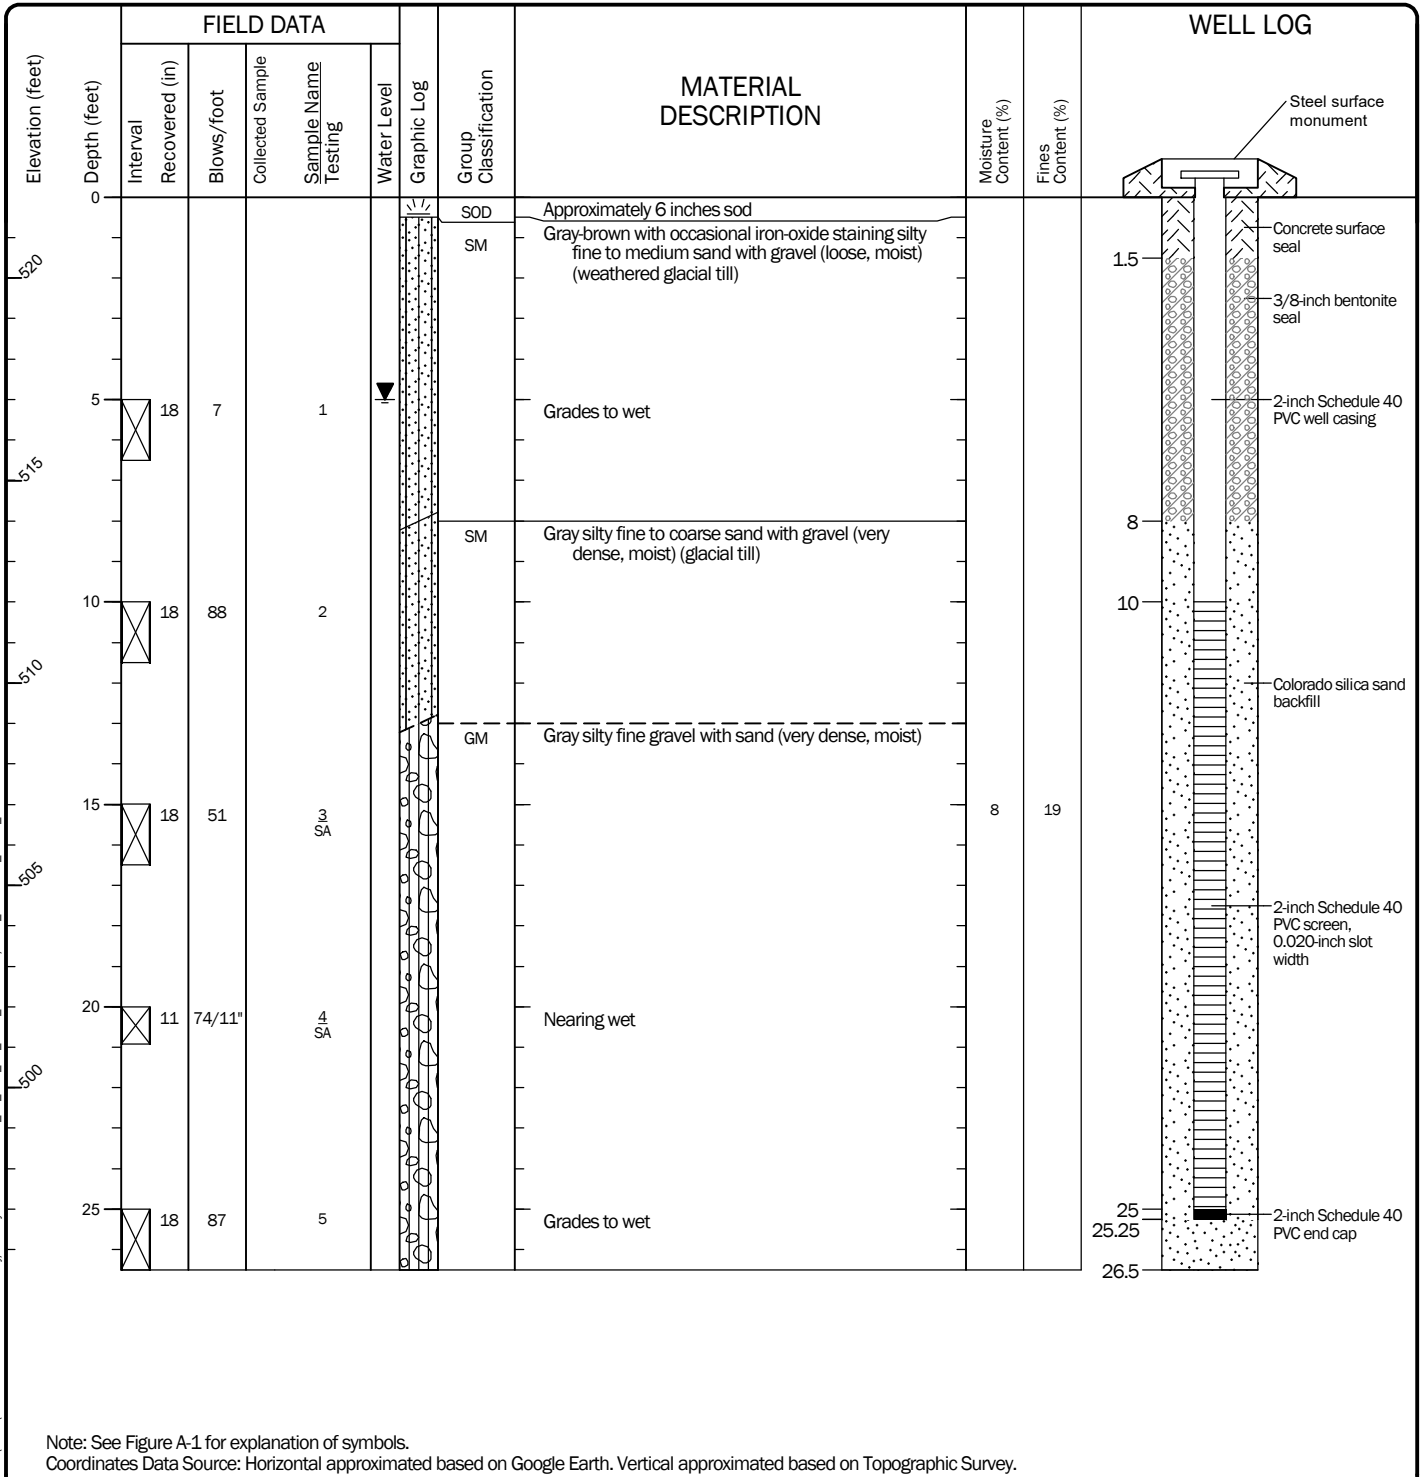
Log of Boring MW-1

Below the sod at MW-1, we observed what we interpret to be glacial till. Glacial till was typically comprised of silty sand with gravel and silty gravel with sand. The upper approximately 8 feet of glacial till was observed to be in a weathered, loose condition. Below the weathered zone, the glacial till was generally observed to be very dense to the depth explored. MW-1 was terminated in glacial till soils.

Drilled	Start 3/9/2022	End 3/9/2022	Total Depth (ft)	26.5	Logged By Checked By	NJO CRN	Driller	Holocene Drilling, Inc.	Drilling Method	Hollow-stem Auger
Hammer Data	Autohammer 140 (lbs) / 30 (in) Drop		Drilling Equipment		Diedrich D-50 (track-mounted)		DOE Well I.D.: BNZ 316 A 2-in well was installed on 3/9/2022 to a depth of 25 ft.			
Surface Elevation (ft) Vertical Datum		522 NAVD88		Top of Casing Elevation (ft)						
Easting (X) Northing (Y)		1199790 670600		Horizontal Datum		WA State Plane South NAD83 (feet)		Groundwater Date Measured	Depth to Water (ft)	Elevation (ft)
								3/9/2022	5.00	517.00
Notes: Samples 3 and 4 combined for one sieve analysis test

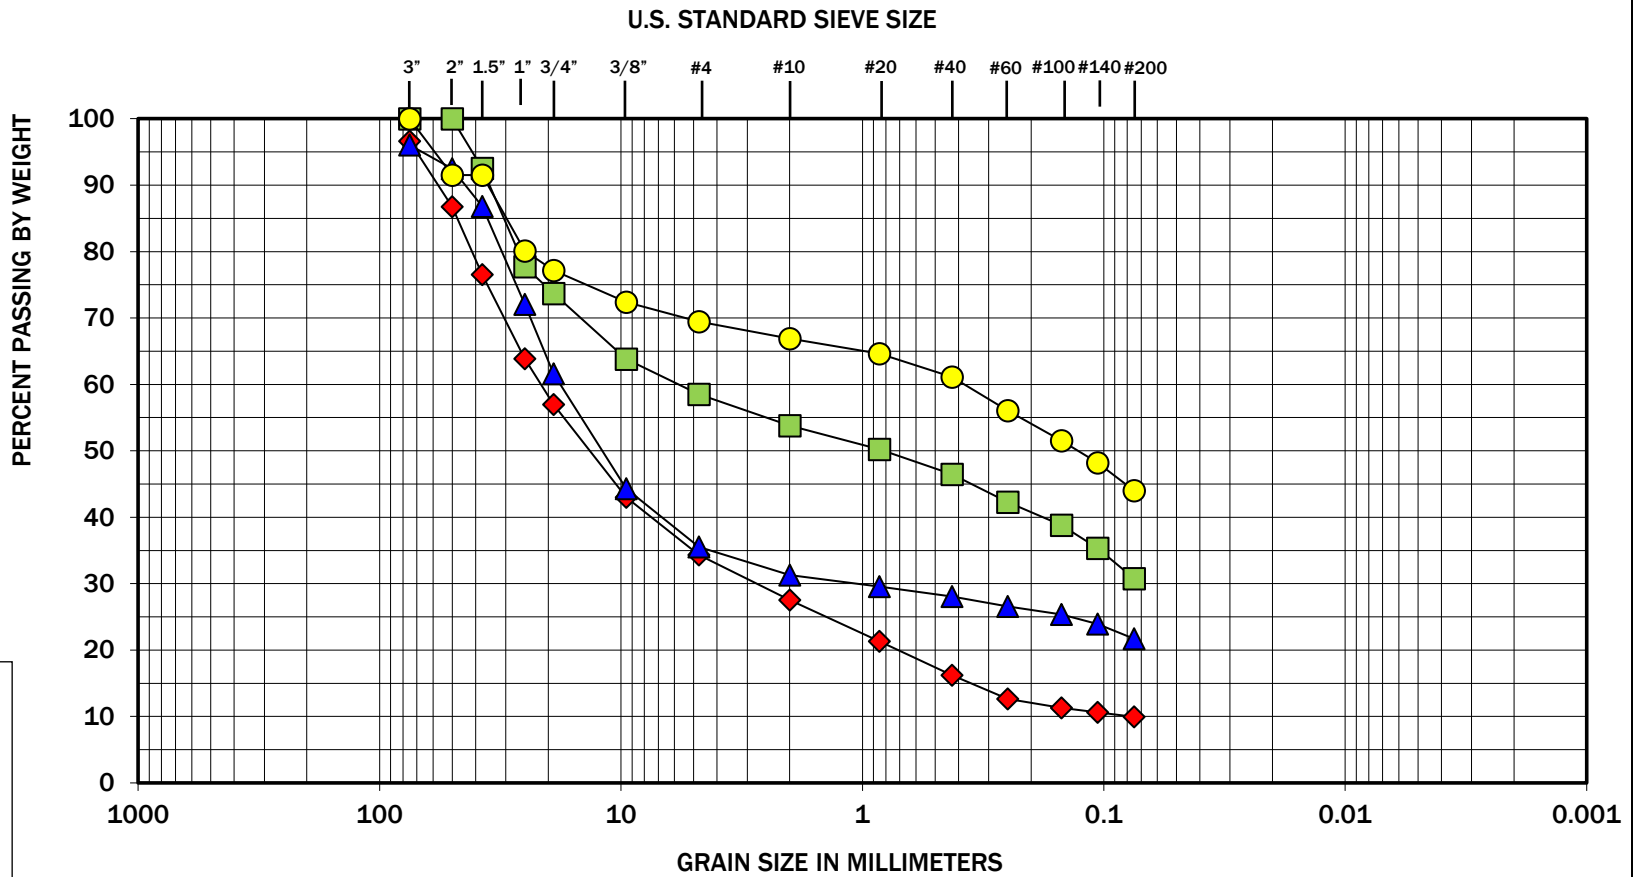
Sieve Analysis Results

Symbol	Boring Number	Depth (feet)	Moisture (%)	Soil Description
◆	TP-1	13	9	Poorly graded gravel with silt and sand (GP-GM)
■	TP-2	6	10	Silty gravel with sand (GM)
▲	TP-3	12.5	27	Silty gravel (GM)
●	TP-5	8.5	11	Silty gravel with sand (GM)

Selected samples collected from our boring and test pits were tested in our laboratory to confirm field classifications and to evaluate pertinent engineering properties. Our laboratory testing program included grain-size distribution analyses and moisture content determinations. A summary of our laboratory testing program and the test results are provided in Appendix A.

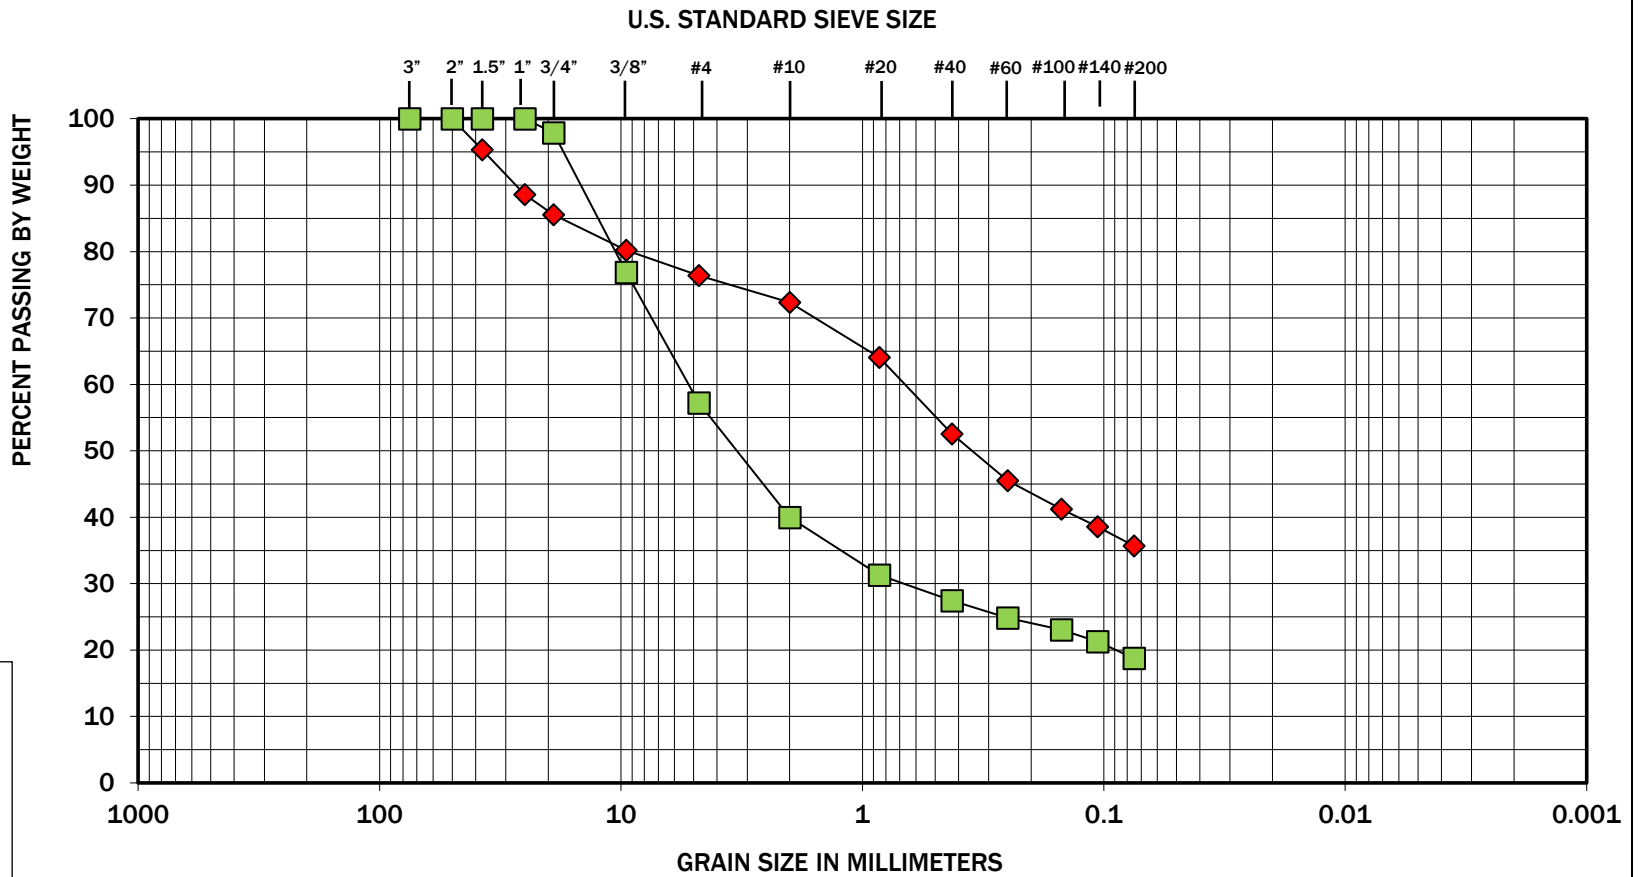
Sieve Analysis Results

Symbol	Boring Number	Depth (feet)	Moisture (%)	Soil Description
◆	TP-6	12	9	Silty sand with gravel (SM)
■	MW-1	15-20	8	Silty gravel with sand (GM)
