**Reference: Geotechnical Engineering Investigation**  
**East Town Crossing**  
Parcel Nos. 0420264053, 0420264054, 0420351066  
SE Corner of E. Shaw Road and E. Pioneer Way  
Puyallup, Washington 98371

**GEOTECHNICAL ENGINEERING INVESTIGATION  
EAST TOWN CROSSING  
PARCEL NOS. 0420264053, 0420264054, 0420351066  
SE CORNER OF E. SHAW ROAD & E. PIONEER WAY  
PUYALLUP, WASHINGTON**

**PROJECT NO. 062-19005  
APRIL 11, 2019**

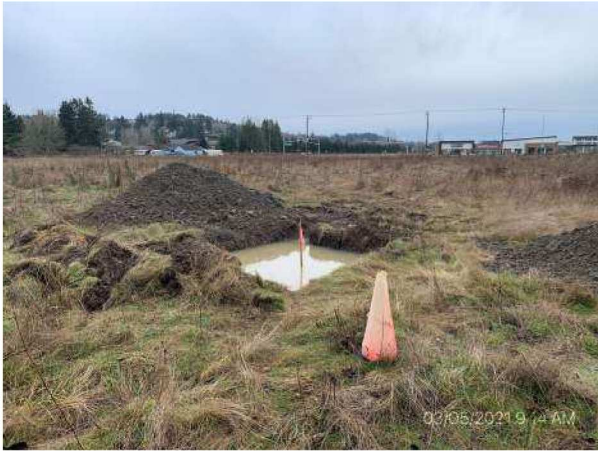
**Water in Pit P-1 on March 5, 2021.**

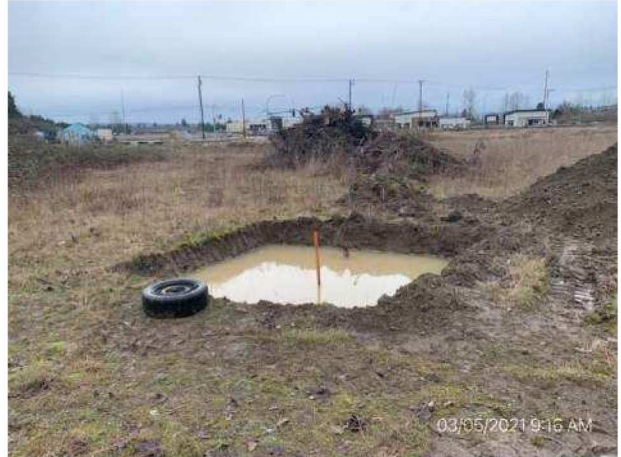
**Water in Pit P-2 on March 5, 2021.**

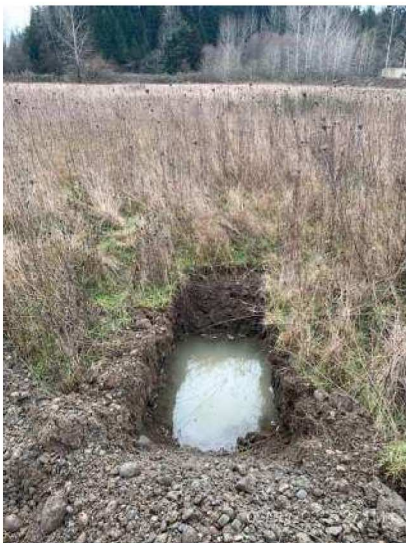
**Figure 2 - Photos (March 5, 2021)**

**Water in Test Pit on March 5, 2021. Test pit was excavated in NE portion of site on March 4, 2021.**

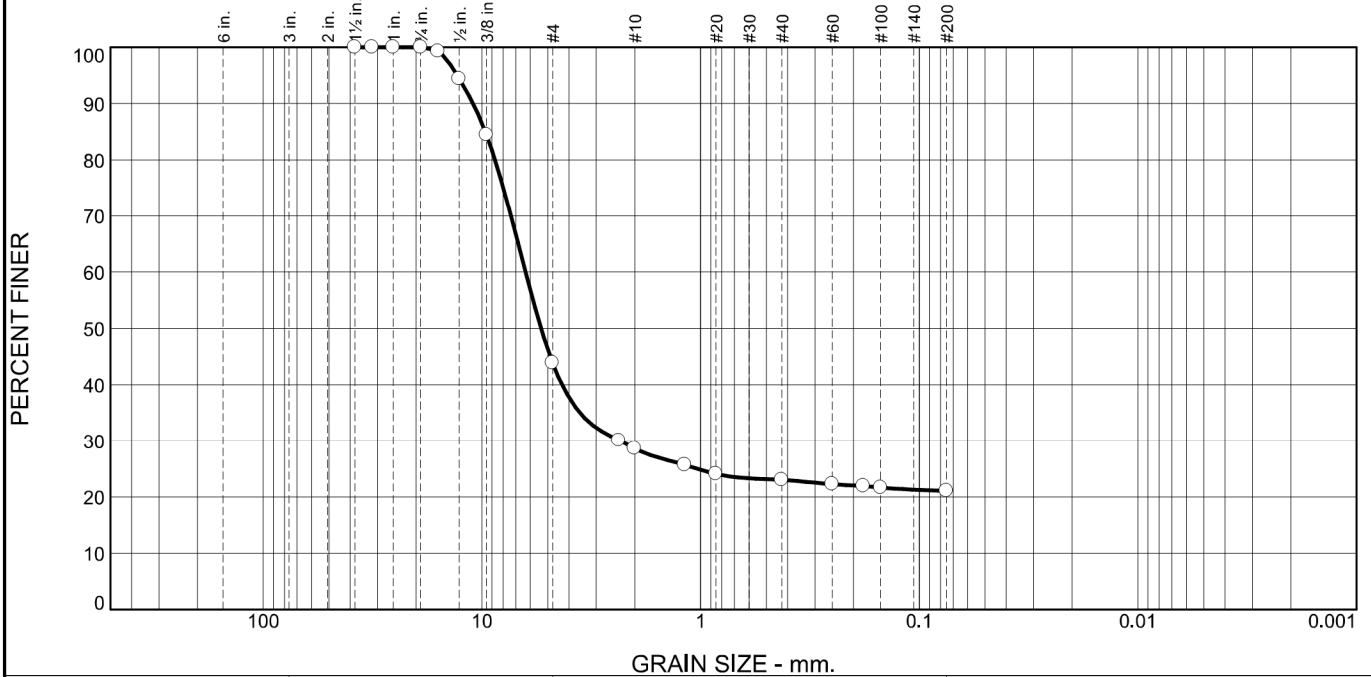
# Particle Size Distribution Report

% +3"	% Gravel		% Sand			% Fines	
	Coarse	Fine	Coarse	Medium	Fine	Silt	Clay
0	0	56	15	6	2	21

Test Results (C-136 & C-117)			
Opening Size	Percent Finer	Spec.* (Percent)	Pass? (X=Fail)
1.5	100		
1.25	100		
1	100		
.75	100		
.625	99		
.5	94		
.375	84		
#4	44		
#8	30		
#10	29		
#16	26		
#20	24		
#40	23		
#60	22		
#80	22		
#100	22		
#200	21
