Drainage Report

For the Dos Lagos Lot 'C' Parcel Number: 0419106030 4202 5th St SE Puyallup, Washington

LeRoy Surveyors & Engineers, Inc. P. O. Box 740 Puyallup, Washington 98371 (253) 848-6608

April 2021 Revised August 2023 Job No: 12896 I hereby state that this Preliminary Drainage Report for the Dos Lagos Lot 'C' Project has been prepared by me or under my supervision and meets the standard of care and expertise which is usual and customary in this community for professional engineers. I understand the City of Puyallup does not and will not assume liability for the sufficiency, suitability, or performance of drainage facilities prepared by me.

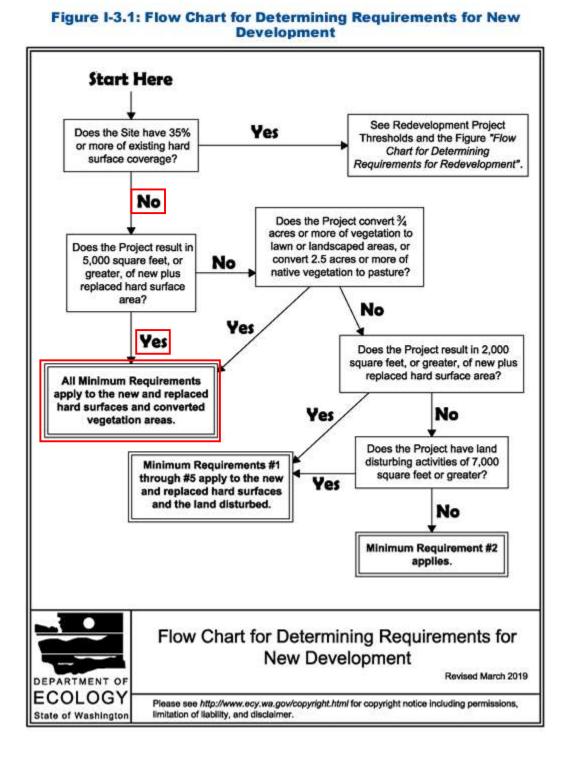
Figure 2: Flow Chart for Determining Requirements for New Development

The project shall comply with the requirements of the 2019 Stormwater Management Manual for Western Washington referred to hereon as 'The Manual', with amendments from City of Puyallup Municipal Code (PMC), Section 21.10. The Dos Lagos Lot 'C' Project is a new development project and proposes to add approximately 51,043 sq. ft. of new hard surfaces. Less than 35% of the site consists of existing impervious coverage, and since more than 5,000 sq. ft. of new impervious surfaces are proposed to be added, minimum requirements 1 through 9 apply. The Washington State Department of Ecology (DOE) flow chart, "Figure I-2.4.1 – Flow Chart for Determining Requirements for New Development," is found in Figure 2 on the following page.

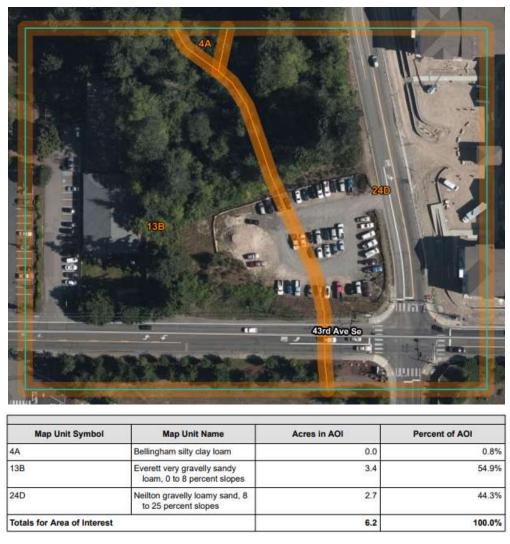
Figure 3: Site Position in NRCS soil mapping (excerpt)

Soil mapping was conducted using the United States Department of Agriculture Natural Resources Conservation Service (NRCS, The Survey) website. The site position within the NRCS soil map is illustrated in Figure 3 below. The soil map for all properties can also be found in the geotechnical report, along with soil descriptions and soil logs, in Appendix D.

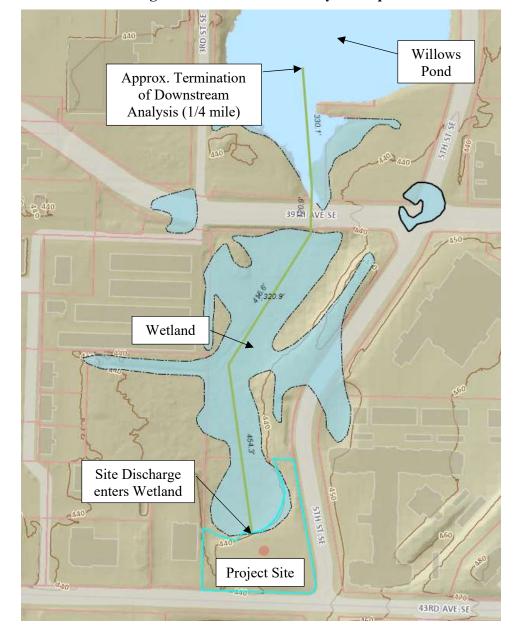
Figure 4: Downstream Analysis Map

A downstream (offsite) analysis has been completed by LS&E for this project. An offsite analysis study area definition map (Figure 4) is shown below. The study area for this project extends to approximately ¹/₄ mile to the approximate center of the water body known as Willow's Pond. This pond eventually drains into Bradley Lake, then downstream for an unspecified distance.

No adverse impacts to downstream waters are anticipated as stormwater runoff from proposed pollution-generating impervious surfaces will first be infiltrated through porous pavement before flowing laterally through the sub-surface into the wetland.

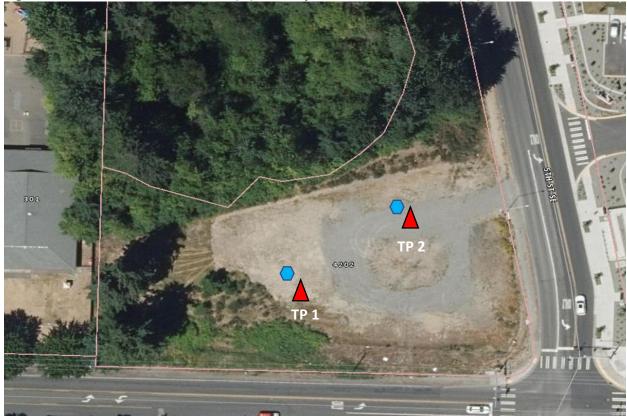
Figure 3: Lot-C Infiltration Test PIT () and Adjacent observation PIT () Locations

• Finally, a test PIT adjacent to the PIT was excavated to determine if water was mounding laterally. This step is intended for the sites with restrictive layers. The practice of adjacent excavation satisfies the requirement to over-excavate the test PIT to examine the groundwater mounding.

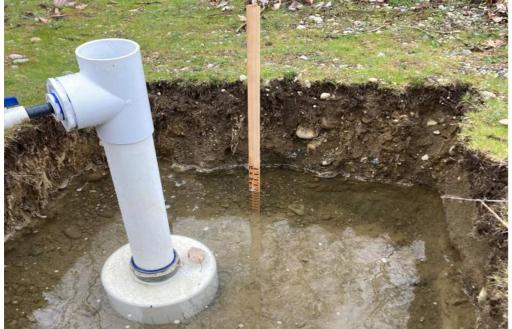
Figure 6: Infiltration Test in Progress PIT 1, Lot C

Figures 6 through 10 provide sampling of the PIT Test photographs.

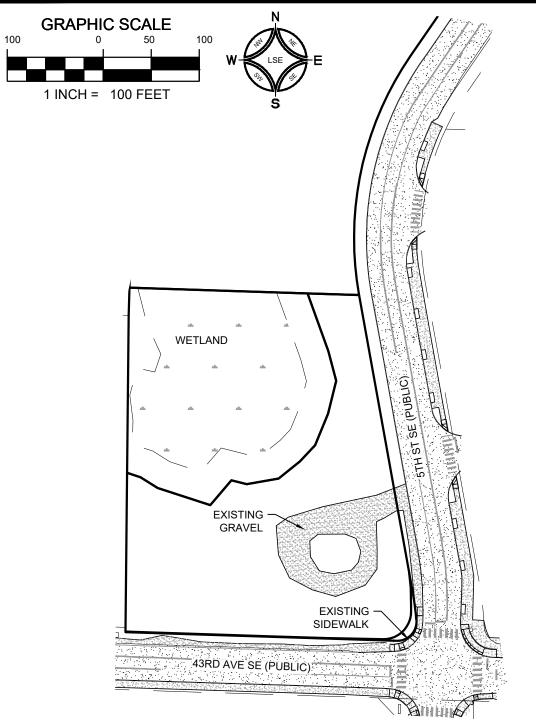
PREDEVELOPED BASIN AREAS:

BASIN AREA: 108,847 SF (2.499 AC)

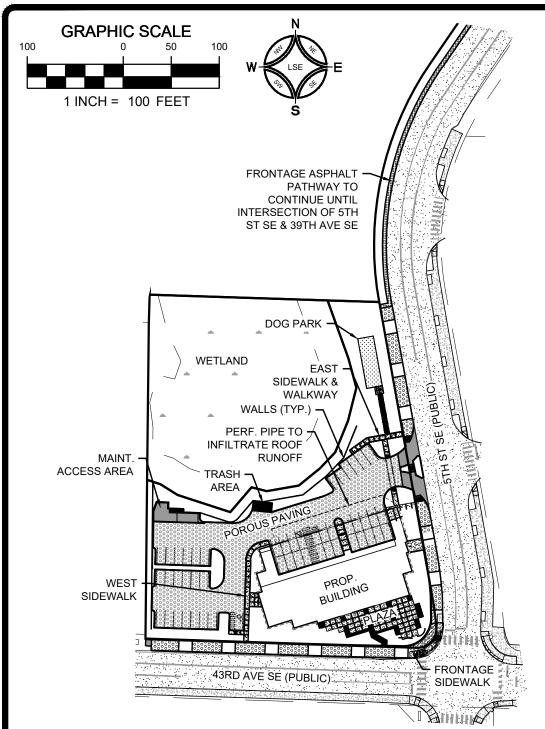
DEVELOPED BASIN AREAS:

BASIN AREA: 108,847 SF (2.499 AC)
