## **Drainage Report**

**For the Dos Lagos Lot 'C'  
Parcel Number: 0419106030  
4202 5<sup>th</sup> St SE  
Puyallup, Washington**

**April 2021  
Revised August 2023  
Revised March 2024  
Job No: 12896**

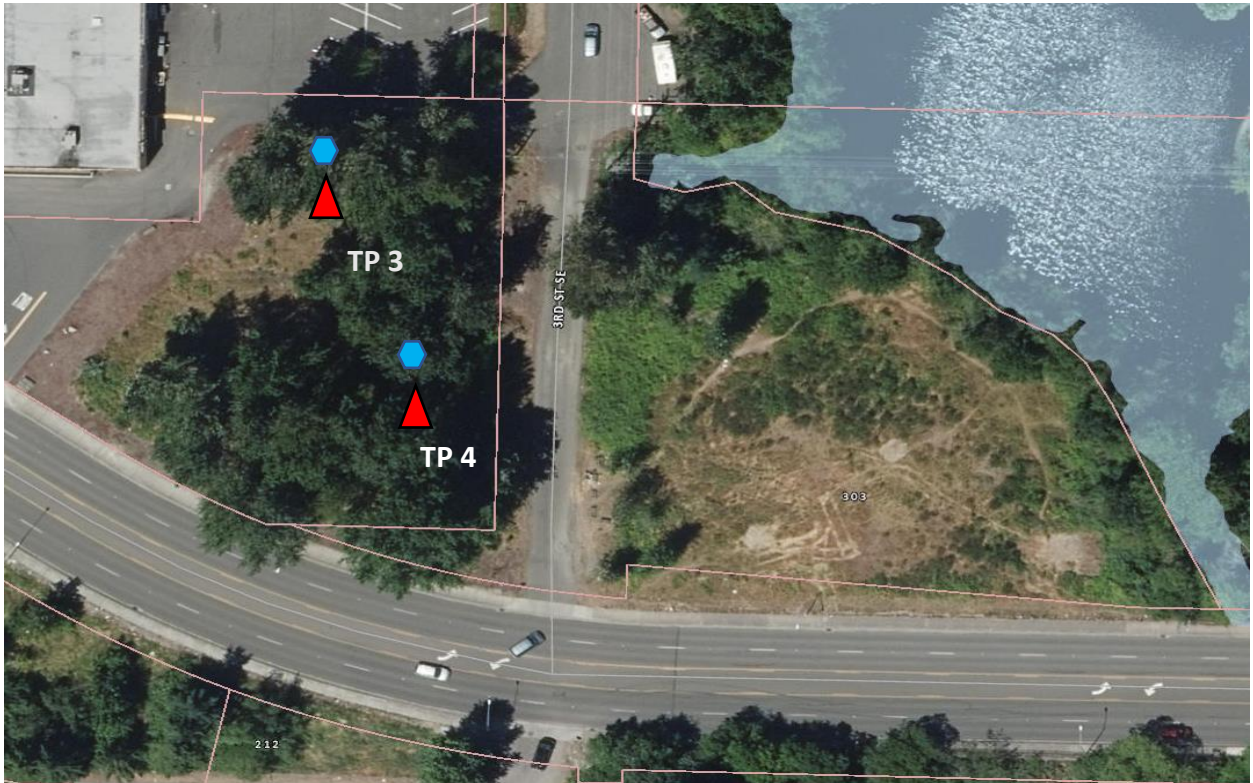
**Figure 4: Lot-D Infiltration Test PIT (●) and Adjacent observation PIT (▲) Locations**

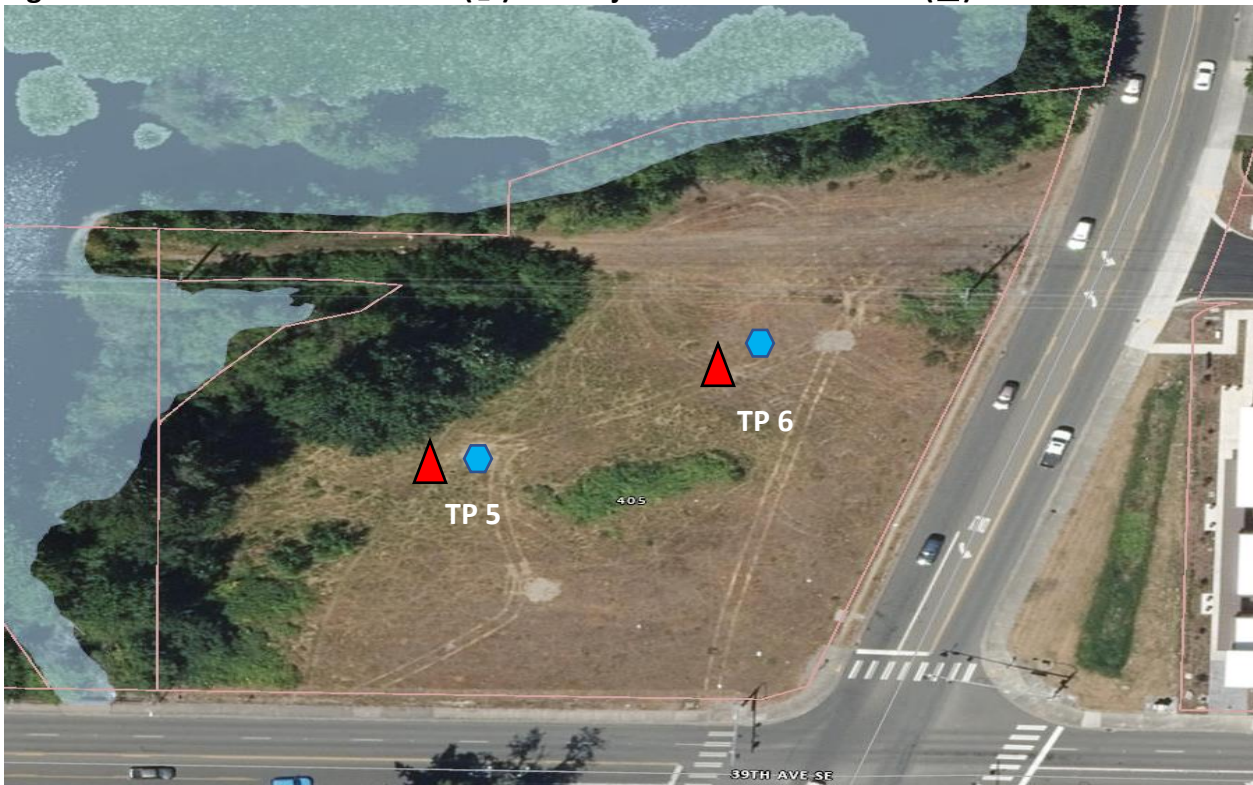
**Figure 5: Lot-E Infiltration Test PIT (●) and Adjacent observation PIT (▲) Locations**

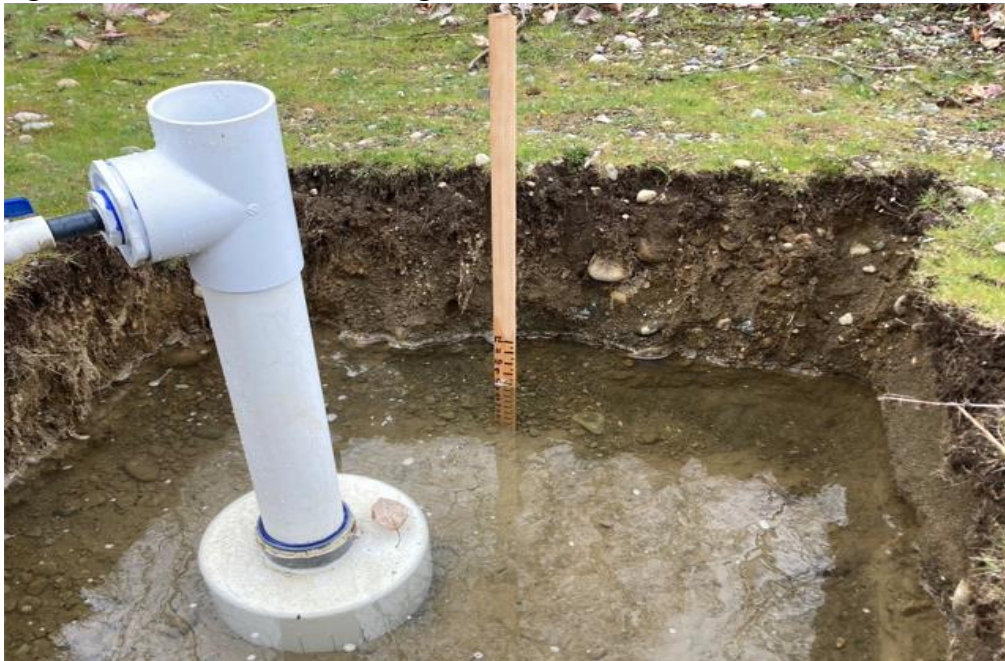
**Figure 6: Infiltration Test in Progress PIT 1, Lot C**

Figures 6 through 10 provide sampling of the PIT Test photographs.

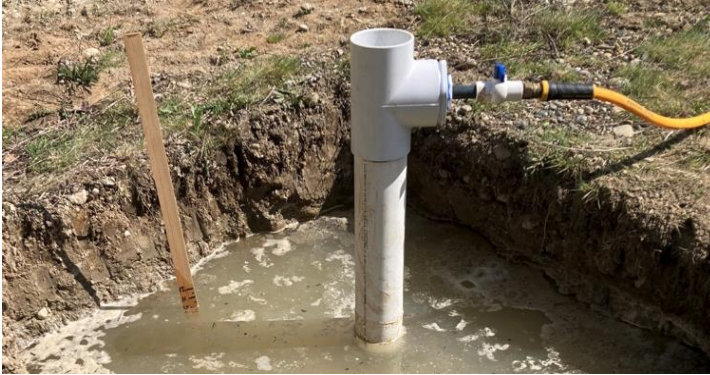
**Figure 7: Infiltration Test in Progress PIT TEST 2, Lot C**
