## **Drainage Report**

**For the Dos Lagos Lot 'D'**  
**Parcel Number: 0419102107 & 0419106026**  
**303 39<sup>th</sup> Ave SE**  
**Puyallup, Washington**

**May 2021**  
**Revised August 2023**  
**Revised March 2024**  
**Job No: 12896**

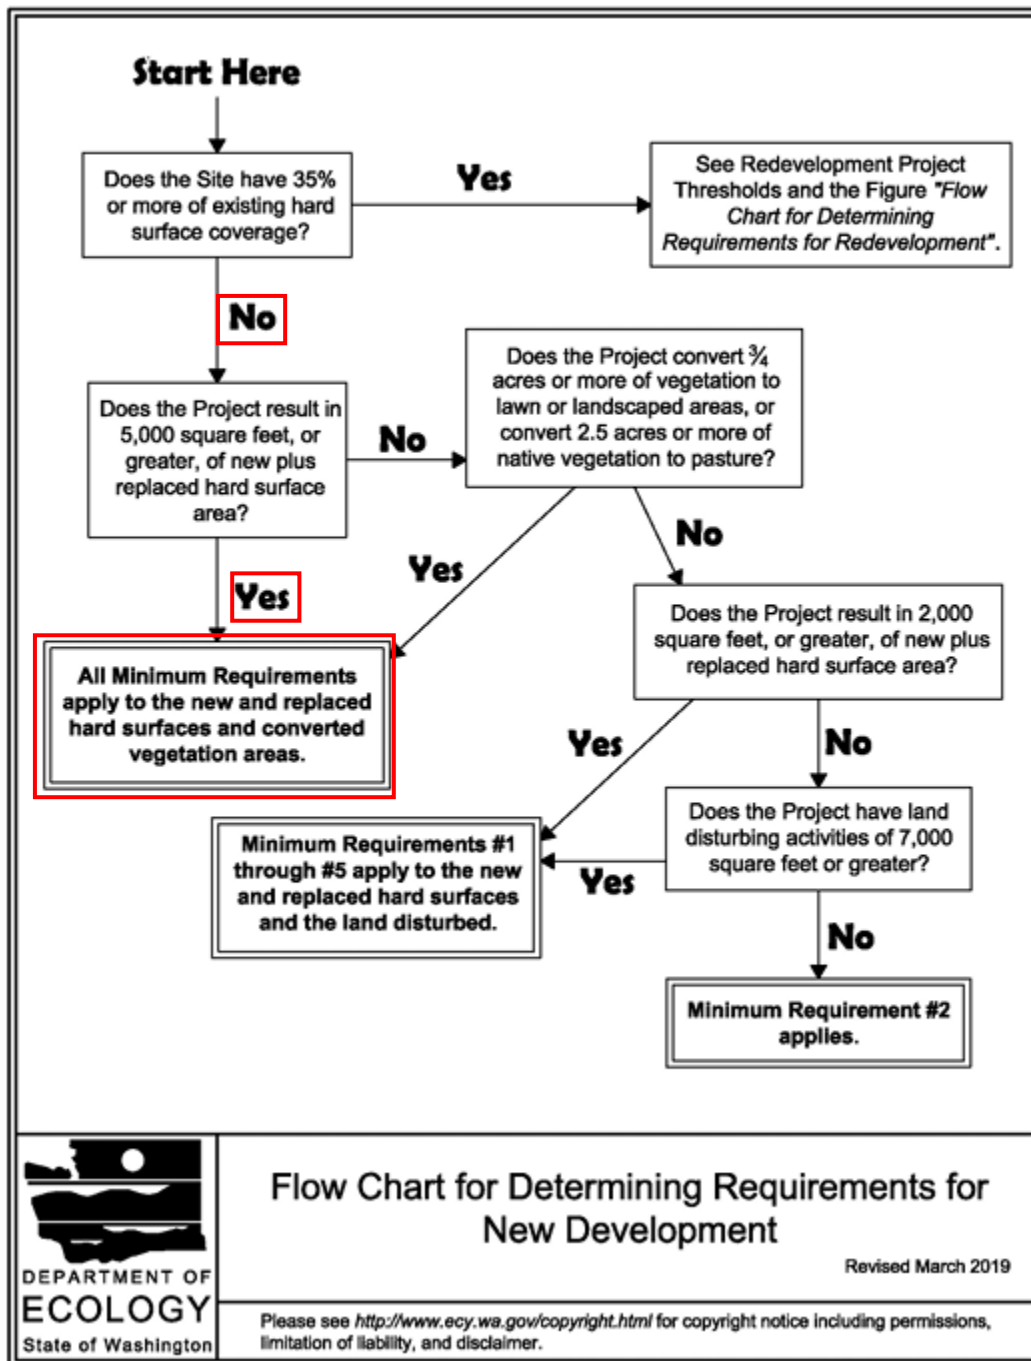
**Figure I-3.1: Flow Chart for Determining Requirements for New Development**

Figure 2: Flow Chart for Determining Requirements for New Development

The project shall comply with the requirements of the 2019 Stormwater Management Manual for Western Washington referred to hereon as ‘The Manual’, with amendments from City of Puyallup Municipal Code (PMC), Section 21.10. Less than 35% of the site consists of existing impervious coverage, and since more than 5,000 sq. ft. of new impervious surfaces are proposed to be added, minimum requirements 1 through 9 apply. The Washington State Department of Ecology (DOE) flow chart, “Figure I-2.4.1 – Flow Chart for Determining Requirements for New Development,” is found in Figure 2 on the following page.

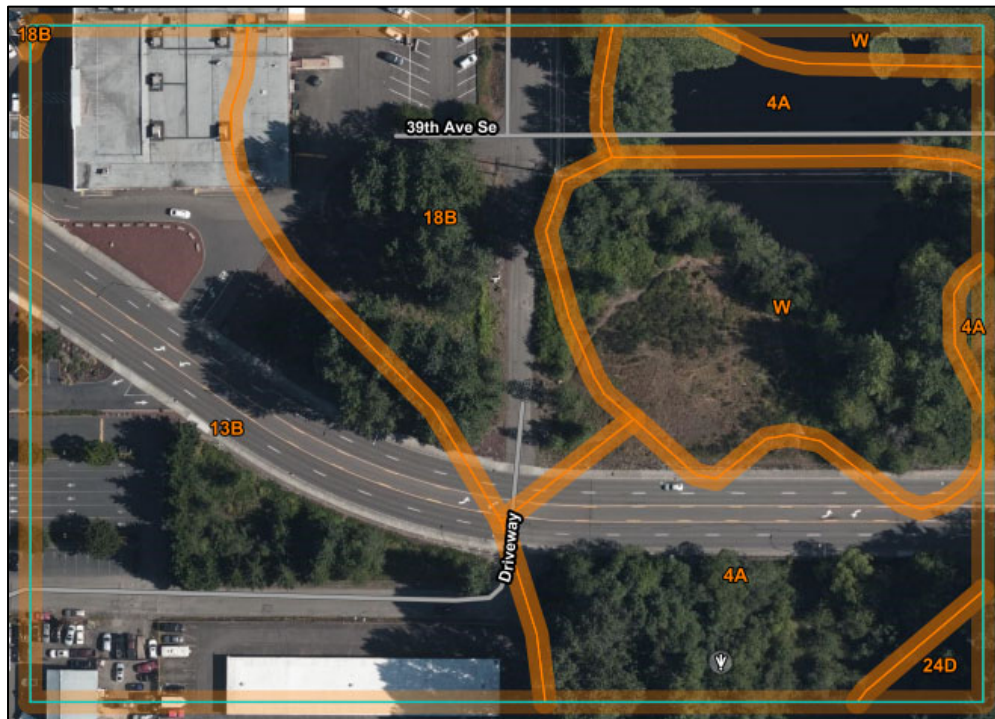
**Figure 3: Site Position in NRCS soil mapping (excerpt)**

Soil mapping was conducted using the United States Department of Agriculture Natural Resources Conservation Service (NRCS, The Survey) website. The site position within the NRCS soil map is illustrated in Figure 3 below. The soil map for all properties can also be found in the geotechnical report, along with soil descriptions and soil logs, in Appendix D.

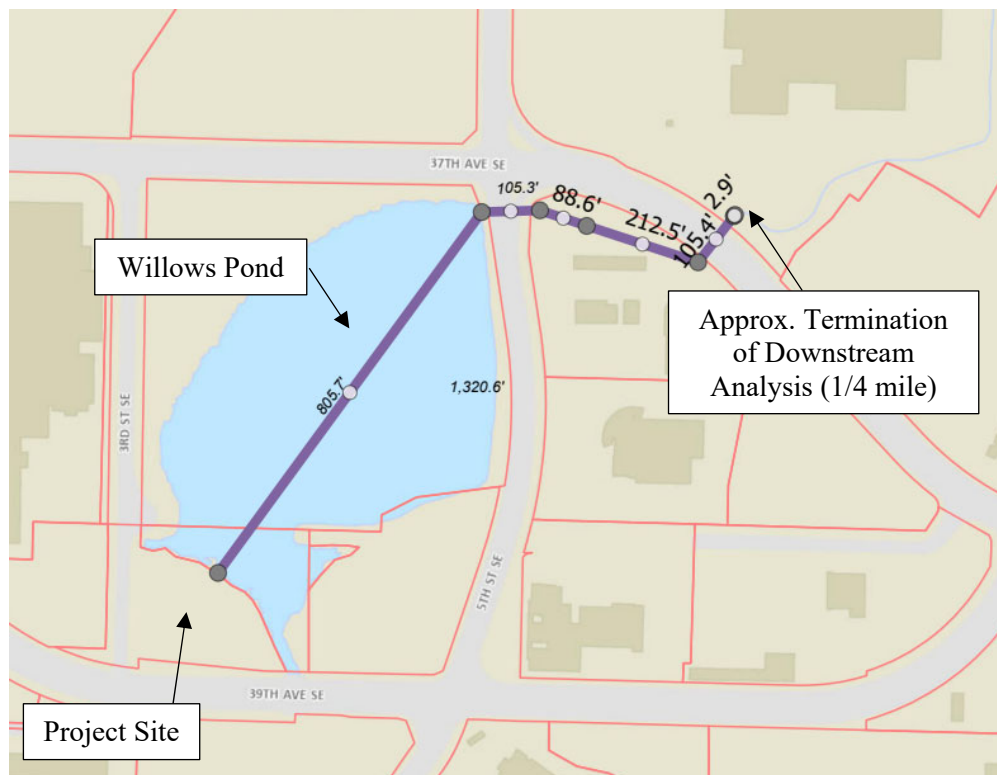
**Figure 4: Willows Pond Basin Downstream Analysis Map**

- East Willows Pond Basin: The study area for this project extends approximately ¼ mile to a portion of the unnamed stream that is released from Willow's Pond, just north of its crossing under 37<sup>th</sup> Ave SE. This stream eventually drains into Bradley Lake, then downstream for an unspecified distance (see Figure 4).

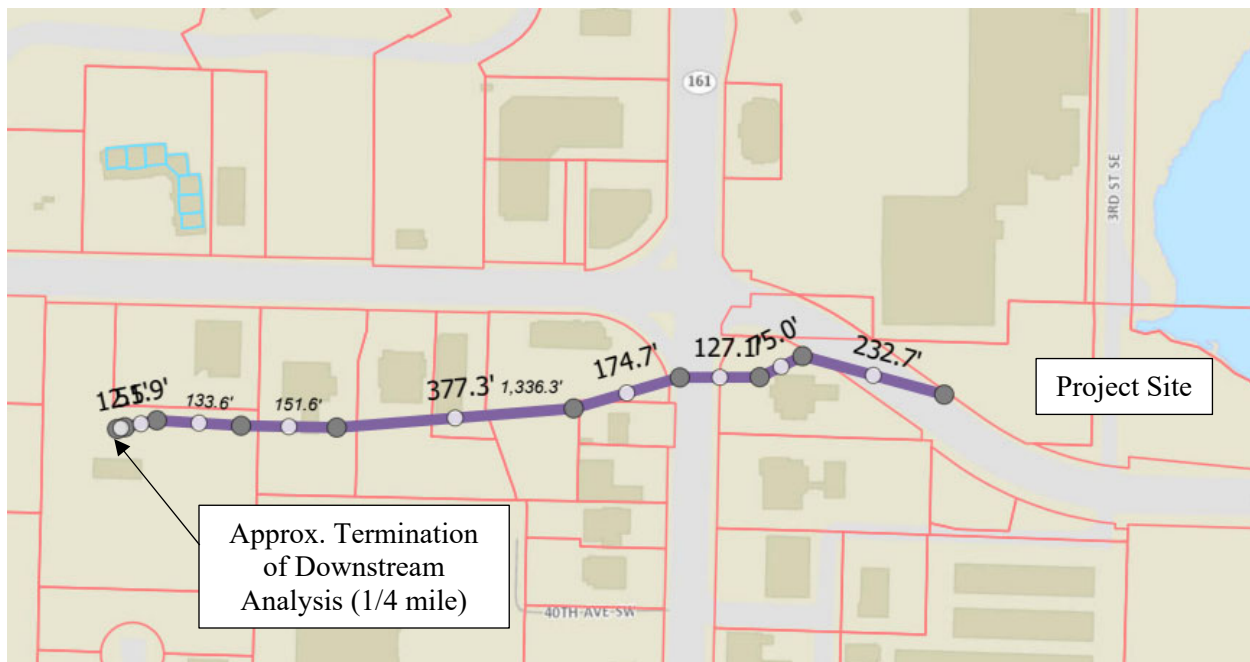
**Figure 5: Black Swamp Basin Downstream Analysis Map**

- West Black Swamp Basin: For the western portion of the site, there is an existing inlet that collects surface water and conveys it through piping to the west. Eventually the piping discharges into a conveyance ditch to the west of the site, which eventually discharges to the Pierce County Black Swamp Pothole.

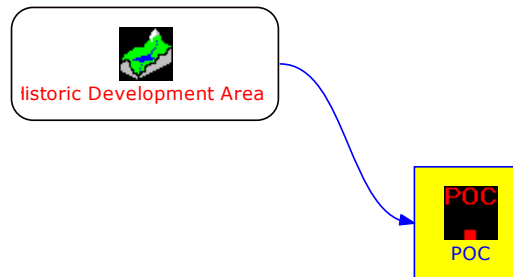
**PREDEVELOPED**

**DOS LAGOS – LOT D (LSE 12896)  
MR7 STORMWATER CALCULATION  
WEST BLACK SWAMP BASIN**

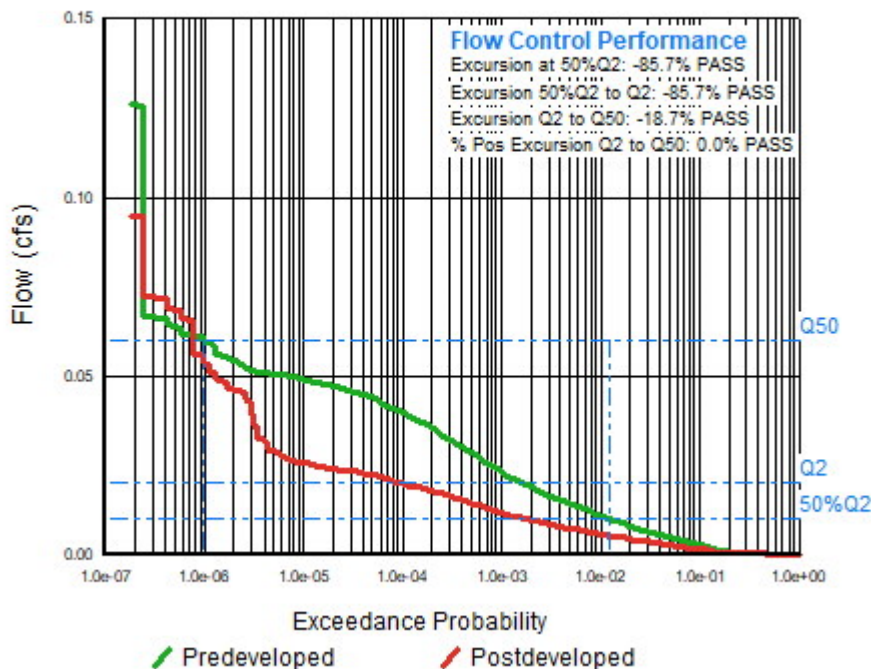
## Flow Duration Plot

MEETS ALL FLOW DURATION DESIGN CRITERIA: PASS

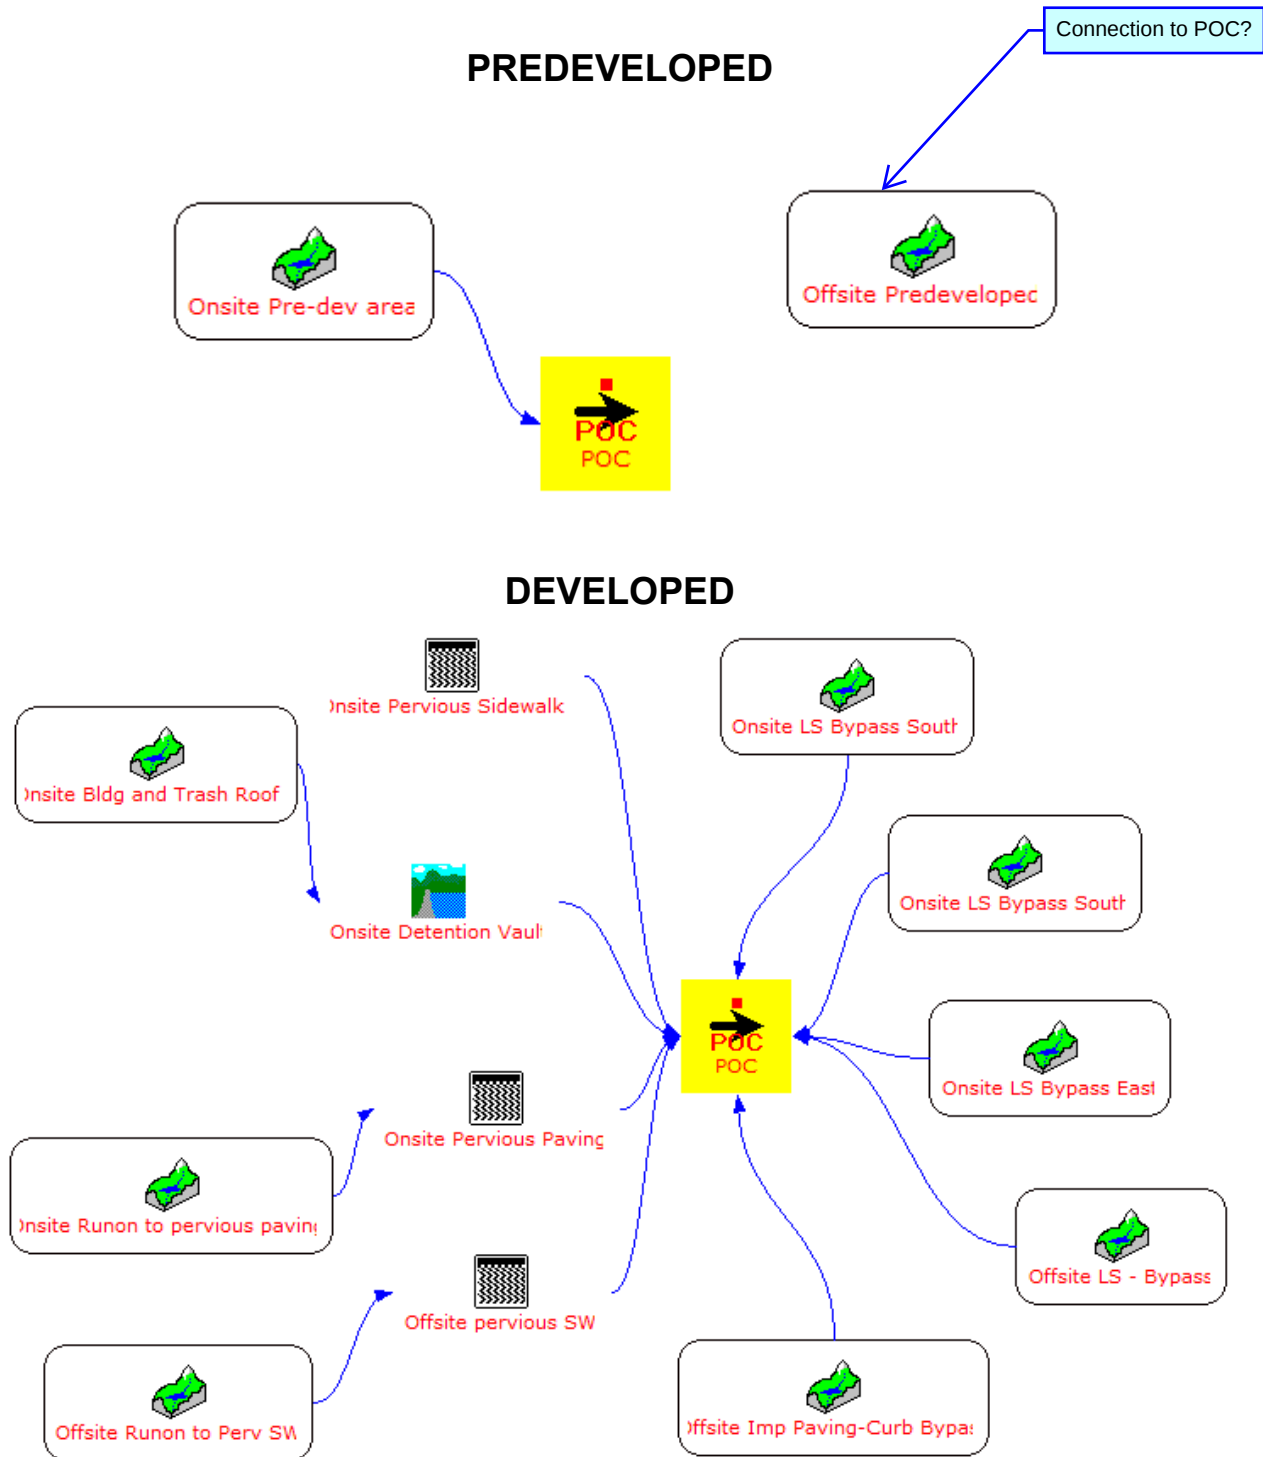
**DOS LAGOS – LOT D (LSE 12896)**  
**MR7 STORMWATER CALCULATION EAST WILLOWS POND BASIN**  
**INCLUDING ONSITE AND OFFSITE**

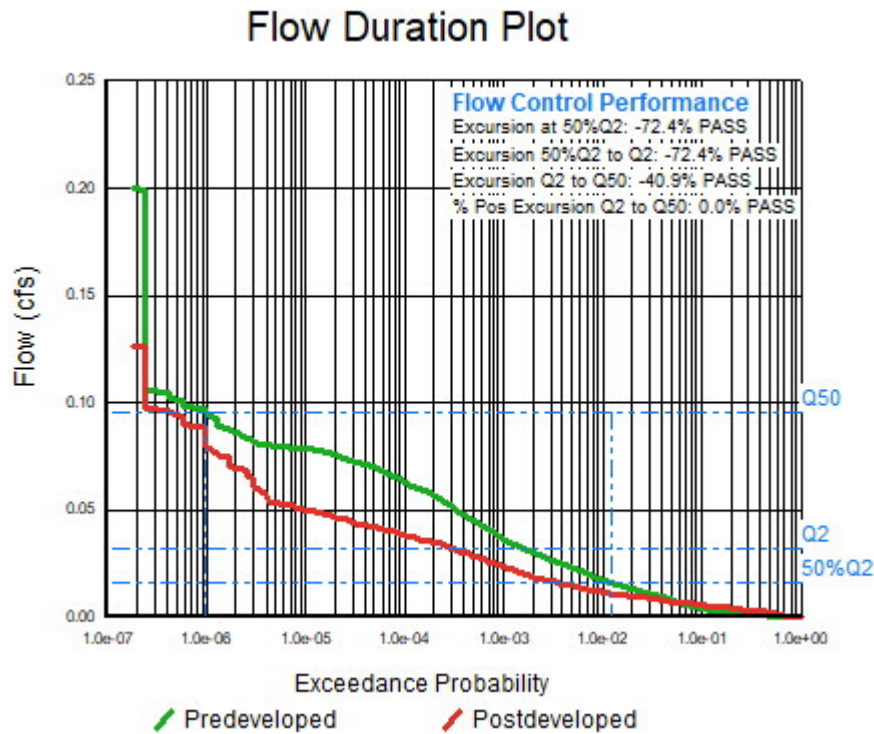
| Percent Excursion from Q2 to Q50 (Must be less than 50%): | 0.0% | PASS |

MEETS ALL FLOW DURATION DESIGN CRITERIA: PASS

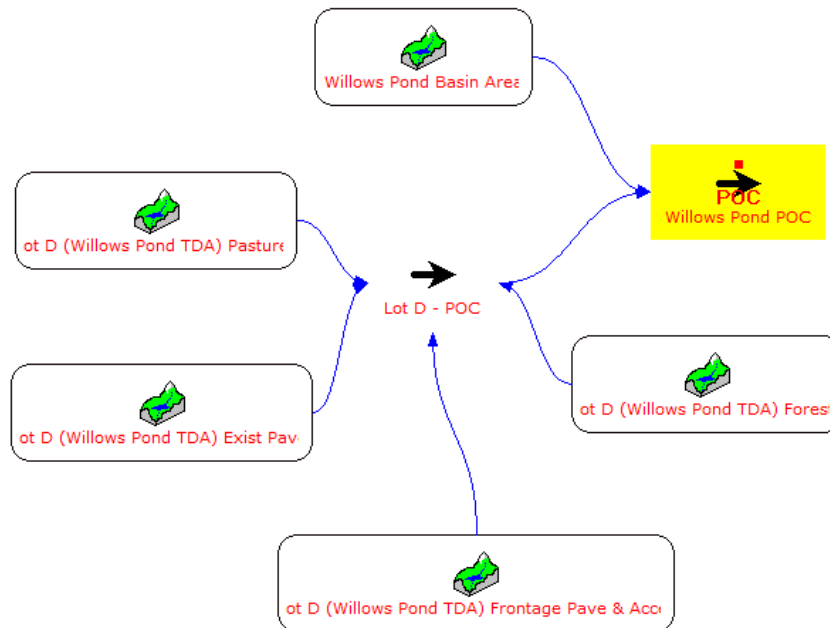
## MR8 STORMWATER CALCULATION EAST WILLOWS POND BASIN INCLUDING ONSITE AND OFFSITE IMPROVEMENTS PREDEVELOPED

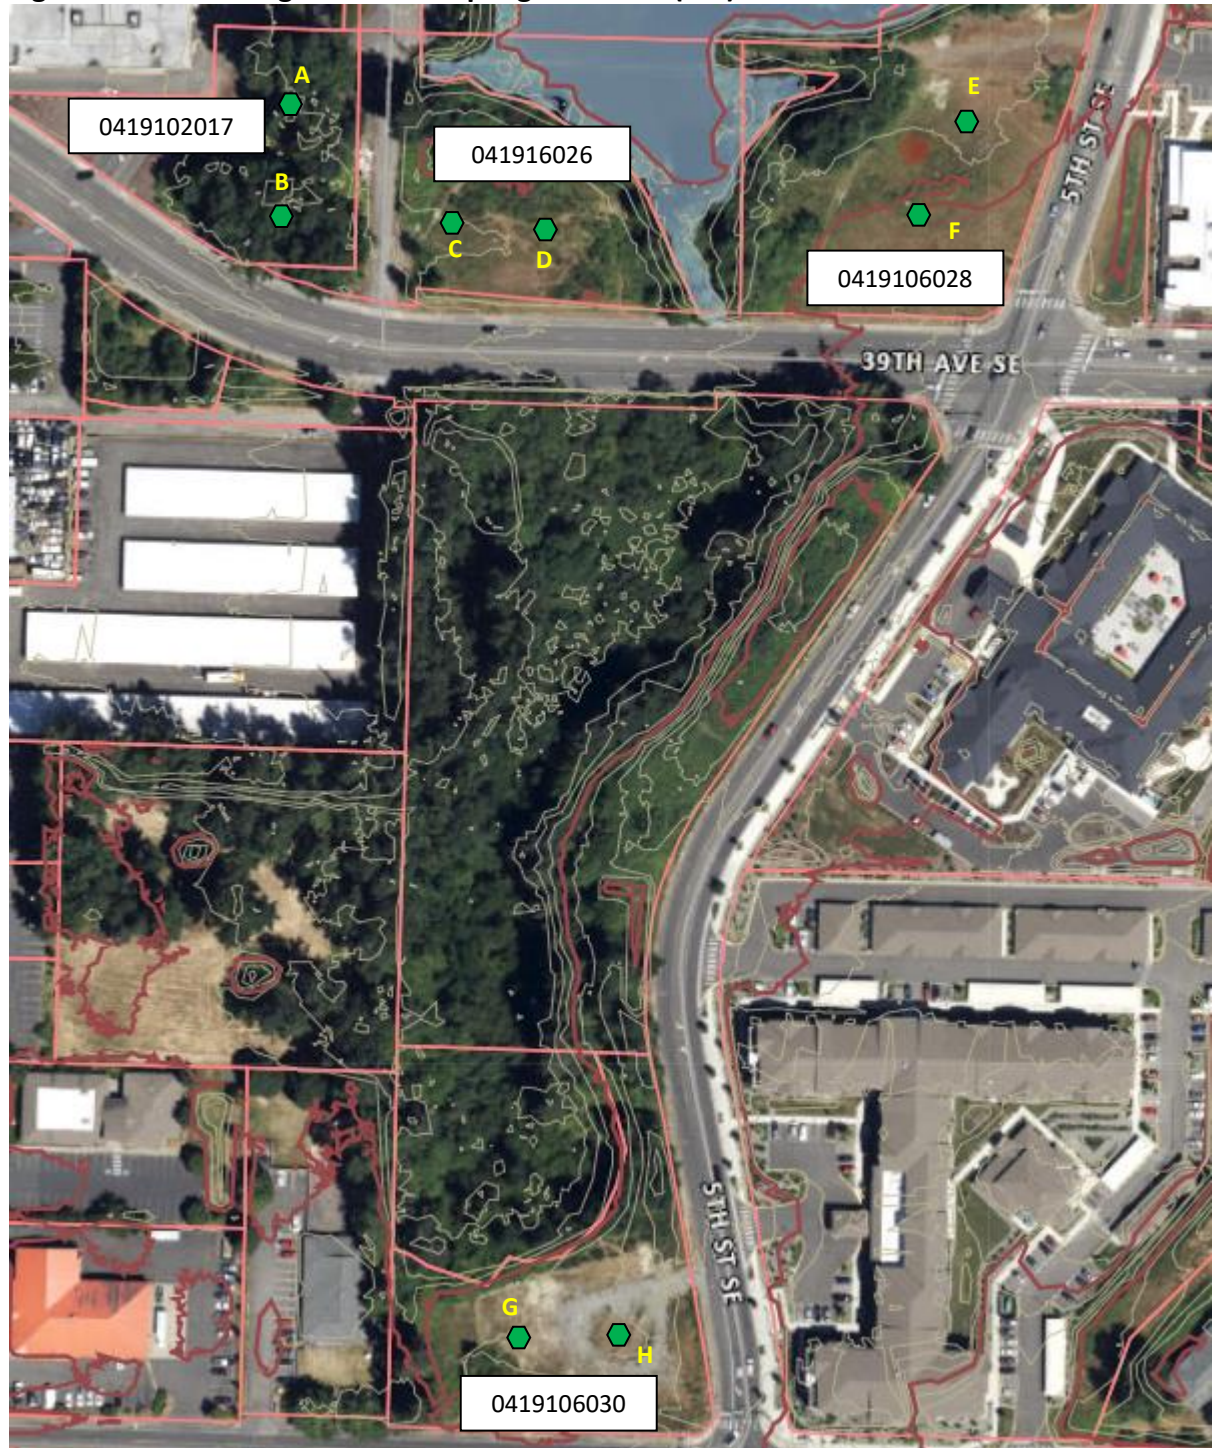
**Figure 1: CEC and Organic Soil Sampling Locations ( ● ) and Associated Parcel Numbers**

The determination of organic percentage per the ASTM D2974 test method can be used to determine the moisture content, ash content, and percent organic matter in soil. Figure 1 illustrates the test locations over the four parcels.

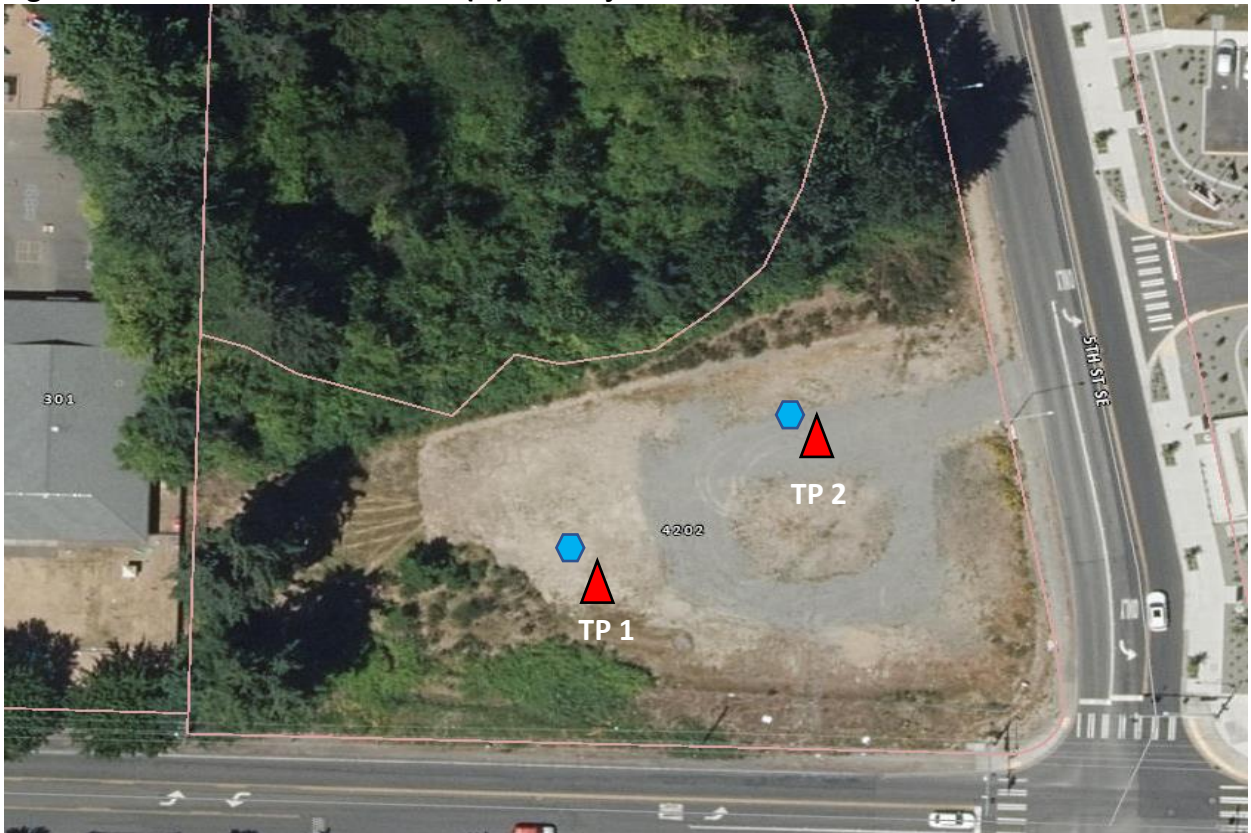
**Figure 3: Lot-C Infiltration Test PIT (●) and Adjacent observation PIT (▲) Locations**

- Finally, a test PIT adjacent to the PIT was excavated to determine if water was mounding laterally. This step is intended for the sites with restrictive layers. The practice of adjacent excavation satisfies the requirement to over-excavate the test PIT to examine the groundwater mounding.

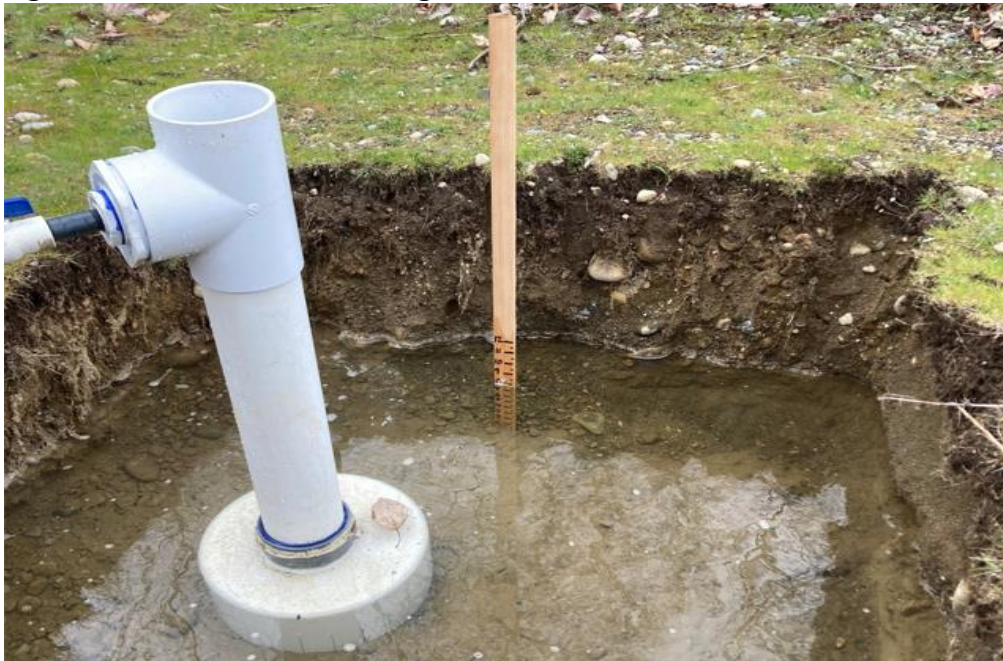
**Figure 6: Infiltration Test in Progress PIT 1, Lot C**

A Licensed Geologist and representative from our firm oversaw the preparation of site and conducted the tests. Excavations measuring 4x4ft i.e., 16 ft<sup>2</sup> were advanced approximately 23 and 22 inches below present grade. Excavated PIT-1 and 2 for Lot C, PIT-3 and 4 for Lot D, PIT-5 and 6 for Lot E respectively. The spoils were set back from the excavation.

Figures 6 through 10 provide sampling of the PIT Test photographs.
