Subject: Geotechnical Engineering Services
MultiCare – Good Samaritan Stormwater Improvements Project
Puyallup, Washington
File No. 2868-039-00

Vicinity Map	
Good Samaritan Stormwater Improvements Puyallup, Washington	
	Figure 1

Site Plan	
Good Samaritan Stormwater Improvements Puyallup, Washington	
	Figure 2a

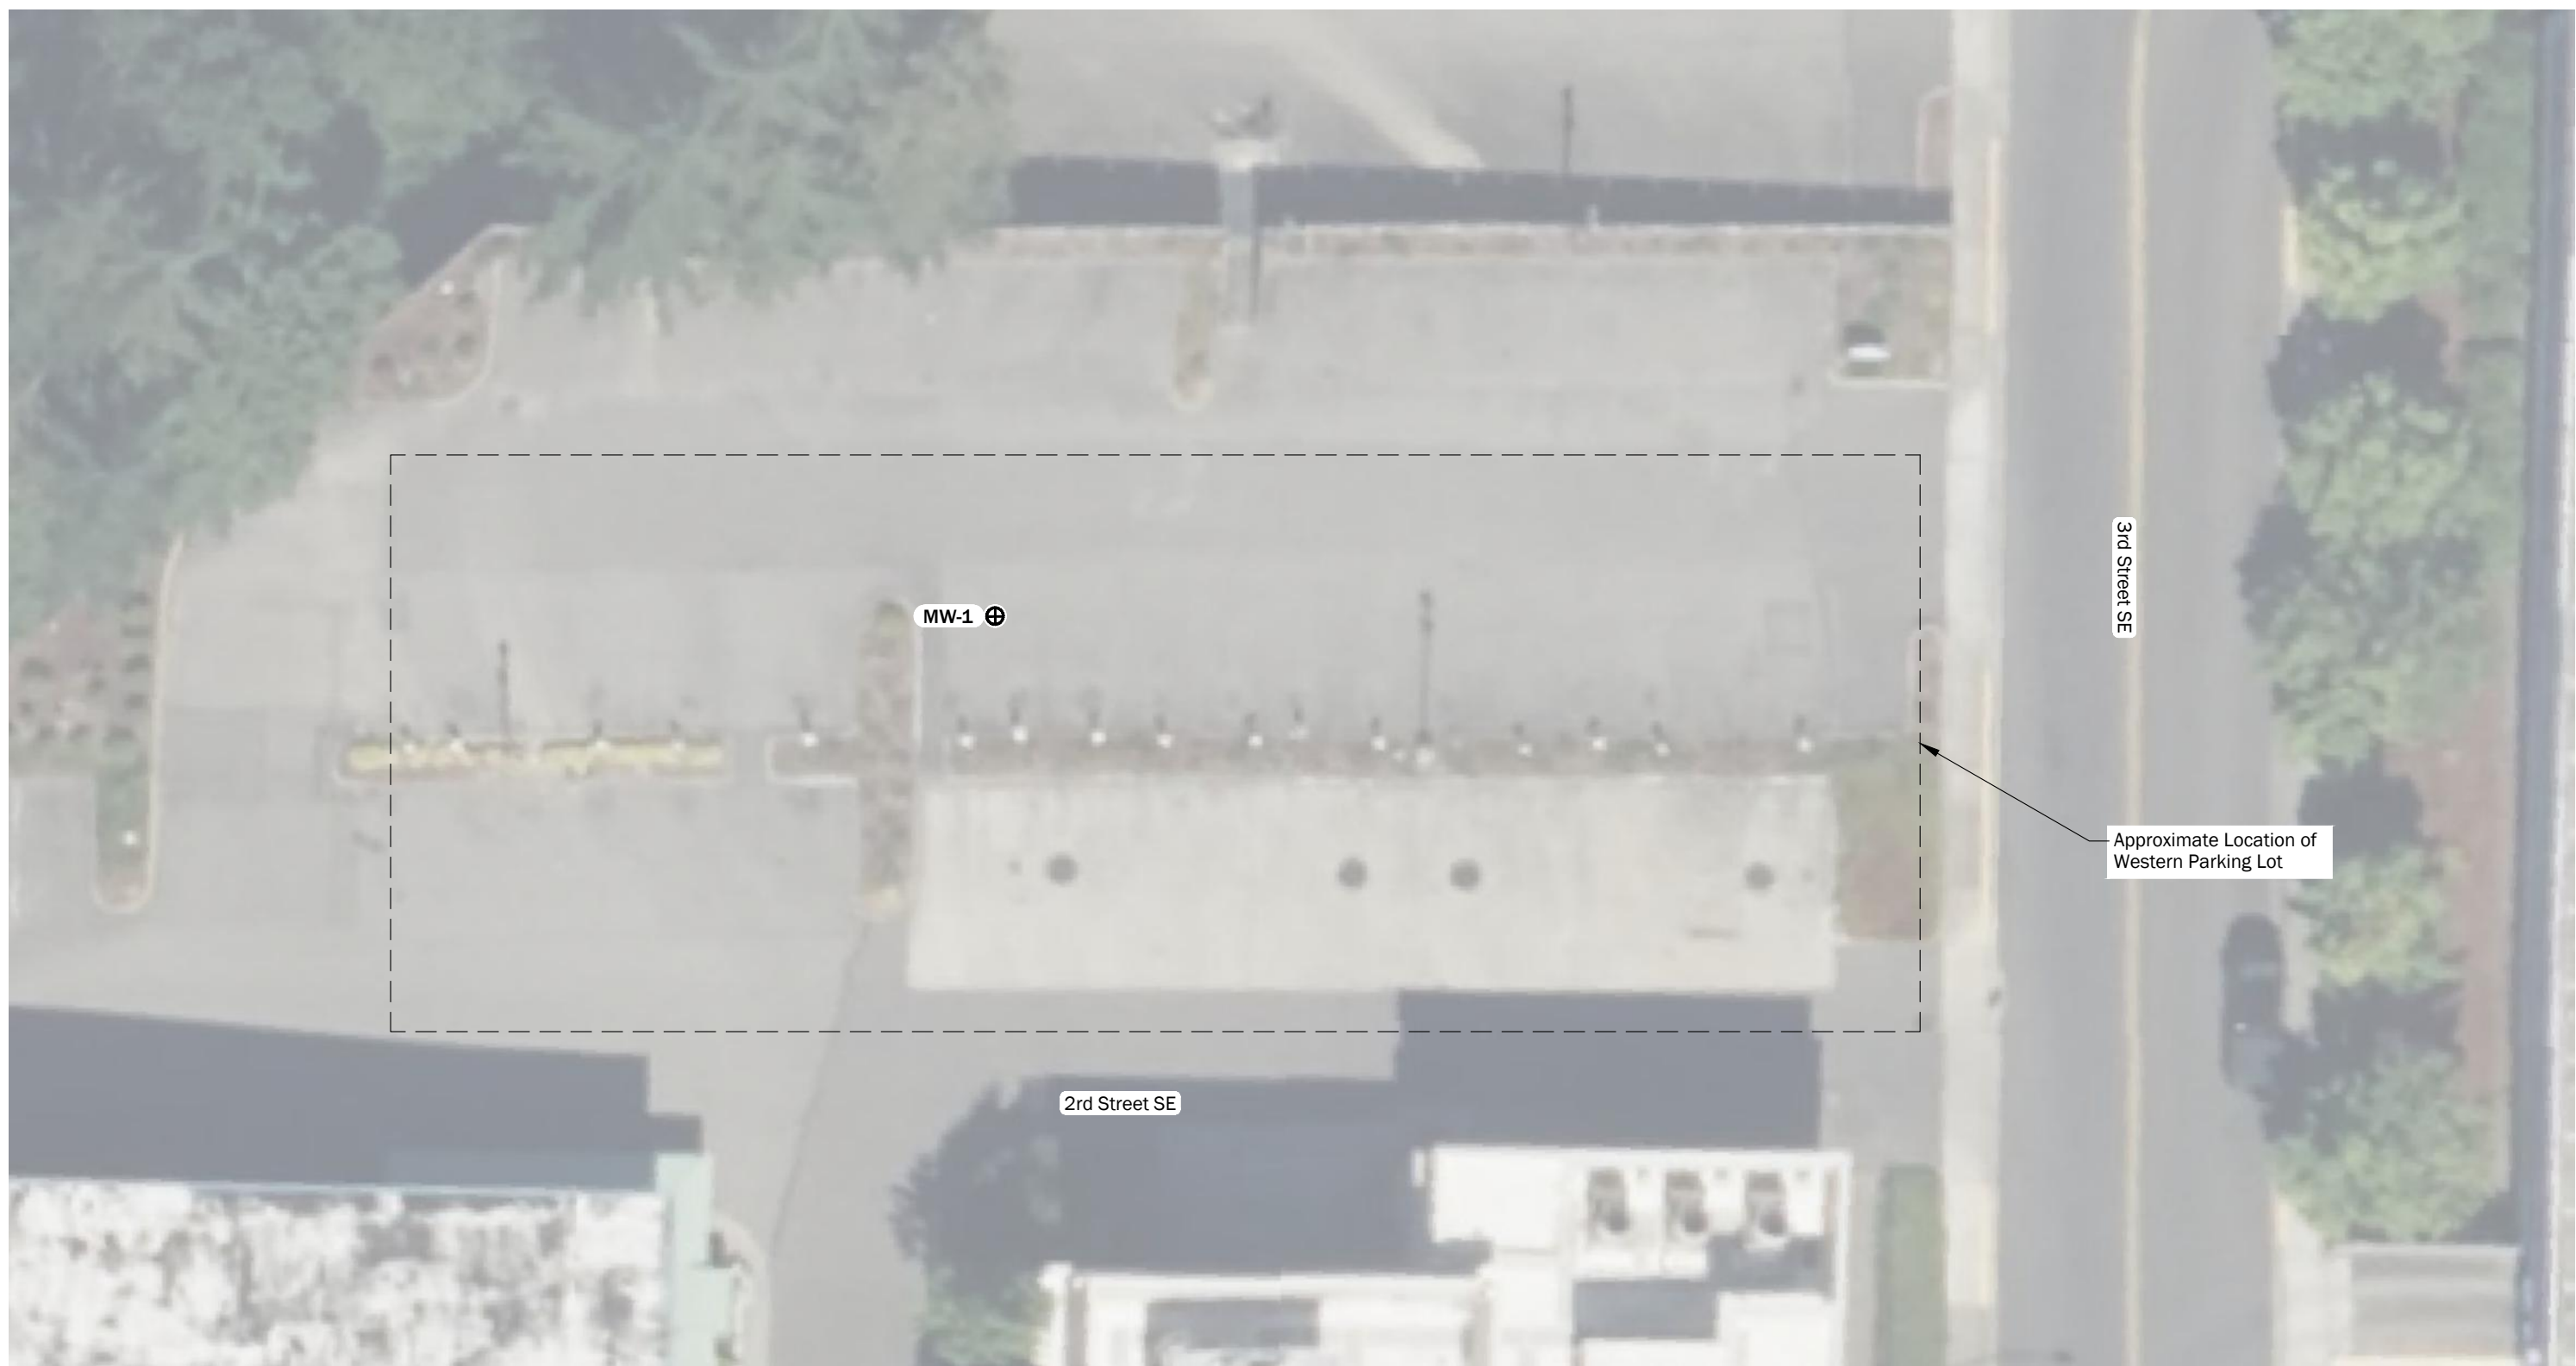
For the purposes of this report, we reference three general focus areas within the MultiCare – Good Samaritan Hospital campus that are proposed to be developed with stormwater facilities: (1) an area in the western portion of the hospital campus that is currently a parking lot that will be developed with a below-grade vault (western parking lot), (2) an existing parking lot in the eastern portion of the hospital campus that will be developed with a below-grade vault (eastern parking lot), and (3) an existing gravel lot in the northeastern portion of the hospital campus that will be developed with a stormwater pond (northeastern gravel lot). The approximate location of each area is shown in the Site Plan, Figures 2a and 2b.

We observed subsurface conditions in the focus areas by excavating two test pits (PIT-1 and TP-2) at the northeastern gravel lot and advancing two borings converted to monitoring wells; MW-1 at the western

parking lot and MW-2 at the eastern parking lot. Approximate locations of the explorations are shown in Figures 2a and 2b.

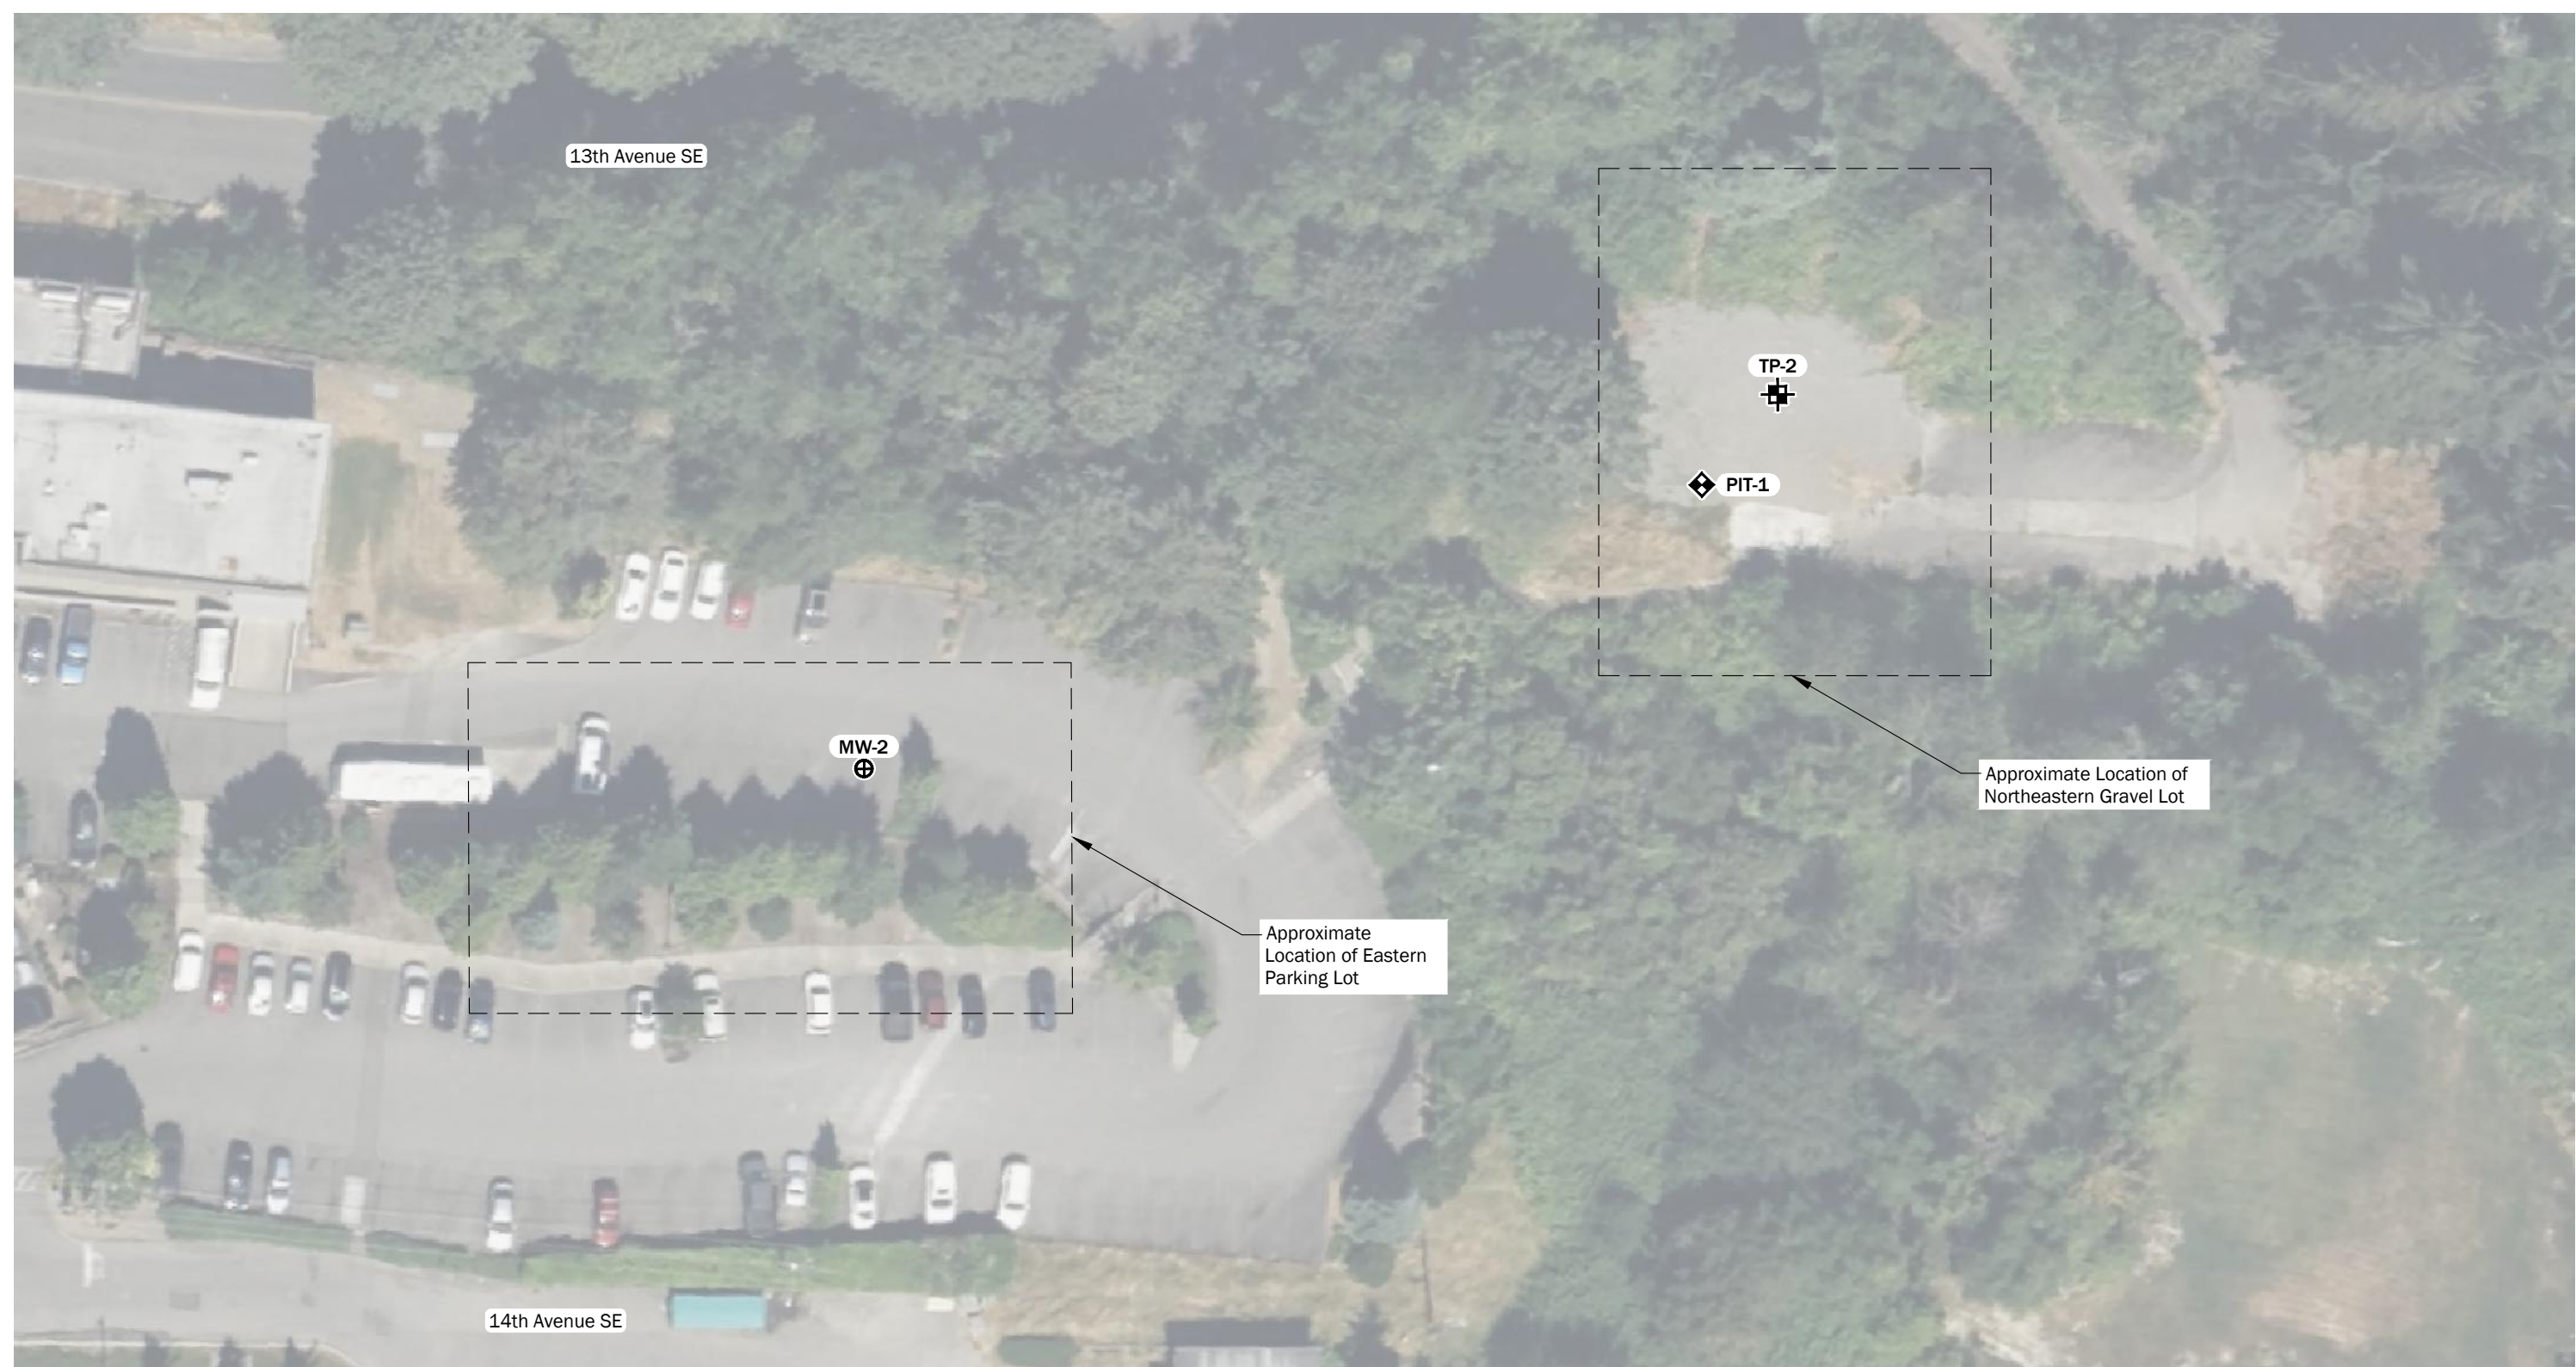
Site Plan	
Good Samaritan Stormwater Improvements Puyallup, Washington	
	Figure 2b

- MW-1 ● Monitoring Well by GeoEngineers, 2024
- PIT-1 ◆ Pilot Infiltration Test by GeoEngineers, 2024
- TP-1 ⊕ Test Pit by GeoEngineers, 2024

Two test pits were excavated on March 28, 2024 at the approximate locations shown in the Site Plan, Figure 2b. The test pits were excavated to depths between about 8¾ and 10¼ feet bgs using an excavator provided and operated by Kelly's Excavating, Inc. under subcontract to GeoEngineers. After each test pit was completed, the excavations were backfilled using the generated material and compacted using the bucket of the excavator. Prior to backfilling, a pilot infiltration test (PIT) was completed at about 8 feet bgs
