Preliminary Drainage Report

**For the Dos Lagos Lot 'E'
Parcel Number: 0419106028
405 39th Ave SE
Puyallup, Washington**

**May 2021
Revised August 2023
Revised March 2024
Revised September 2024
Job No: 12896**

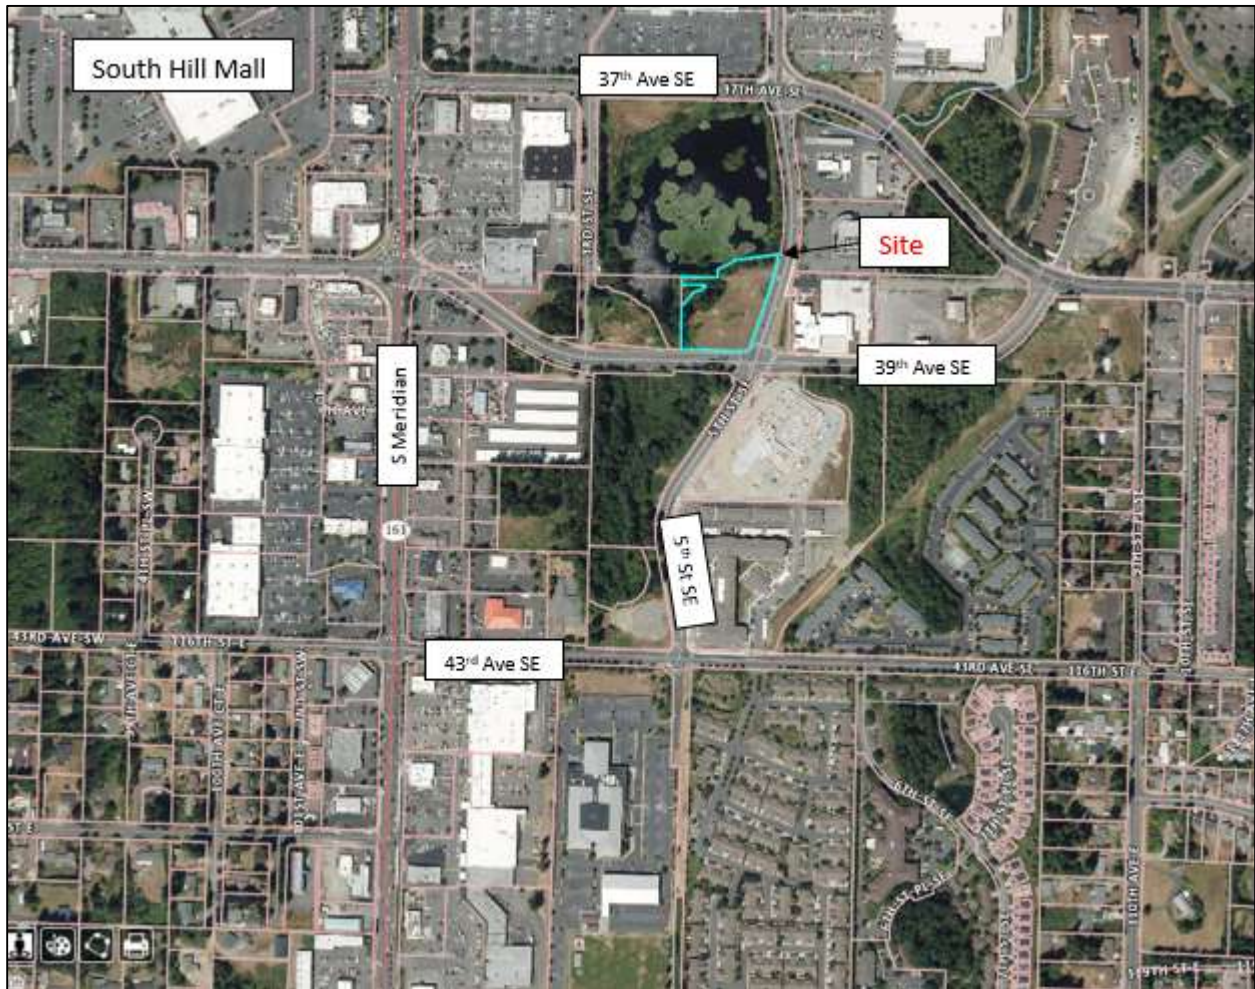
Figure 1: Site Vicinity Map

The project proposes to construct a 46-unit apartment complex with associated parking on 1.89 acres, located at the corner of 5th Street SE and 39th Ave SE in Puyallup, Washington, 98374. Figure 1 illustrates the site parcel location within the local vicinity. Associated right-of-way (ROW) improvements will be constructed, including sidewalk and street trees. Access to the site will be from public road 39th Ave SE. The project is connected to a predevelopment application (No. P-20-0088) and requires a completed SEPA checklist.

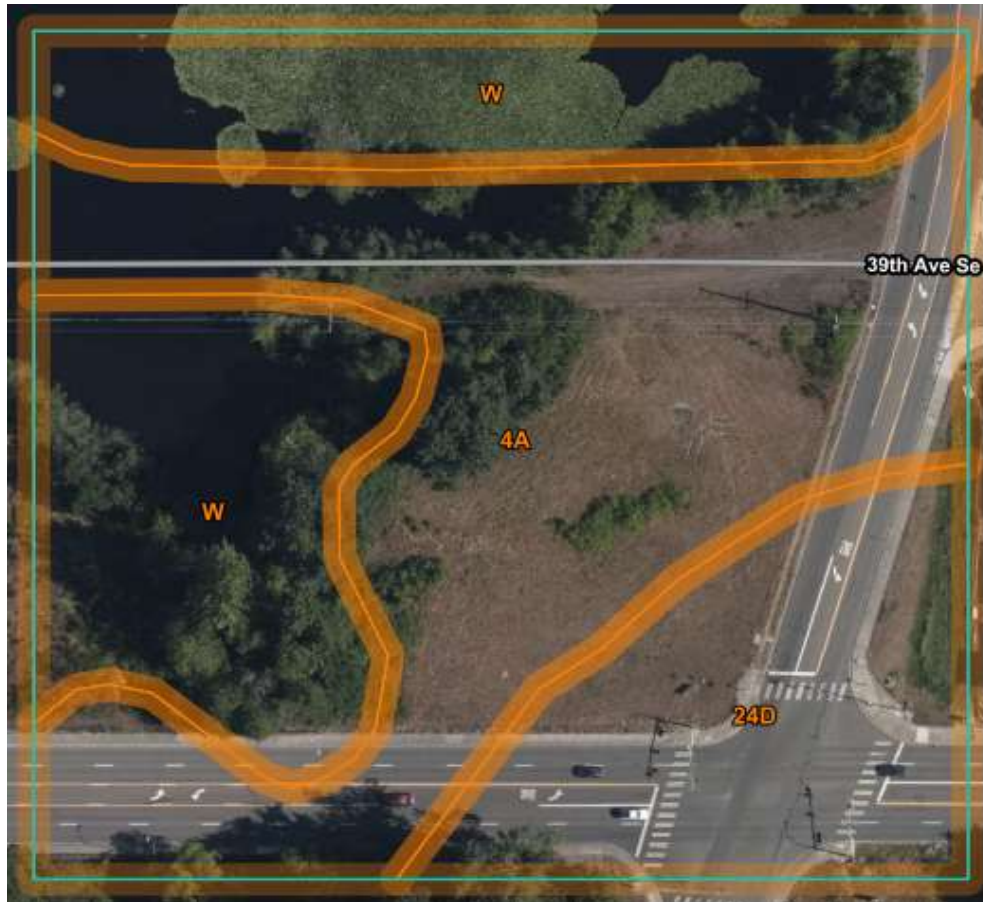
Figure 3: Site Position in NRCS soil mapping (excerpt)

Soil mapping was conducted using the United States Department of Agriculture Natural Resources Conservation Service (NRCS, The Survey) website. The site position within the NRCS soil map is illustrated in Figure 3 below. The soil map for all properties can also be found in the geotechnical report, along with soil descriptions and soil logs, in Appendix D.

Map Unit Symbol	Map Unit Name	Acres in AOI	Percent of AOI
4A	Bellingham silty clay loam	2.8	46.2%
24D	Neilton gravelly loamy sand, 8 to 25 percent slopes	1.2	19.7%
W	Water	2.1	34.2%
Totals for Area of Interest		6.1	100.0%

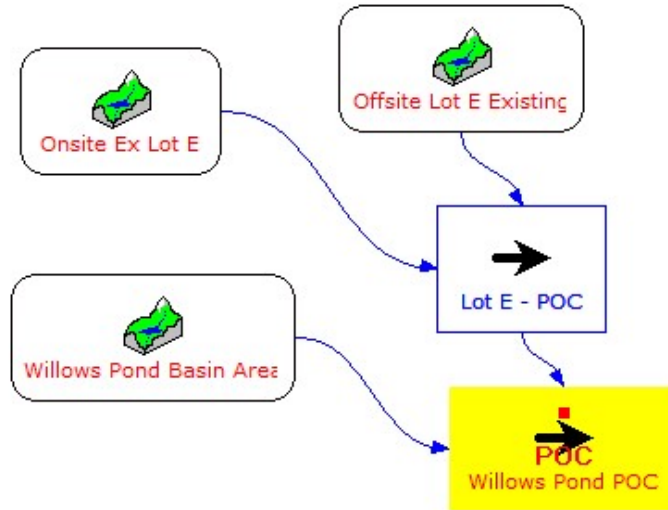
**DOS LAGOS – LOT E (LSE 12896)
MR8 STORMWATER CALCULATION WILLOWS POND BASIN
INCLUDING ONSITE AND OFFSITE IMPROVEMENTS
PREDEVELOPED**

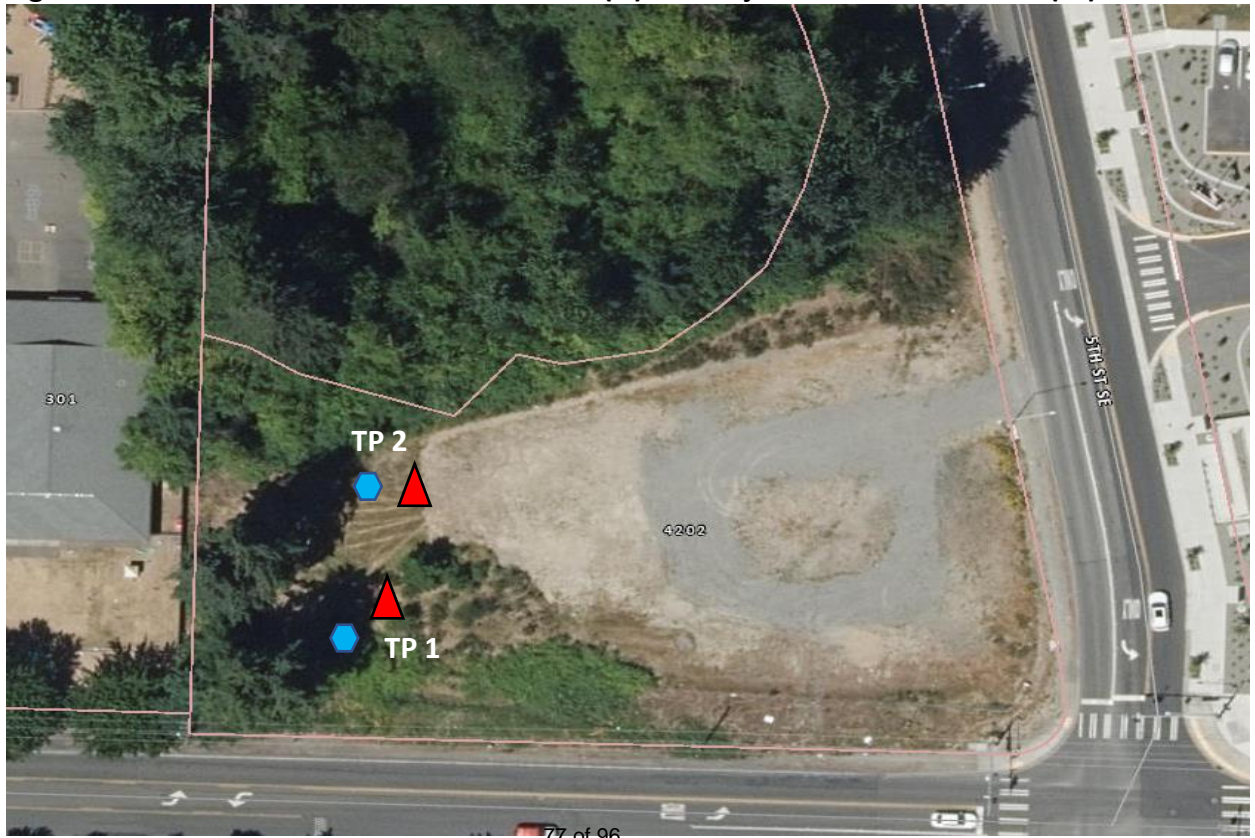
Figure 3: Lot-C *Corrected* Infiltration Test PIT (●) and Adjacent observation PIT (▲) Locations

Test PIT Number	Average Cumulative Volume (gallons @ 15min)	Average Instantaneous Flow Rate (gal/min)
1	26.60	1.76
2	1.3	0.08
3	5.05	0.33
4	35	2.33
5	7.43	0.49
6	No presoak success	No presoak success

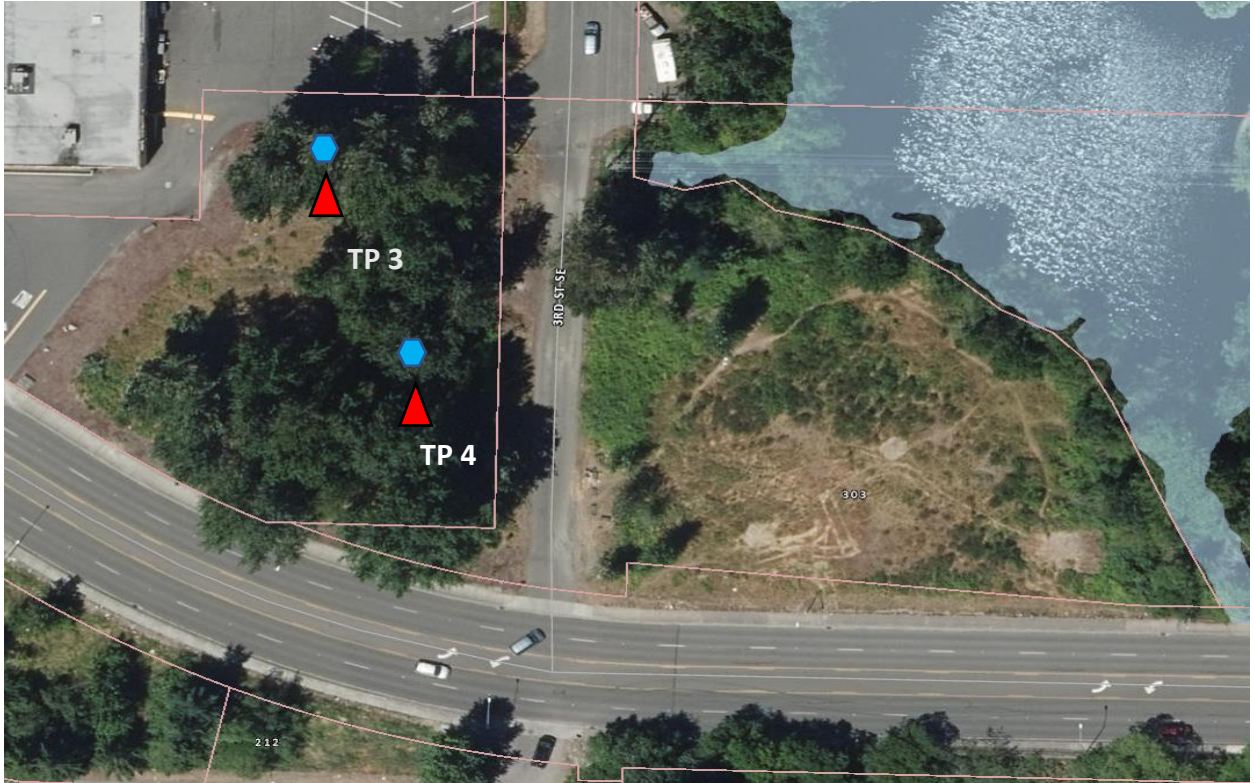
Figure 4: Lot-D Infiltration Test PIT (◈) and Adjacent observation PIT (▲) Locations

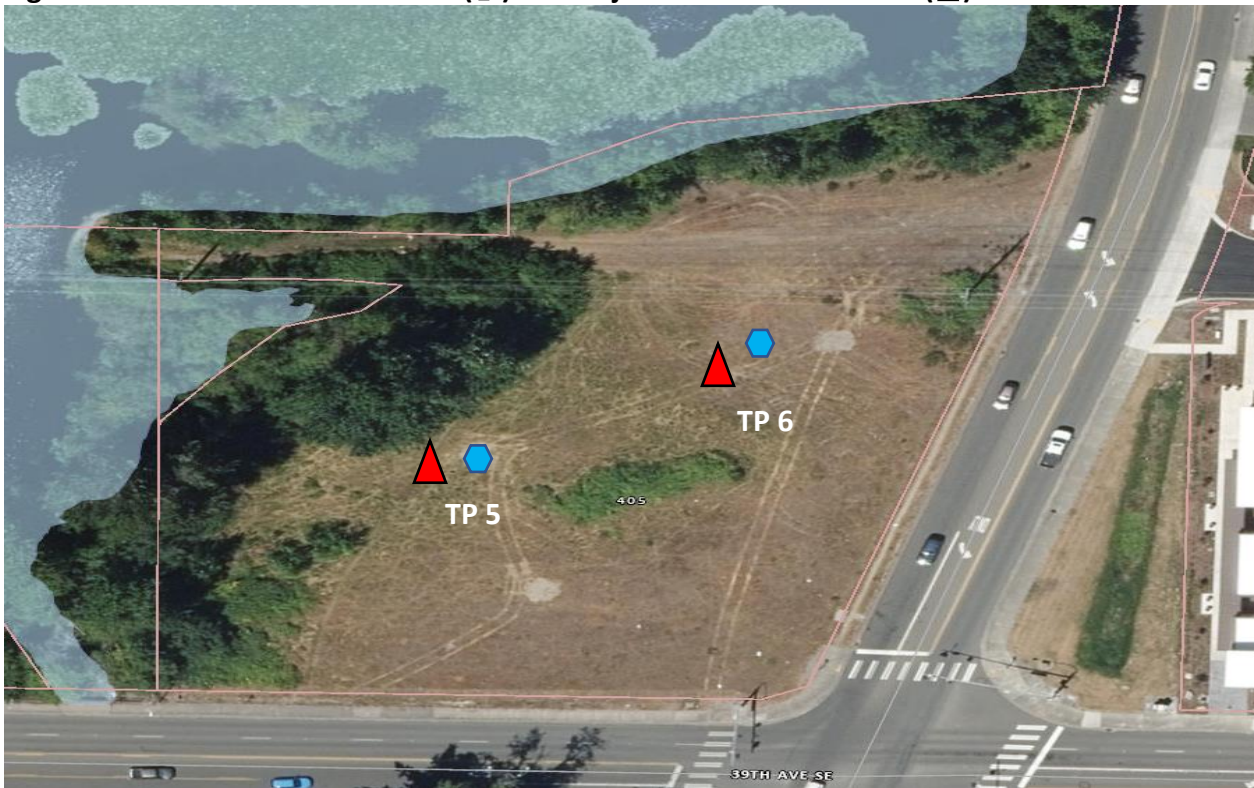
Figure 5: Lot-E Infiltration Test PIT (◈) and Adjacent observation PIT (▲) Locations

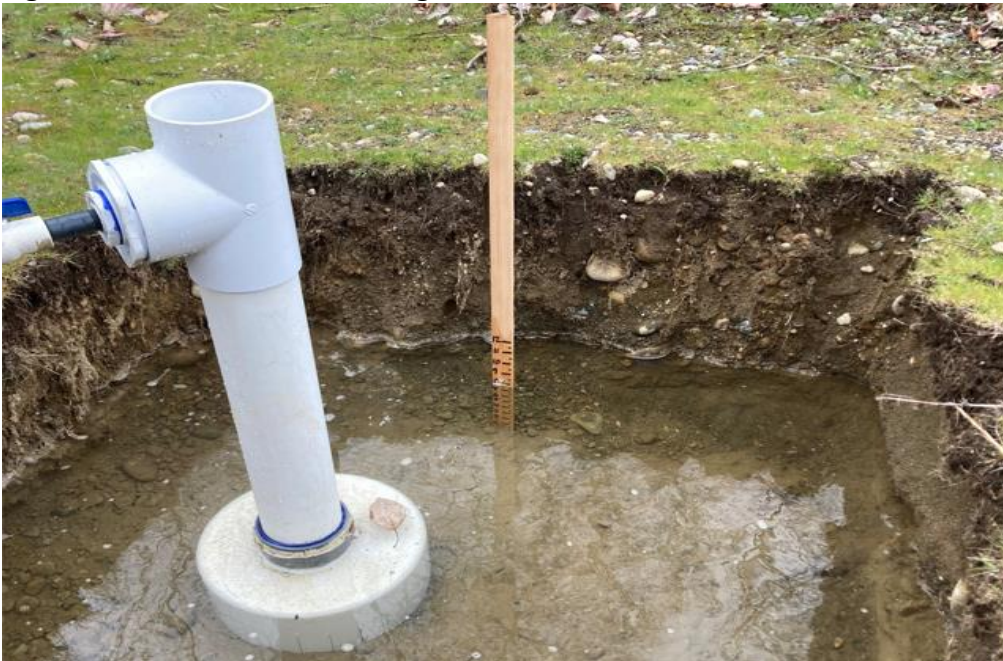
Figure 6: Infiltration Test in Progress PIT 1, Lot C

Figures 6 through 10 provide sampling of the PIT Test photographs.

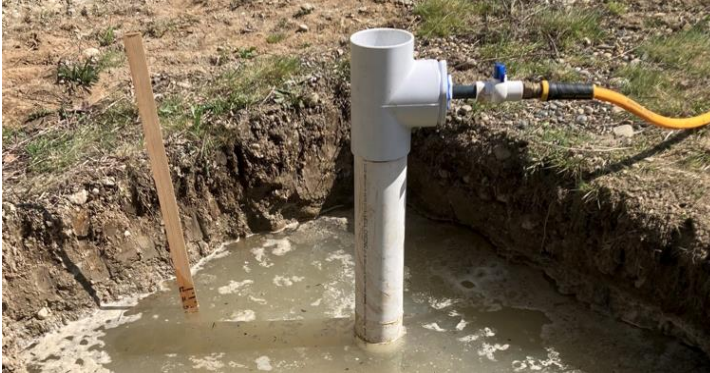
Figure 7: Infiltration Test in Progress PIT TEST 2, Lot C

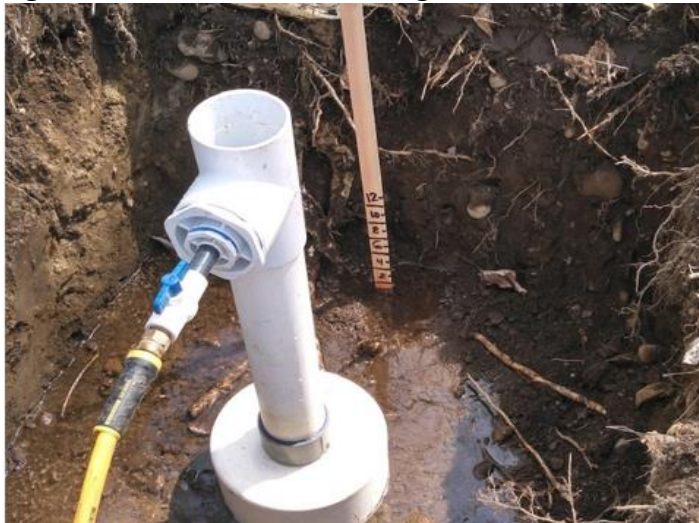
Figure 8: Infiltration Test in Progress PIT 3, Lot D

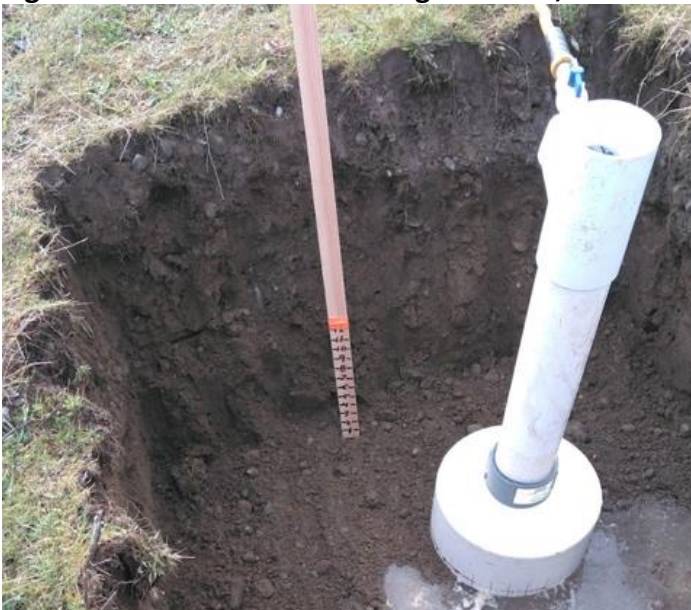
Figure 9: Infiltration Test in Progress PIT 5, Lot E

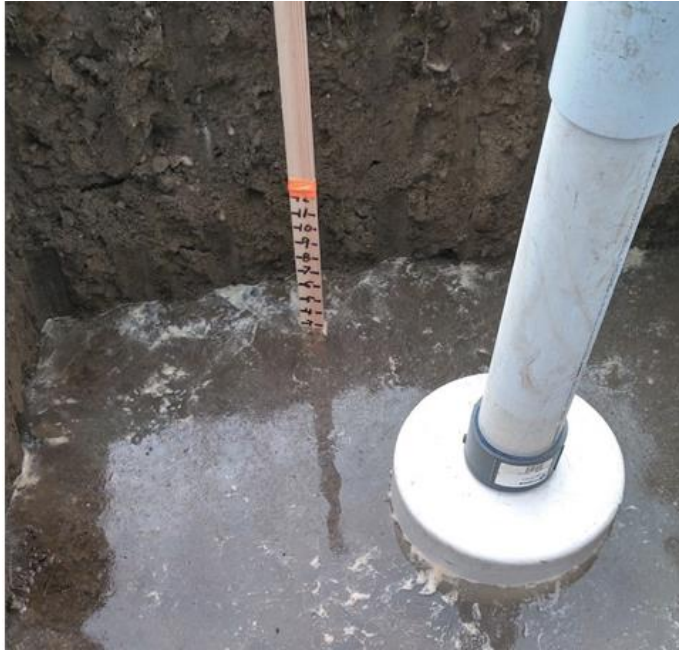
Figure 10: Infiltration Test in Progress PIT 6, Lot E

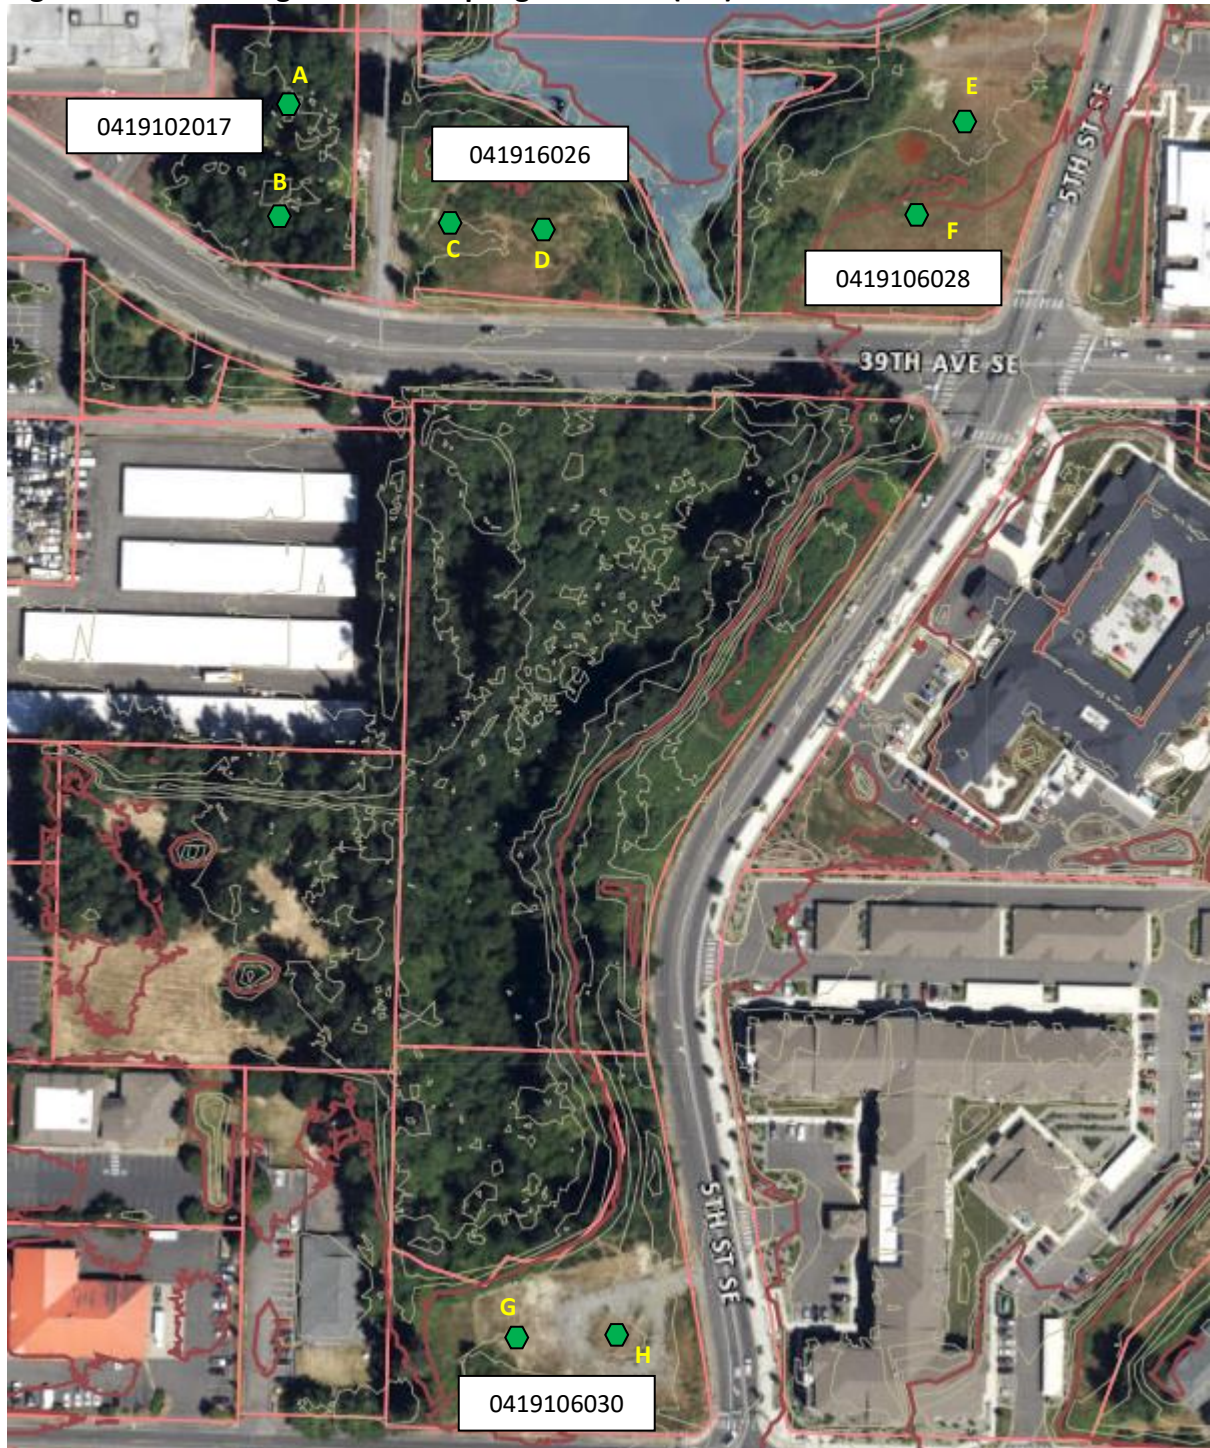
The determination of organic percentage per the ASTM D2974 test method can be used to determine the moisture content, ash content, and percent organic matter in soil. Figure 1 illustrates the test locations over the four parcels.

Figure 1: CEC and Organic Soil Sampling Locations (●) and Associated Parcel Numbers
