**Subject: Geotechnical Services Report**

**43<sup>rd</sup> Avenue Apartments Geotechnical Investigation**

7<sup>th</sup> St SW & 43<sup>rd</sup> Ave SW, Puyallup, WA 98465 (GPS:47.151659, -122.30189)

Project Number: QG24-160

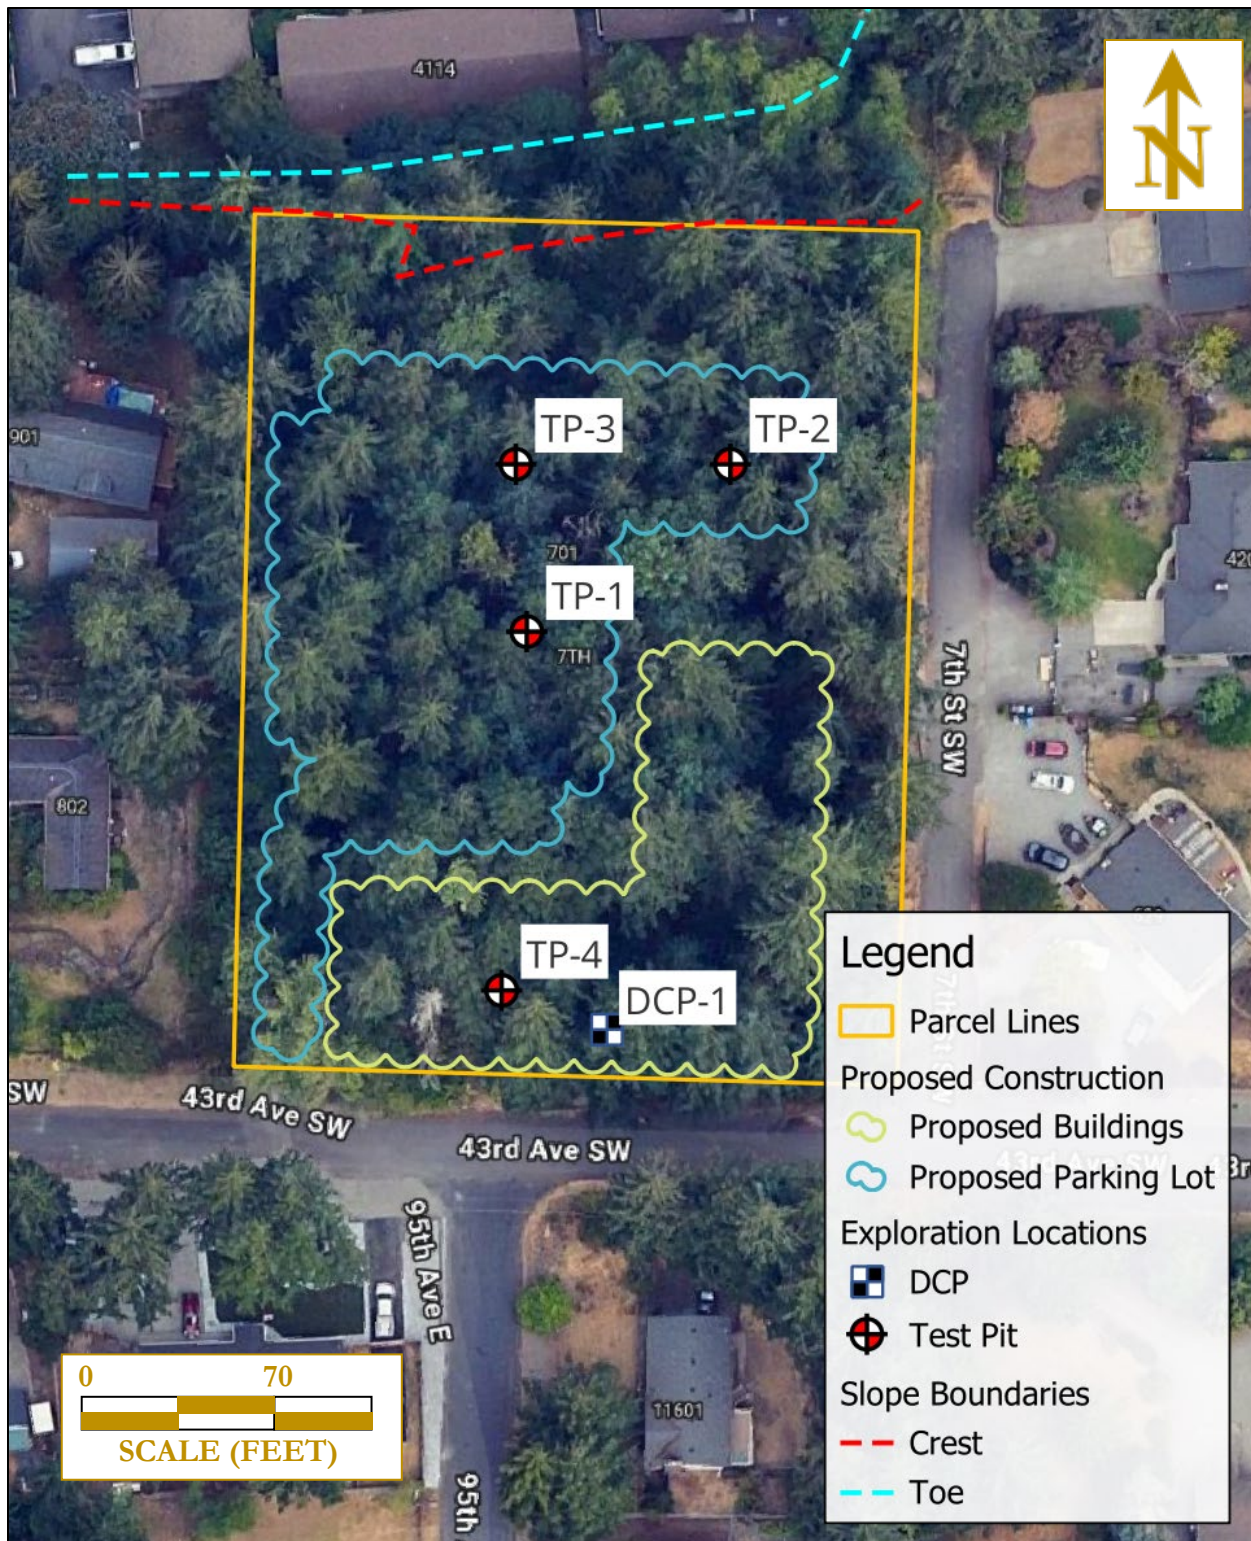
## Appendix B. Exploration Map

Site exploration activities were performed on 12/16/2024. Exploration locations were marked in the field by a QG Staff Geologist with respect to the map provided and cleared for public conductible utilities. Our exploration locations were selected by a QG Staff Geologist prior to fieldwork to provide safest access to relevant soil conditions. The geologist directed the advancement of 4 excavated test pits (TP). The test pits were advanced within the vicinity of the anticipated development footprint areas, to maximum depths of 10 feet below present grade (BPG) in general accordance with the specified contract depth.

Site Map  
43<sup>rd</sup> Ave Apartments Geo

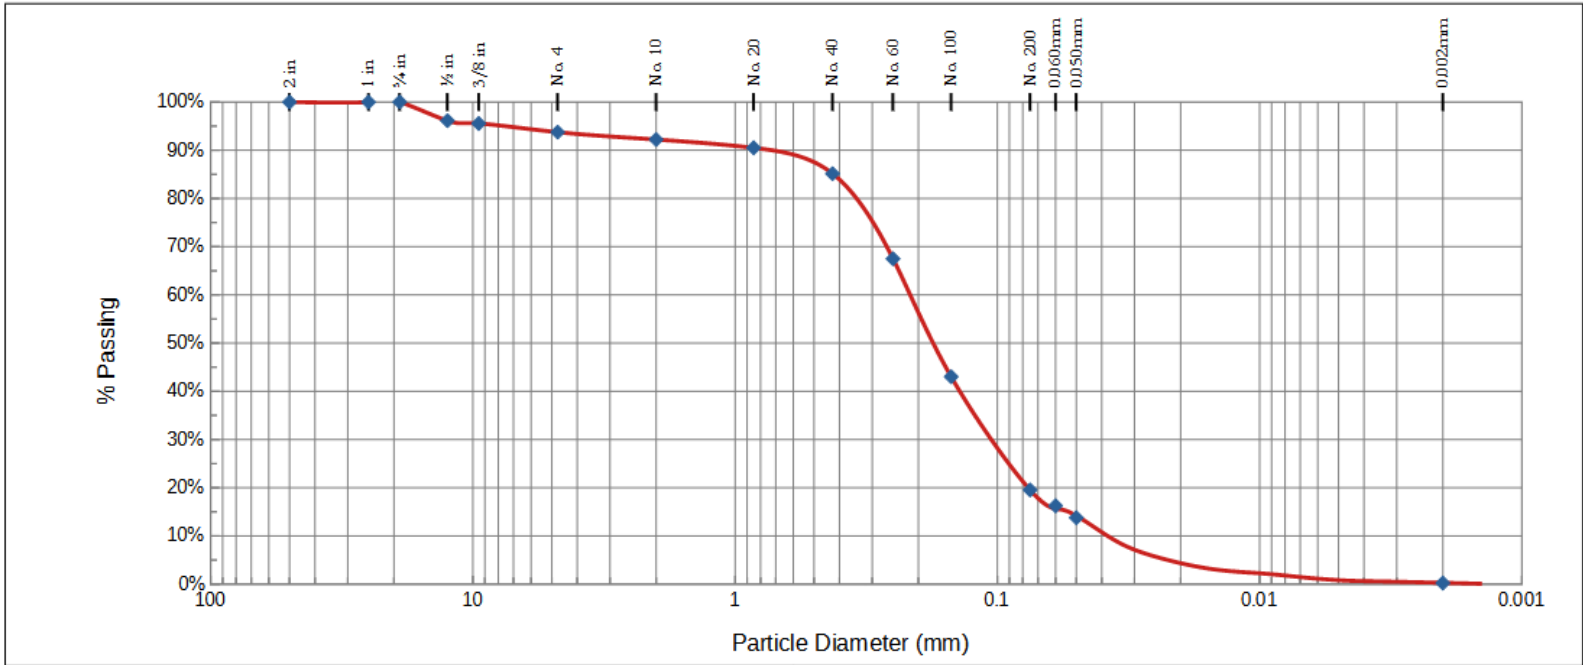
Project Name: 43rd Ave Apartment  
Project Number: QG24-160  
Date Collected: 12/16/24  
Date Reported: 01/10/25  
Boring ID: TP-1  
Boring Depth: 8ft

| USCS Scale | Coarse Gravel | | Fine Gravel | | | Coarse Sand | | Medium Sand | | Fine Sand | | | (% of Fines Passing #200 Sieve) | | | Sand Total | Gravel Total |
| Sieve # | 2" | 1" | 3/4" | 1/2" | 3/8" | 4 | 10 | 20 | 40 | 60 | 100 | 200 | Hydrometer Method | | | | |

During test pit excavations for general site investigation, QG collected representative samples of native soil deposits among potential infiltration strata and depths. Representative soil samples were selected from native soils within TP-1 and TP-2 to characterize the local infiltration conditions.

Laboratory results were interpreted to recommended design inputs in accordance with methods of the 2024 DoE SMMWW. Gradation results were applied to the Massmann (2003) equation (1) to calculate Ksat representing the initial saturated hydraulic conductivity.

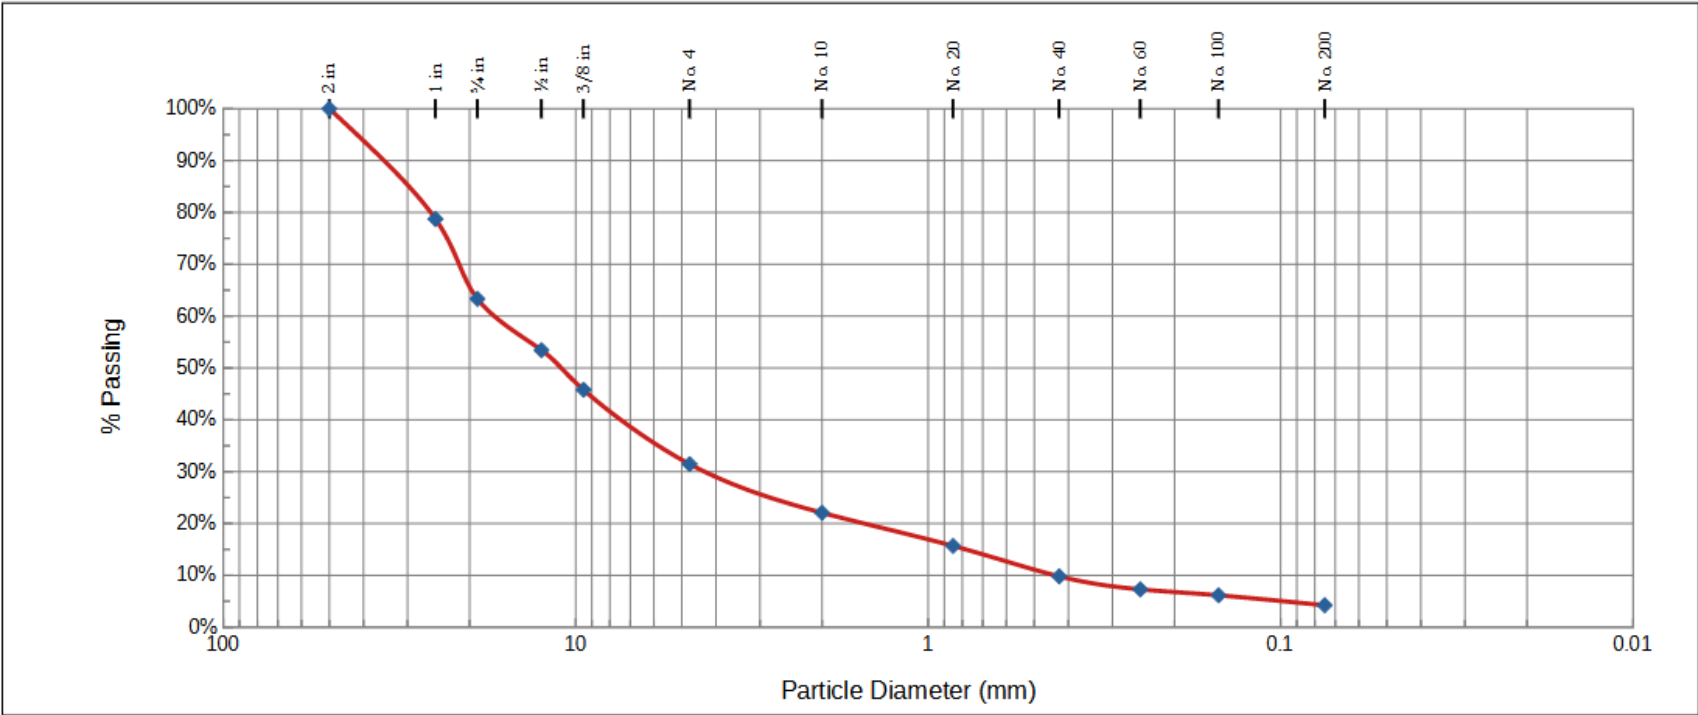
Project Name: 43rd Ave Apartment  
Project Number: QG24-160  
Date Collected: 12/16/24  
Date Reported: 01/08/25  
Boring ID: TP-2  
Boring Depth: 2.5ft

| USCS Scale | Coarse Gravel | | Fine Gravel | | | Coarse Sand | | Medium Sand | | Fine Sand | | | (% of Fines Passing #200 Sieve) | | | Sand Total | Gravel Total |
| Sieve # | 2" | 1" | 3/4" | 1/2" | 3/8" | 4 | 10 | 20 | 40 | 60 | 100 | 200 | Hydrometer Method | | | | |
