PRELIMINARY  
STORMWATER DRAINAGE REPORT  
FOR  
43<sup>rd</sup> AVE MULTI-FAMILY  
701 43<sup>rd</sup> AVE SW  
TPN 4320000160

**PRELIMINARY  
STORMWATER DRAINAGE REPORT**

**43<sup>rd</sup> AVE MULTI-FAMILY**

A portion of the NW Quarter of the NE Quarter of Section 9, Township 19 North,  
Range 4 East, W.M. City of Puyallup, Pierce County, Washington

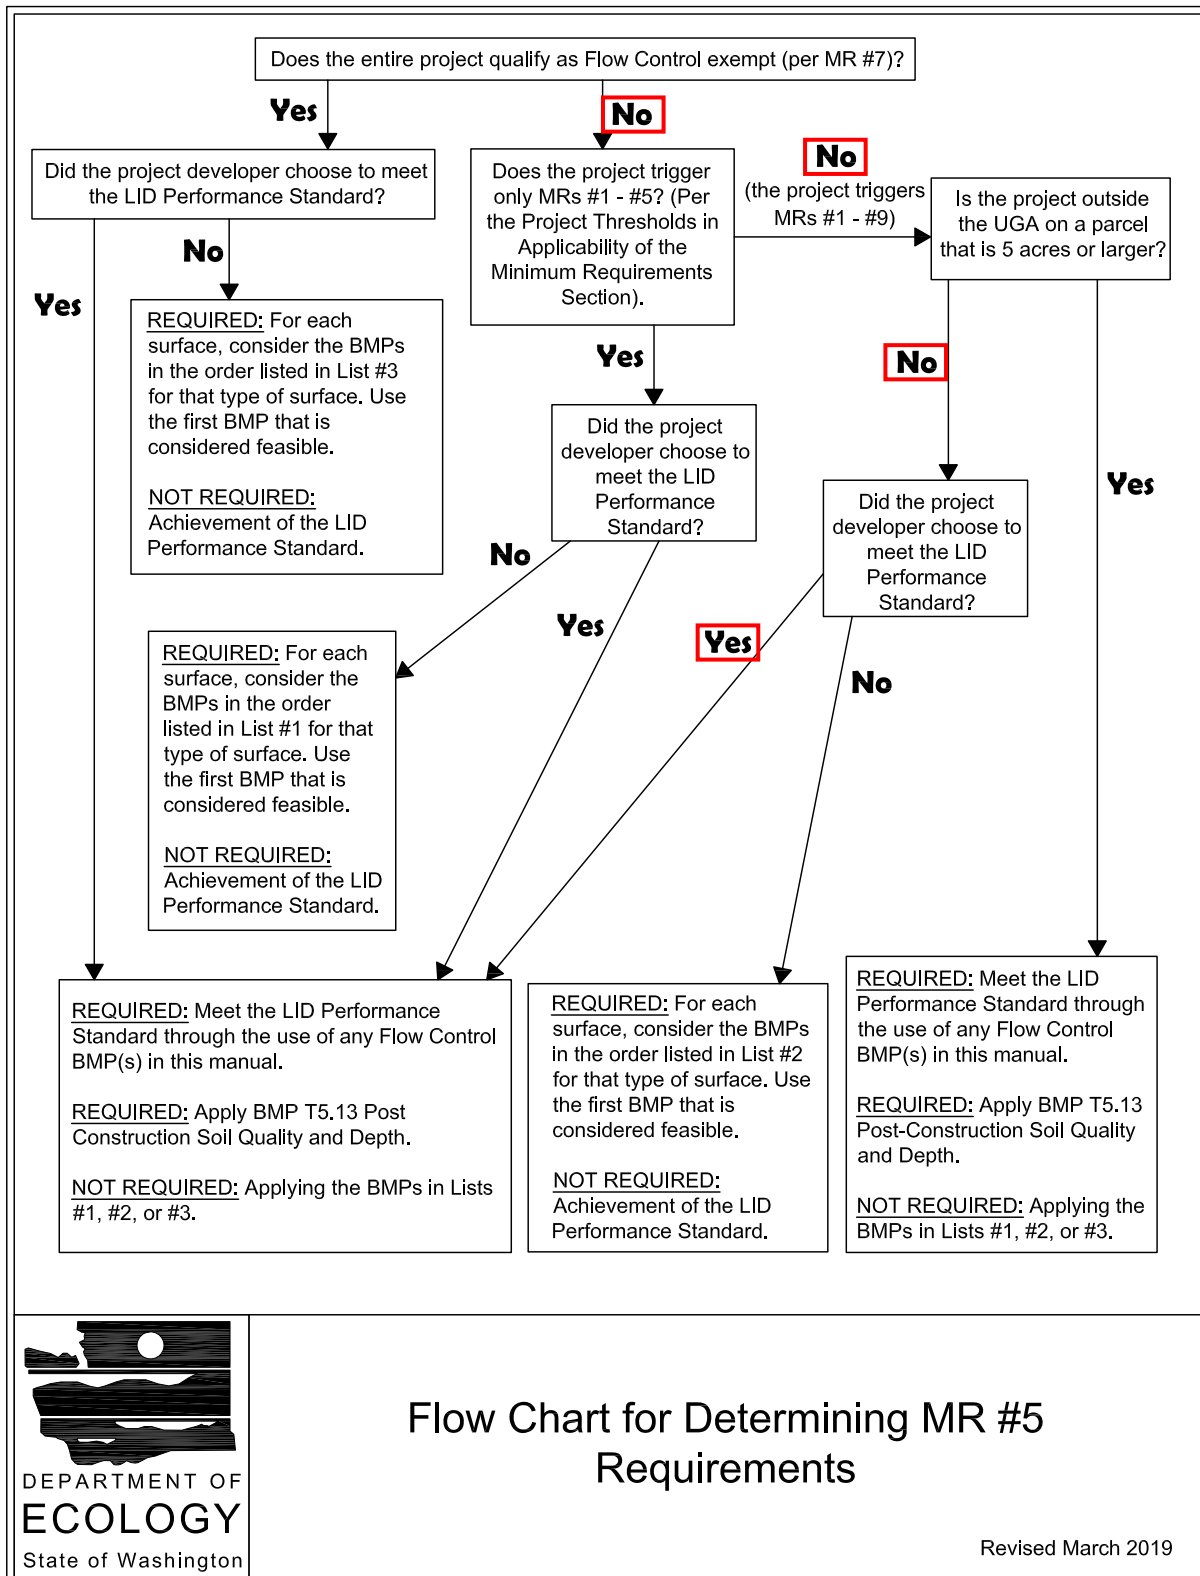
**Figure I-3.3: Flow Chart for Determining MR #5 Requirements**

## Flow Chart for Determining MR #5 Requirements

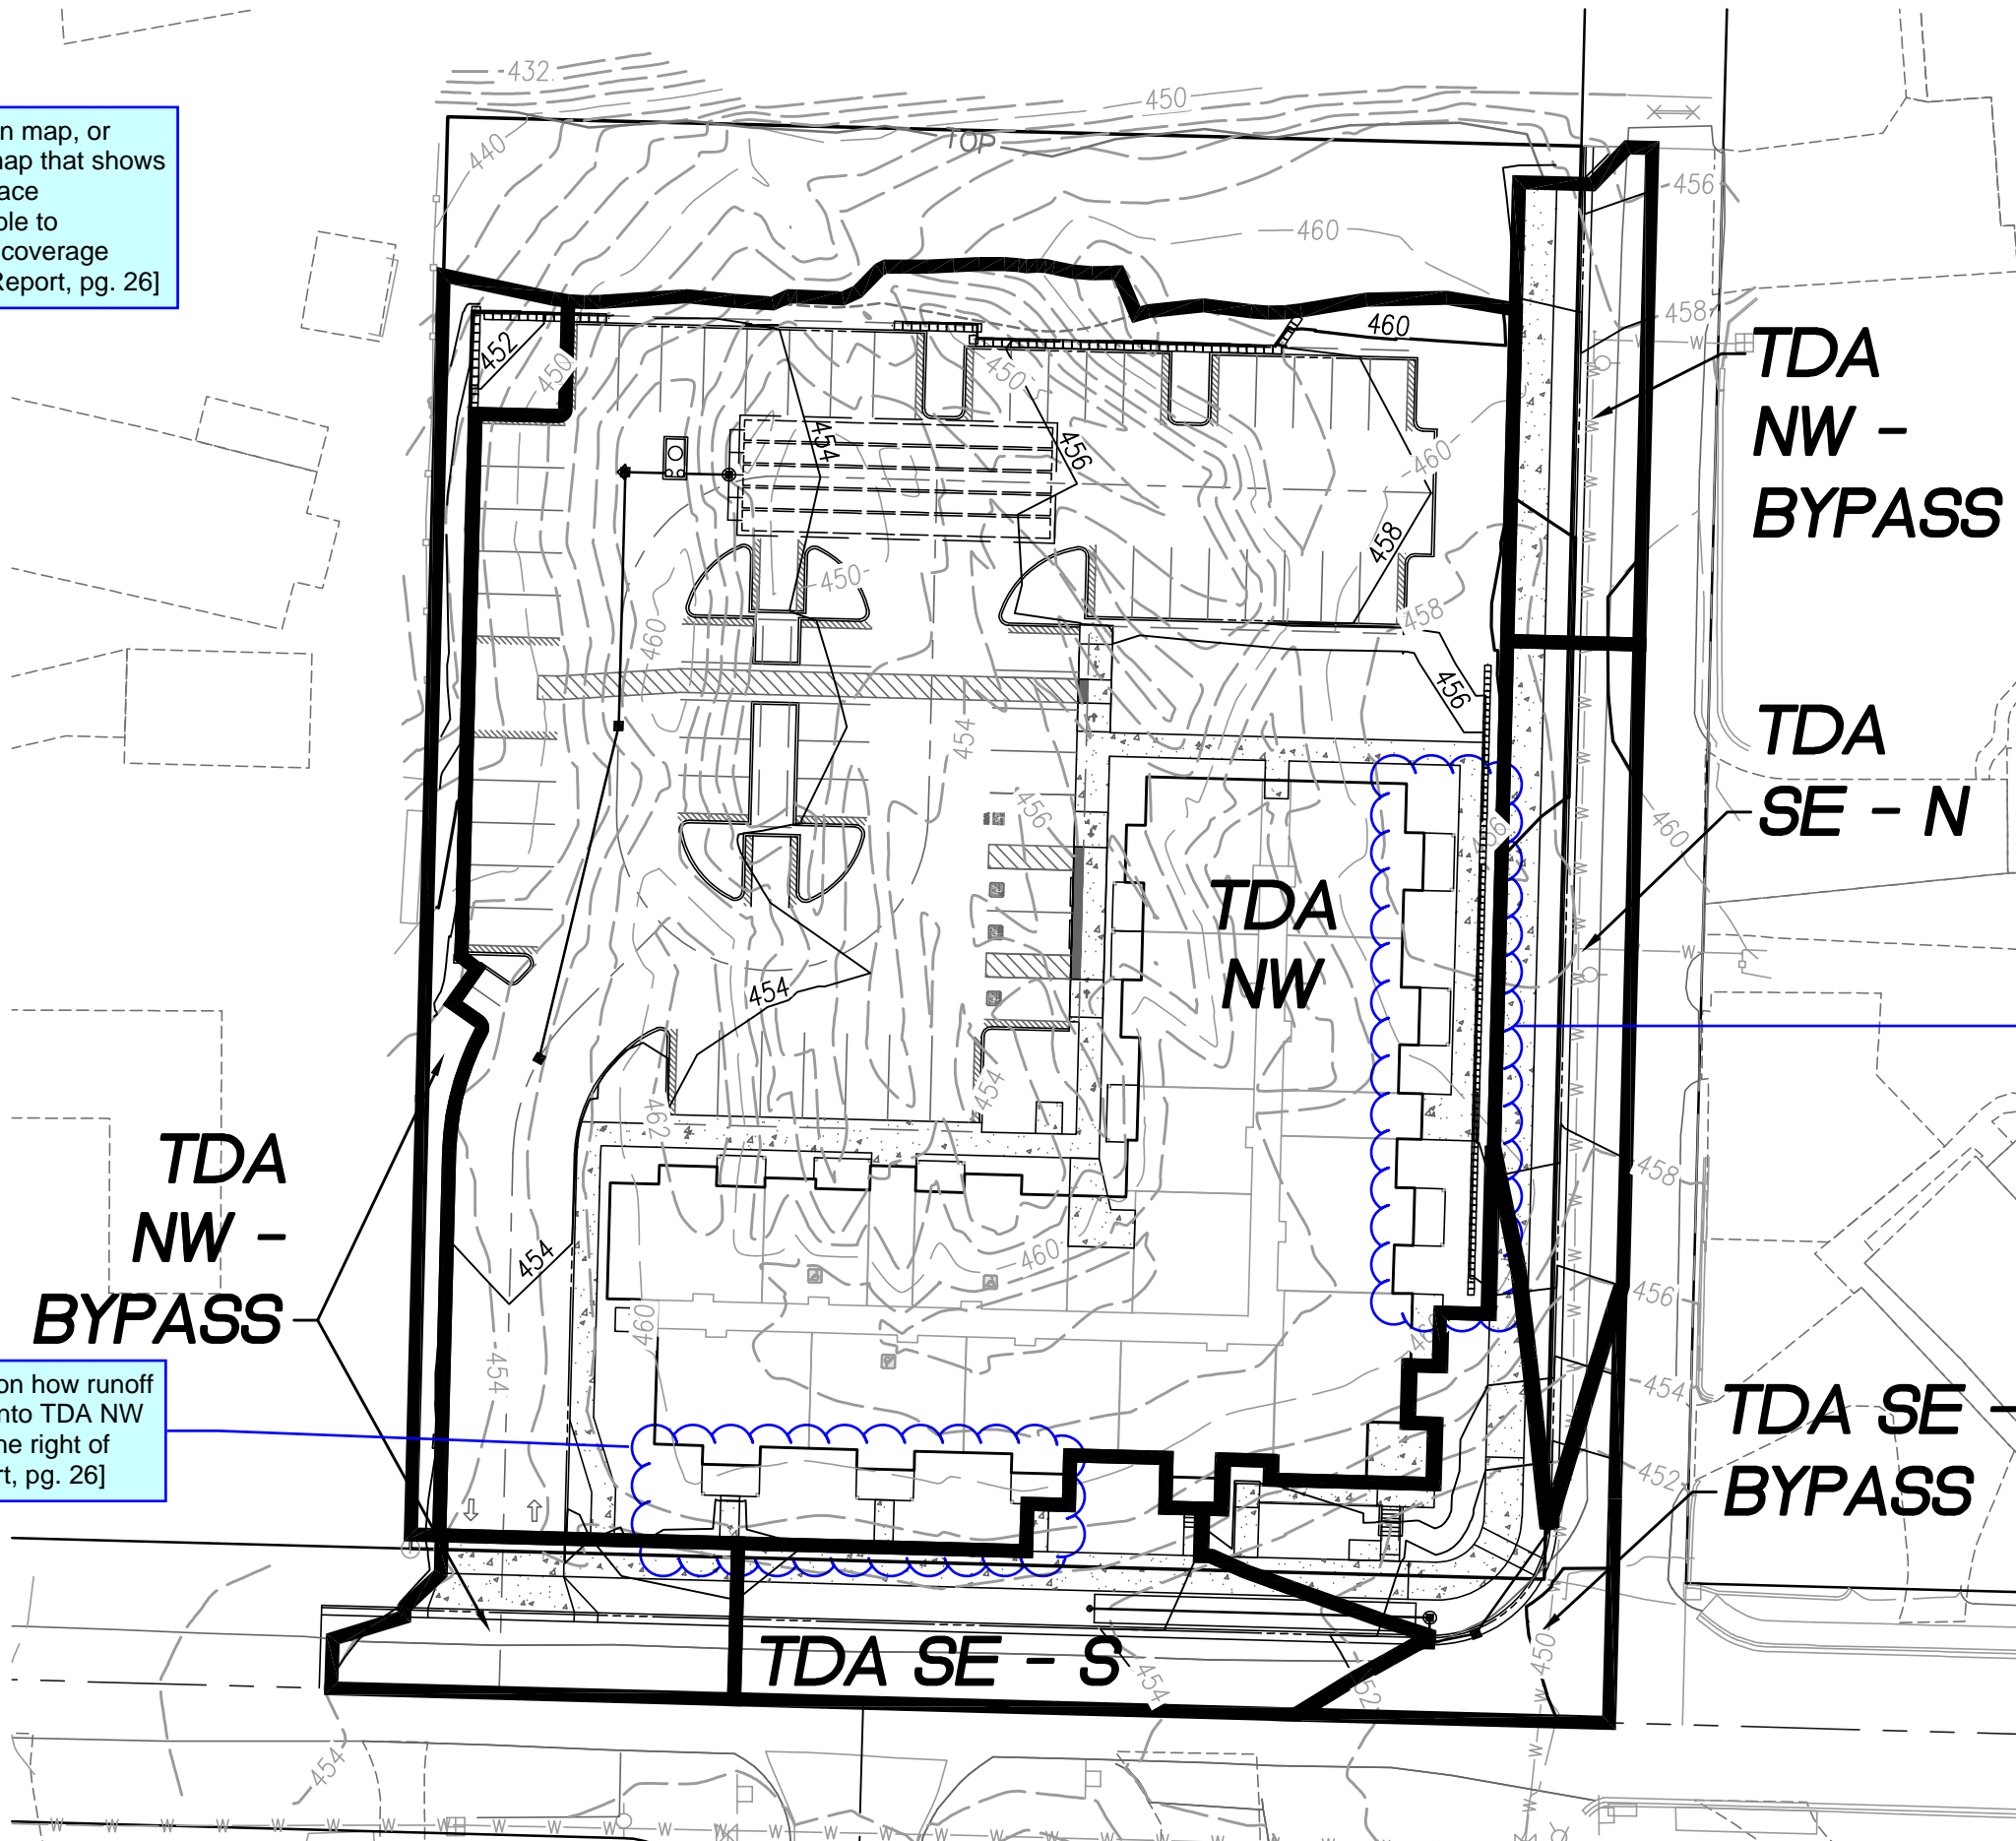
# DEVELOPED BASIN MAP

Either show on this basin map, or provide another basin map that shows a breakdown of the surface coverages. Include a table to accompany the surface coverage breakdown. [Drainage Report, pg. 26]

Provide further clarification on how runoff from this area is conveyed into TDA NW rather than flowing toward the right of way TDAs. [Drainage Report, pg. 26]

Sub-Basin ID	Land Use and Cover Condition	Acreage
TDA NW	Roads/Flat	0.641+/-
TDA NW	Roof Tops/Flat	0.362 +/-
TDA NW	C, Pasture, Flat	0.282 +/-
TDA NW - BYPASS	Roads/Flat	0.102 +/-
TDA NW - BYPASS	C, Pasture, Flat	0.073 +/-
TDA SE - N	Roads/Mod	0.077+/-
TDA SE - N	C, Pasture, Mod	0.021 +/-
TDA SE - S	Roads/Mod	0.076 +/-
TDA SE - S	C, Pasture, Mod	0.035 +/-
TDA SE - BYPASS	Roads/Mod	0.070 +/-
TDA SE - BYPASS	C, Pasture, Mod	0.035 +/-

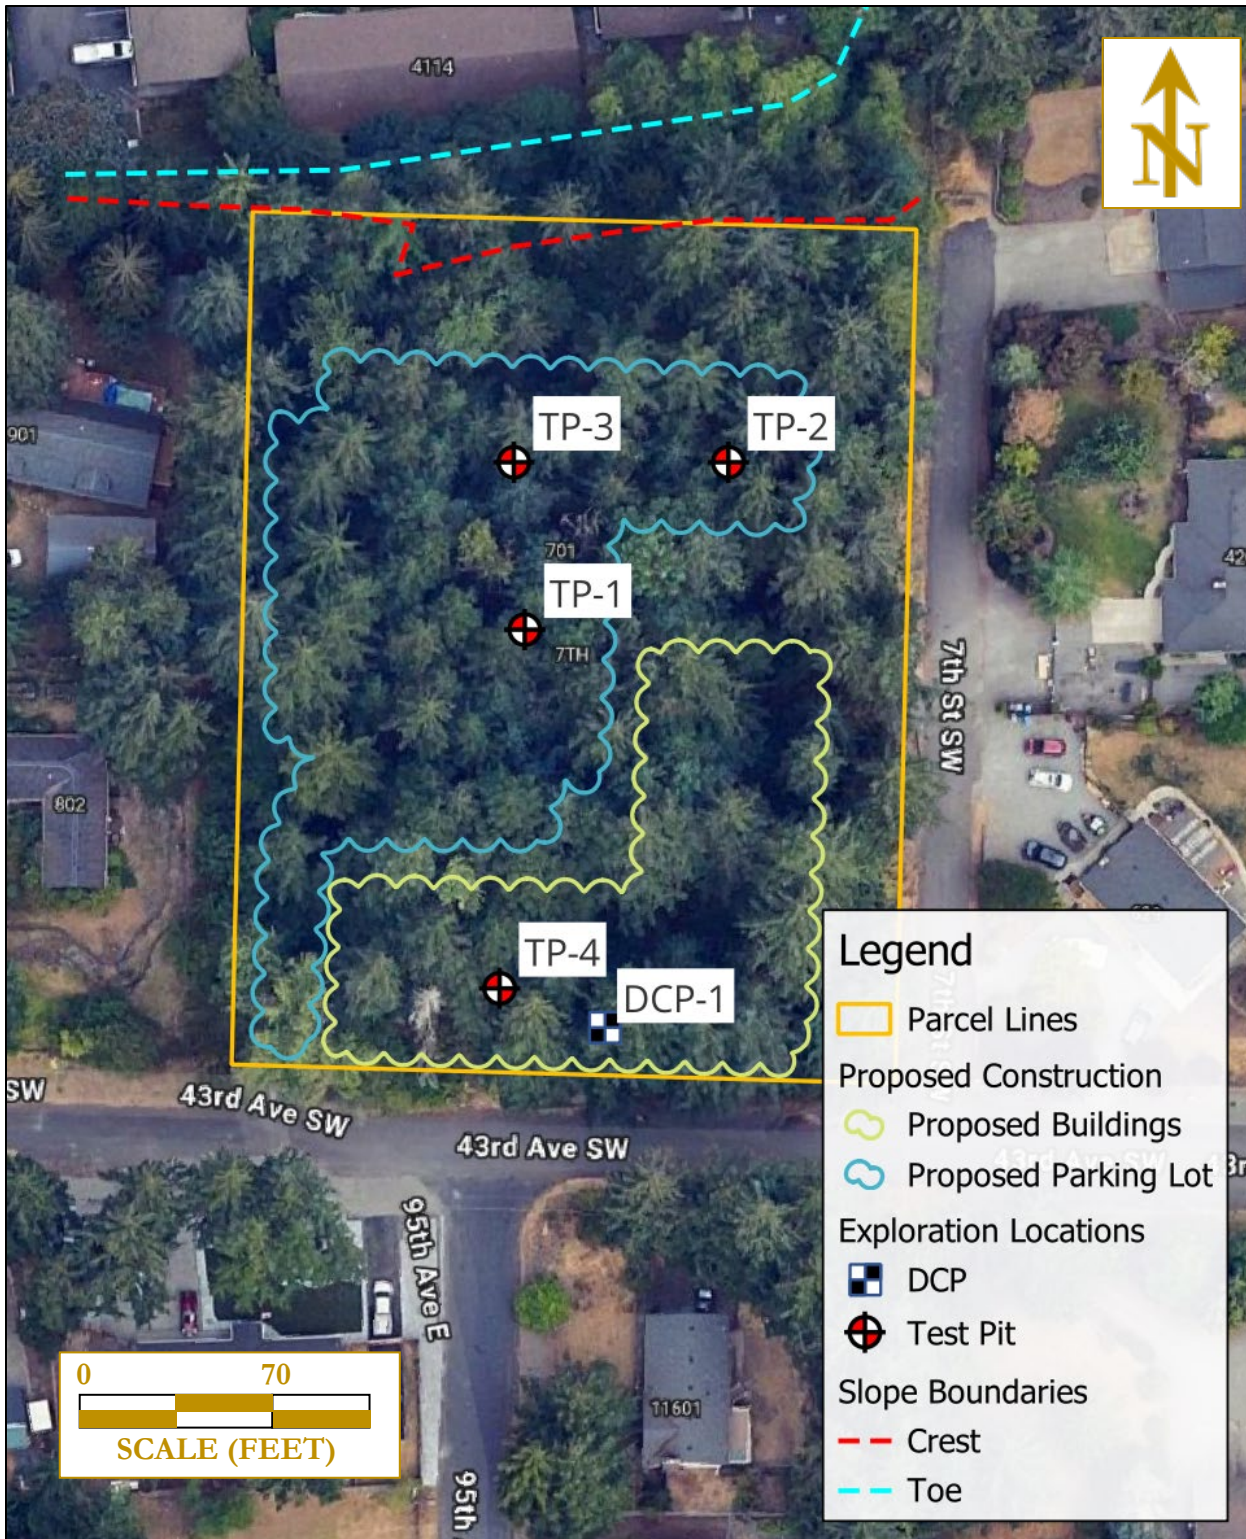
**Figure 1**

## Appendix B. Exploration Map

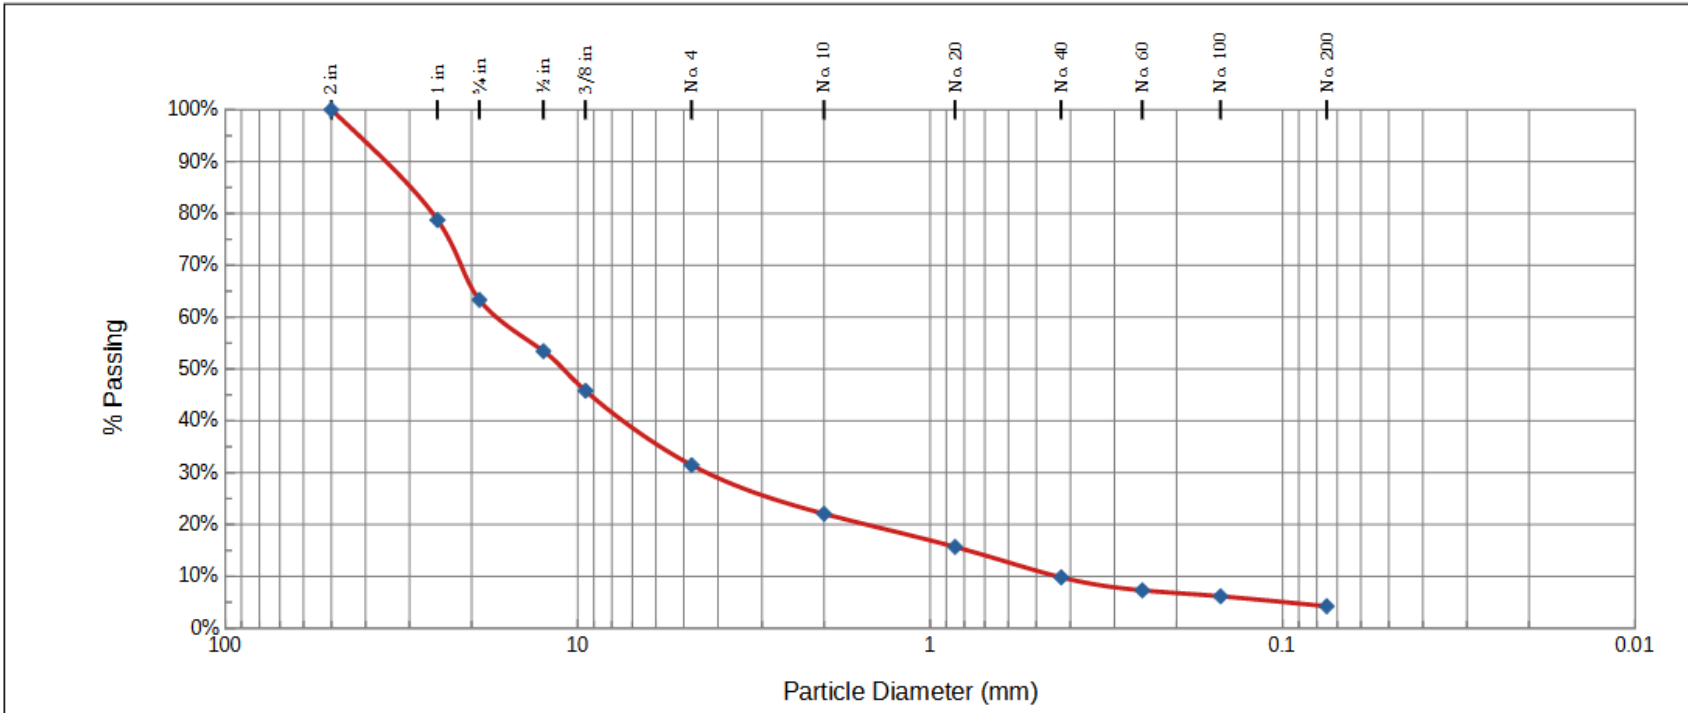
Project Name: 43rd Ave Apartment  
Project Number: QG24-160  
Date Collected: 12/16/24  
Date Reported: 01/08/25  
Boring ID: TP-2  
Boring Depth: 2.5ft

USCS Scale	Coarse Gravel		Fine Gravel			Coarse Sand		Medium Sand		Fine Sand			(% of Fines Passing #200 Sieve)			Sand Total	Gravel Total
	Sieve #	Diameter, mm	3/4"	1/2"	3/8"	4	10	20	40	60	100	200	0.060	0.050	0.002		
Retained	0.0%	21.3%	36.7%	46.6%	54.2%	68.5%	77.9%	84.3%	90.2%	92.7%	93.9%	95.8%	NA	NA	NA	27.2%	68.5%
Passing	100.0%	78.7%	63.3%	53.4%	45.8%	31.5%	22.1%	15.7%	9.8%	7.3%	6.1%	4.2%

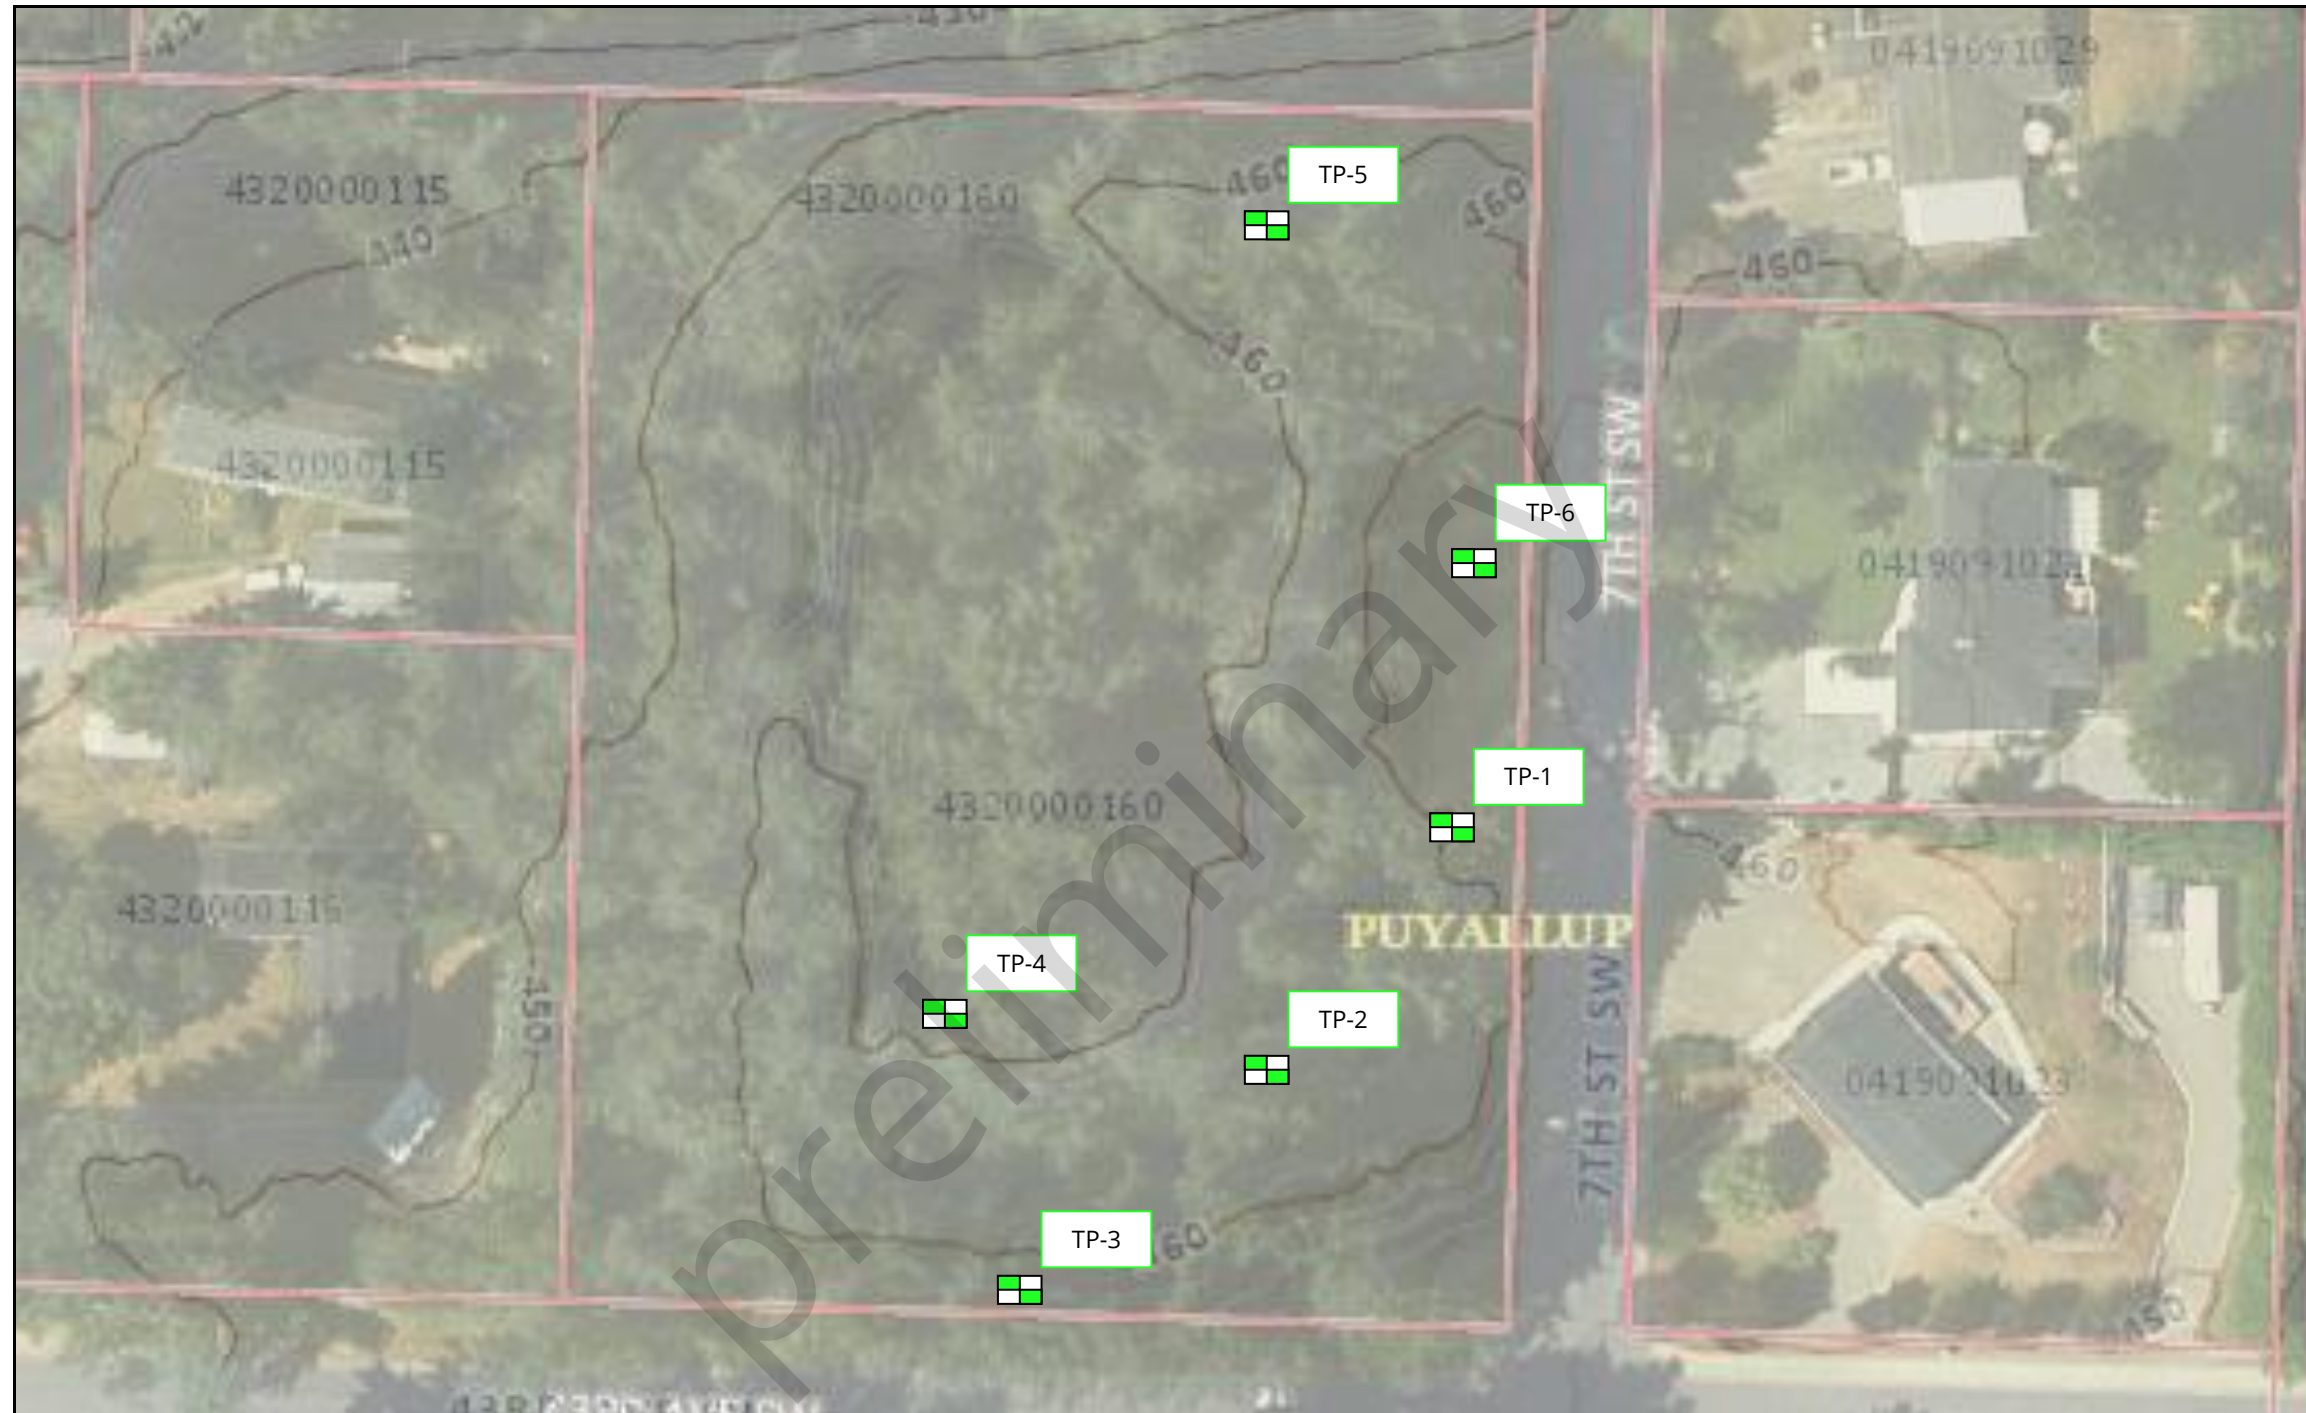
Figure 2

Number and approximate location of test pit

**Site and Exploration Map**  
 Proposed Multi-family Development  
 xxx - 7<sup>th</sup> Street SW  
 Puyallup, Washington  
 PN: 4320000160
