CRITICAL AREAS ASSESSMENT

**SUNSET POINTE RESIDENTIAL COMMUNITY
PARCELS 0420353026 and 0420353027
2100 - 19th Avenue SE, City of Puyallup, Washington**

January 19, 2018

**REVISED
SEPTEMBER 21, 2018**

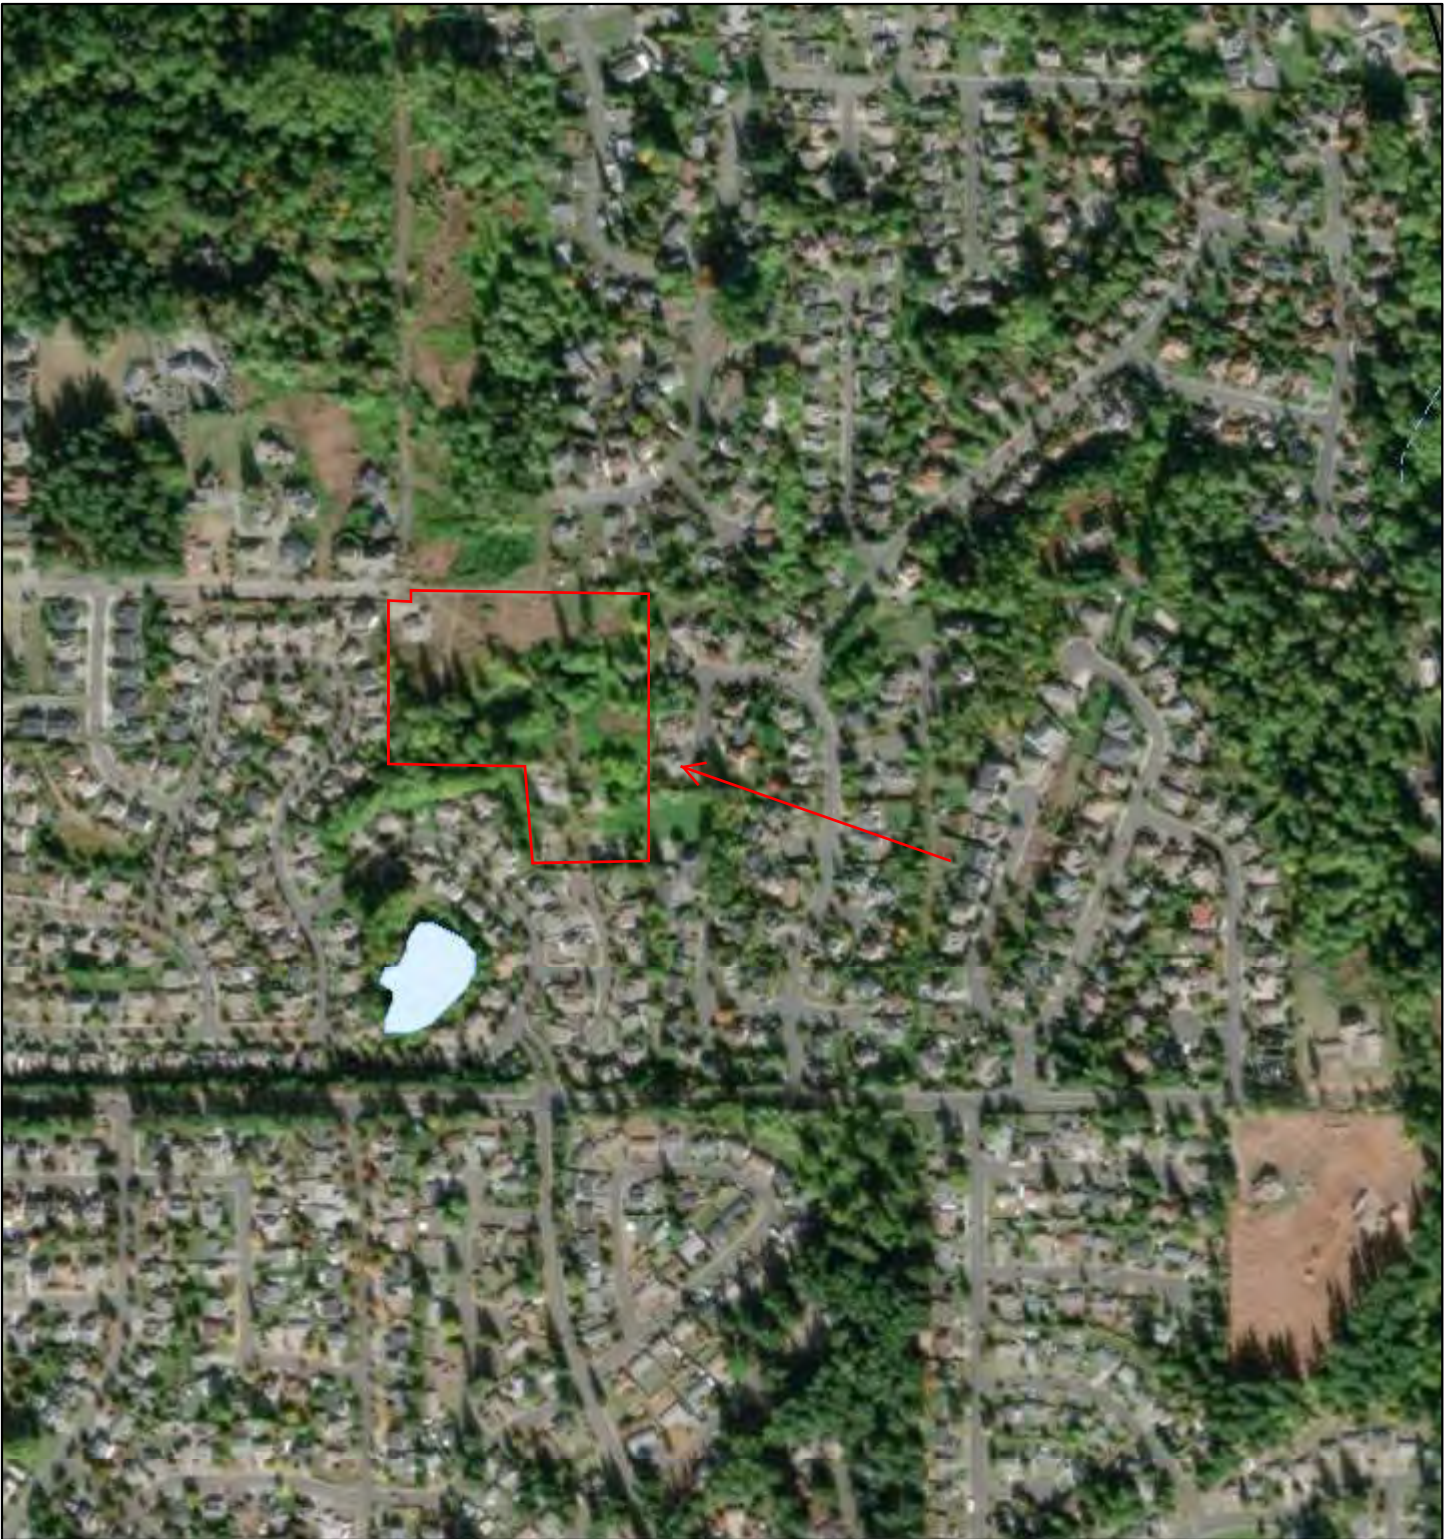
Figure 4 WDFW Mapping

The State of Washington Department of Fish and Wildlife (WDFW) *SalmonScape Mapping* was reviewed as a part of this assessment (Figure 4). This mapping resource did not identify any drainage corridors within or immediately adjacent to the project site.
