HYDROGEOLOGIC REPORT

ARCO AMPM, PUYALLUP, WASHINGTON

Project No. M2303.02

CRITICAL AQUIFER RECHARGE AREA
HYDROGEOLOGIC REPORT

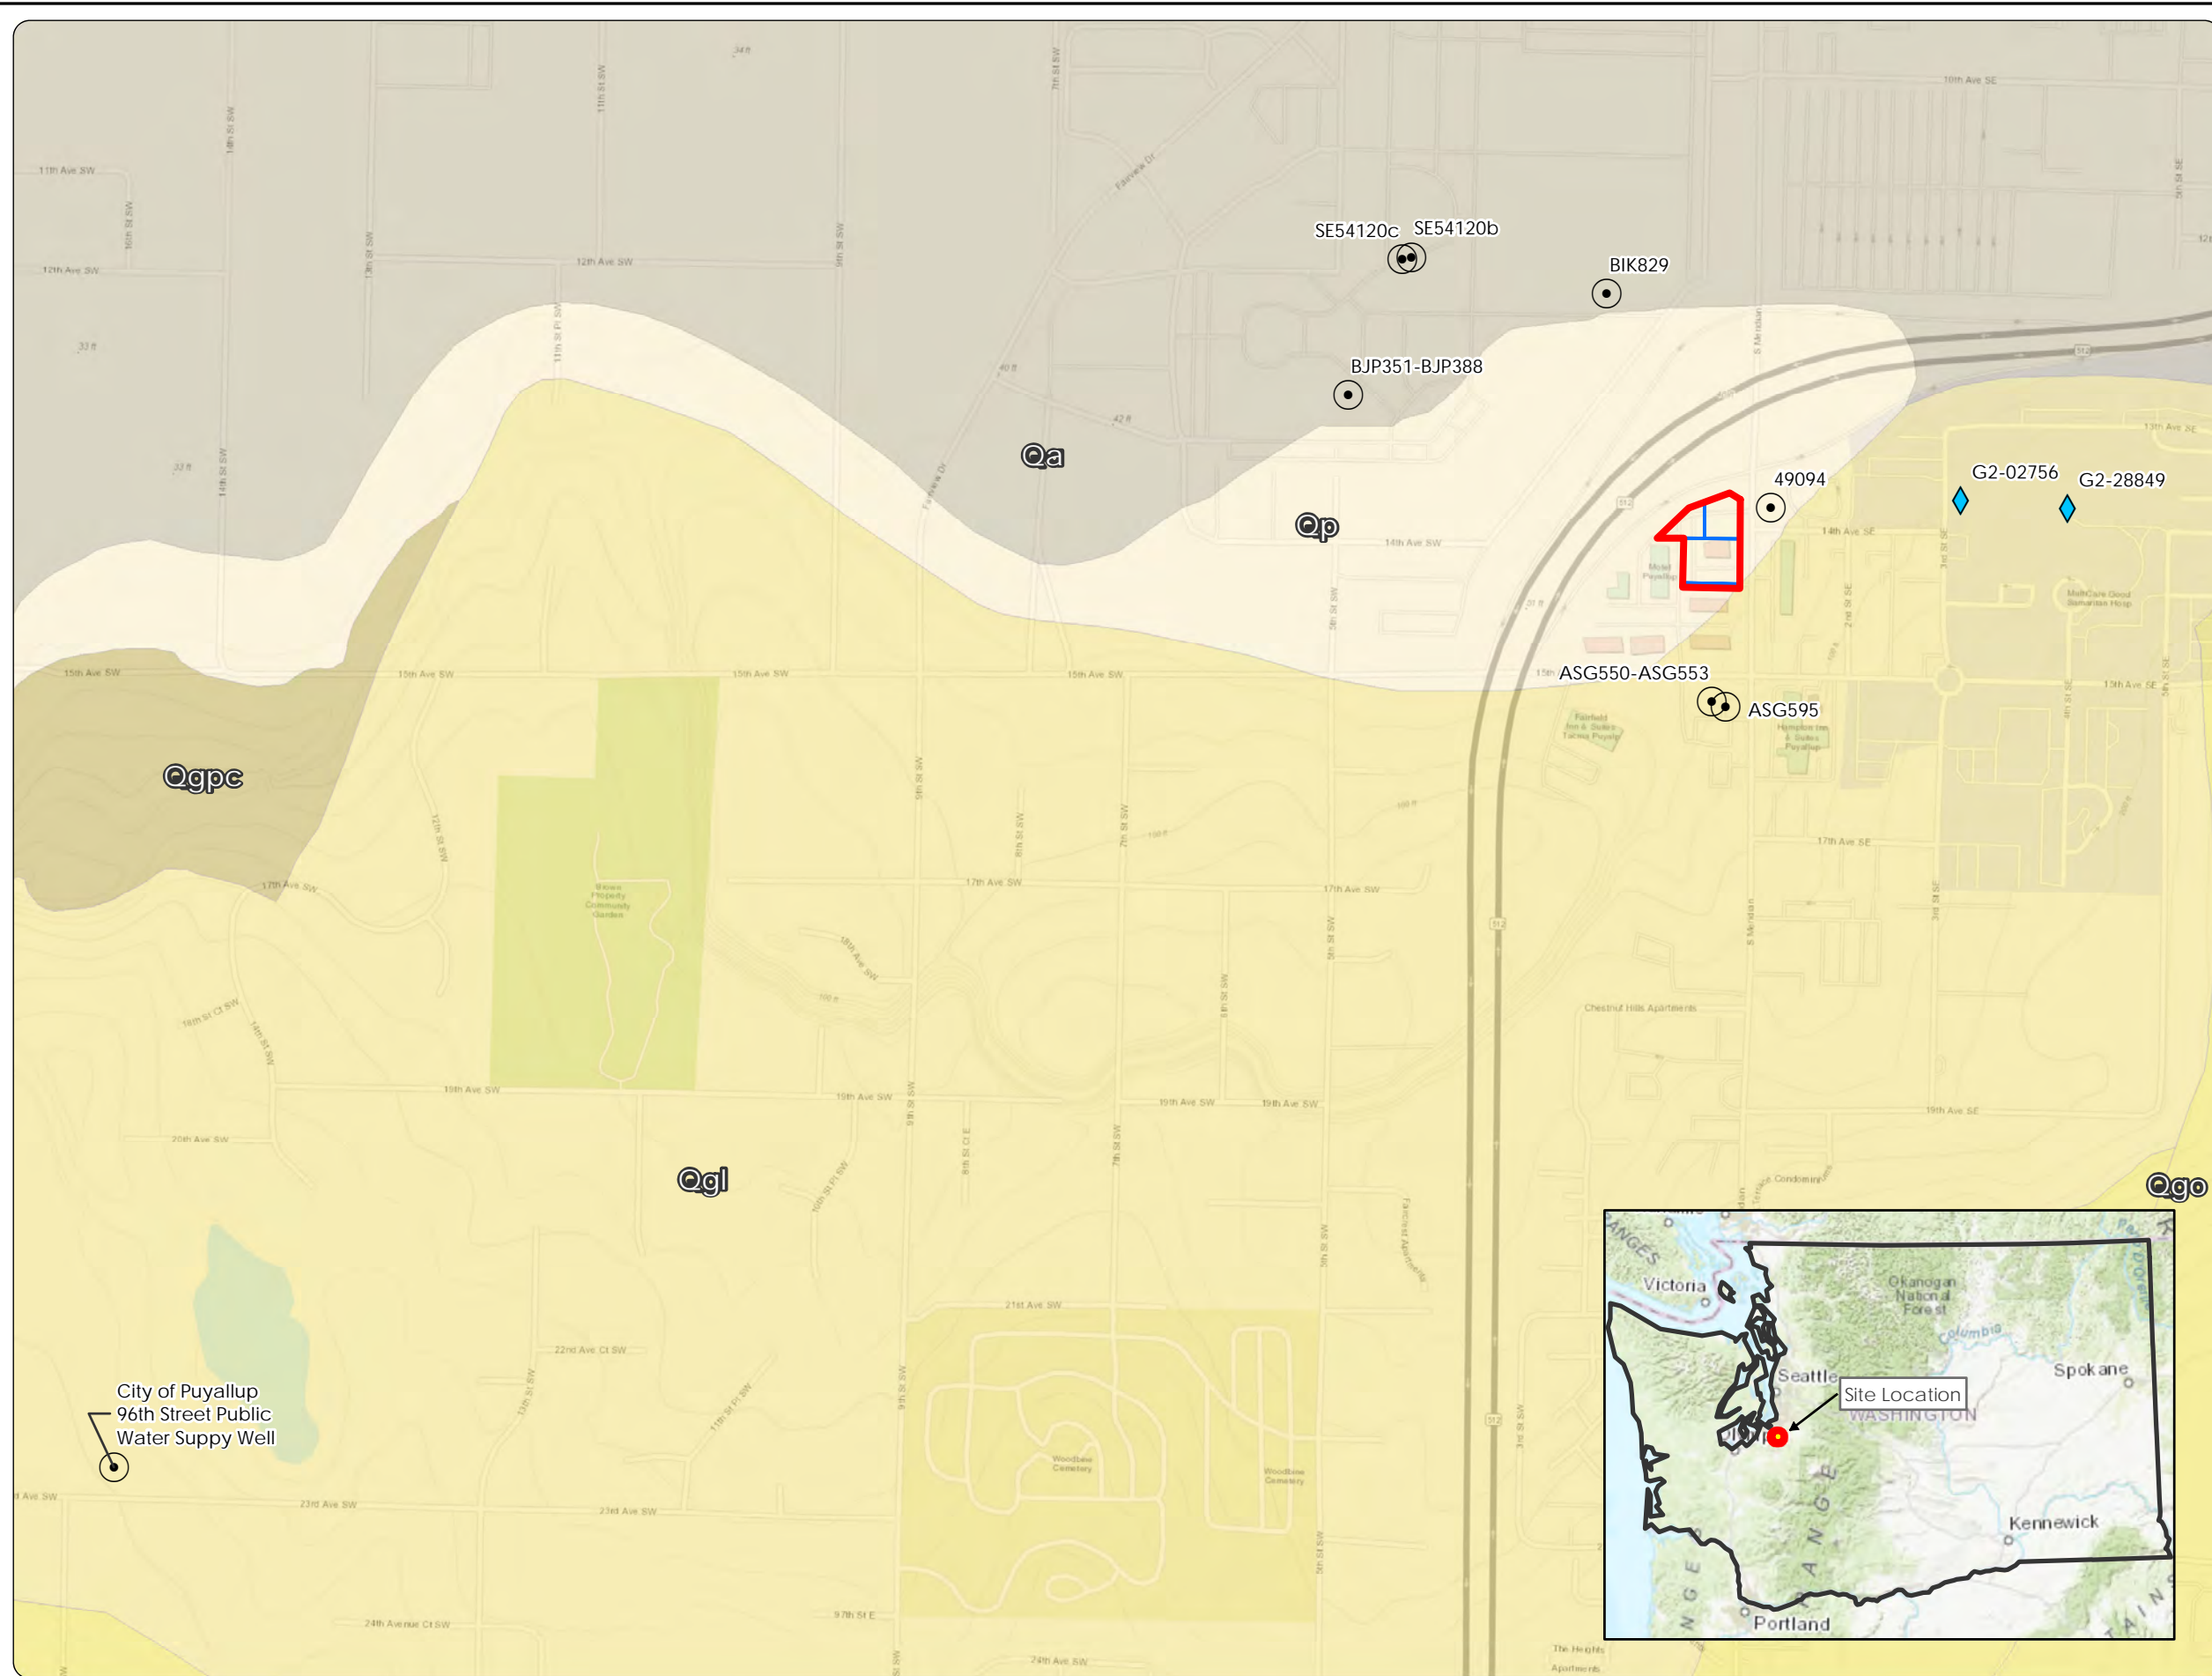
**Figure 1-1
Site Location and
Surface Geology**
Barghausen Consulting
Engineers, Inc.
ARCO ampm
Puyallup, Washington

- Legend**
- Wells
 - Water Rights
- Geologic Units**
- Quaternary Peat Deposits (Qp)
 - Pleistocene continental glacial drift (Qgo(sg))
 - Pleistocene glacial and nonglacial deposits (Qgpc)
 - Quaternary Alluvium (Qa)
 - Quaternary bog, marsh, swamp, or lake deposits (Qgl)
 - Site Boundary
 - Parcel Boundaries

According to the Lewis County Assessor's Office, the Site includes four parcels currently owned by H&H Puyallup LLC (Figure 1-1). The northern portion of the Site is comprised of two parcels: parcel 7730000021, is a total of 0.096 acres, and parcel 7730000031 is a total of 0.324 acres. The southern portion of the Site is also comprised of two parcels: parcel 77300000281 totals 0.724 acres, and parcel 77300000288 totals just 0.061 acres. In total, the Site encompasses approximately 1.205 acres of generally level terrain ranging from 47 feet to 49 feet in elevation. The Site currently consists of a vacant building with landscaped areas and gravel and paved parking lots. The City of Puyallup website shows the Site is within the City of Puyallup development boundary and is currently zoned as General Commercial (City of Puyallup, 2021). Adjacent properties share the same zoning designation.

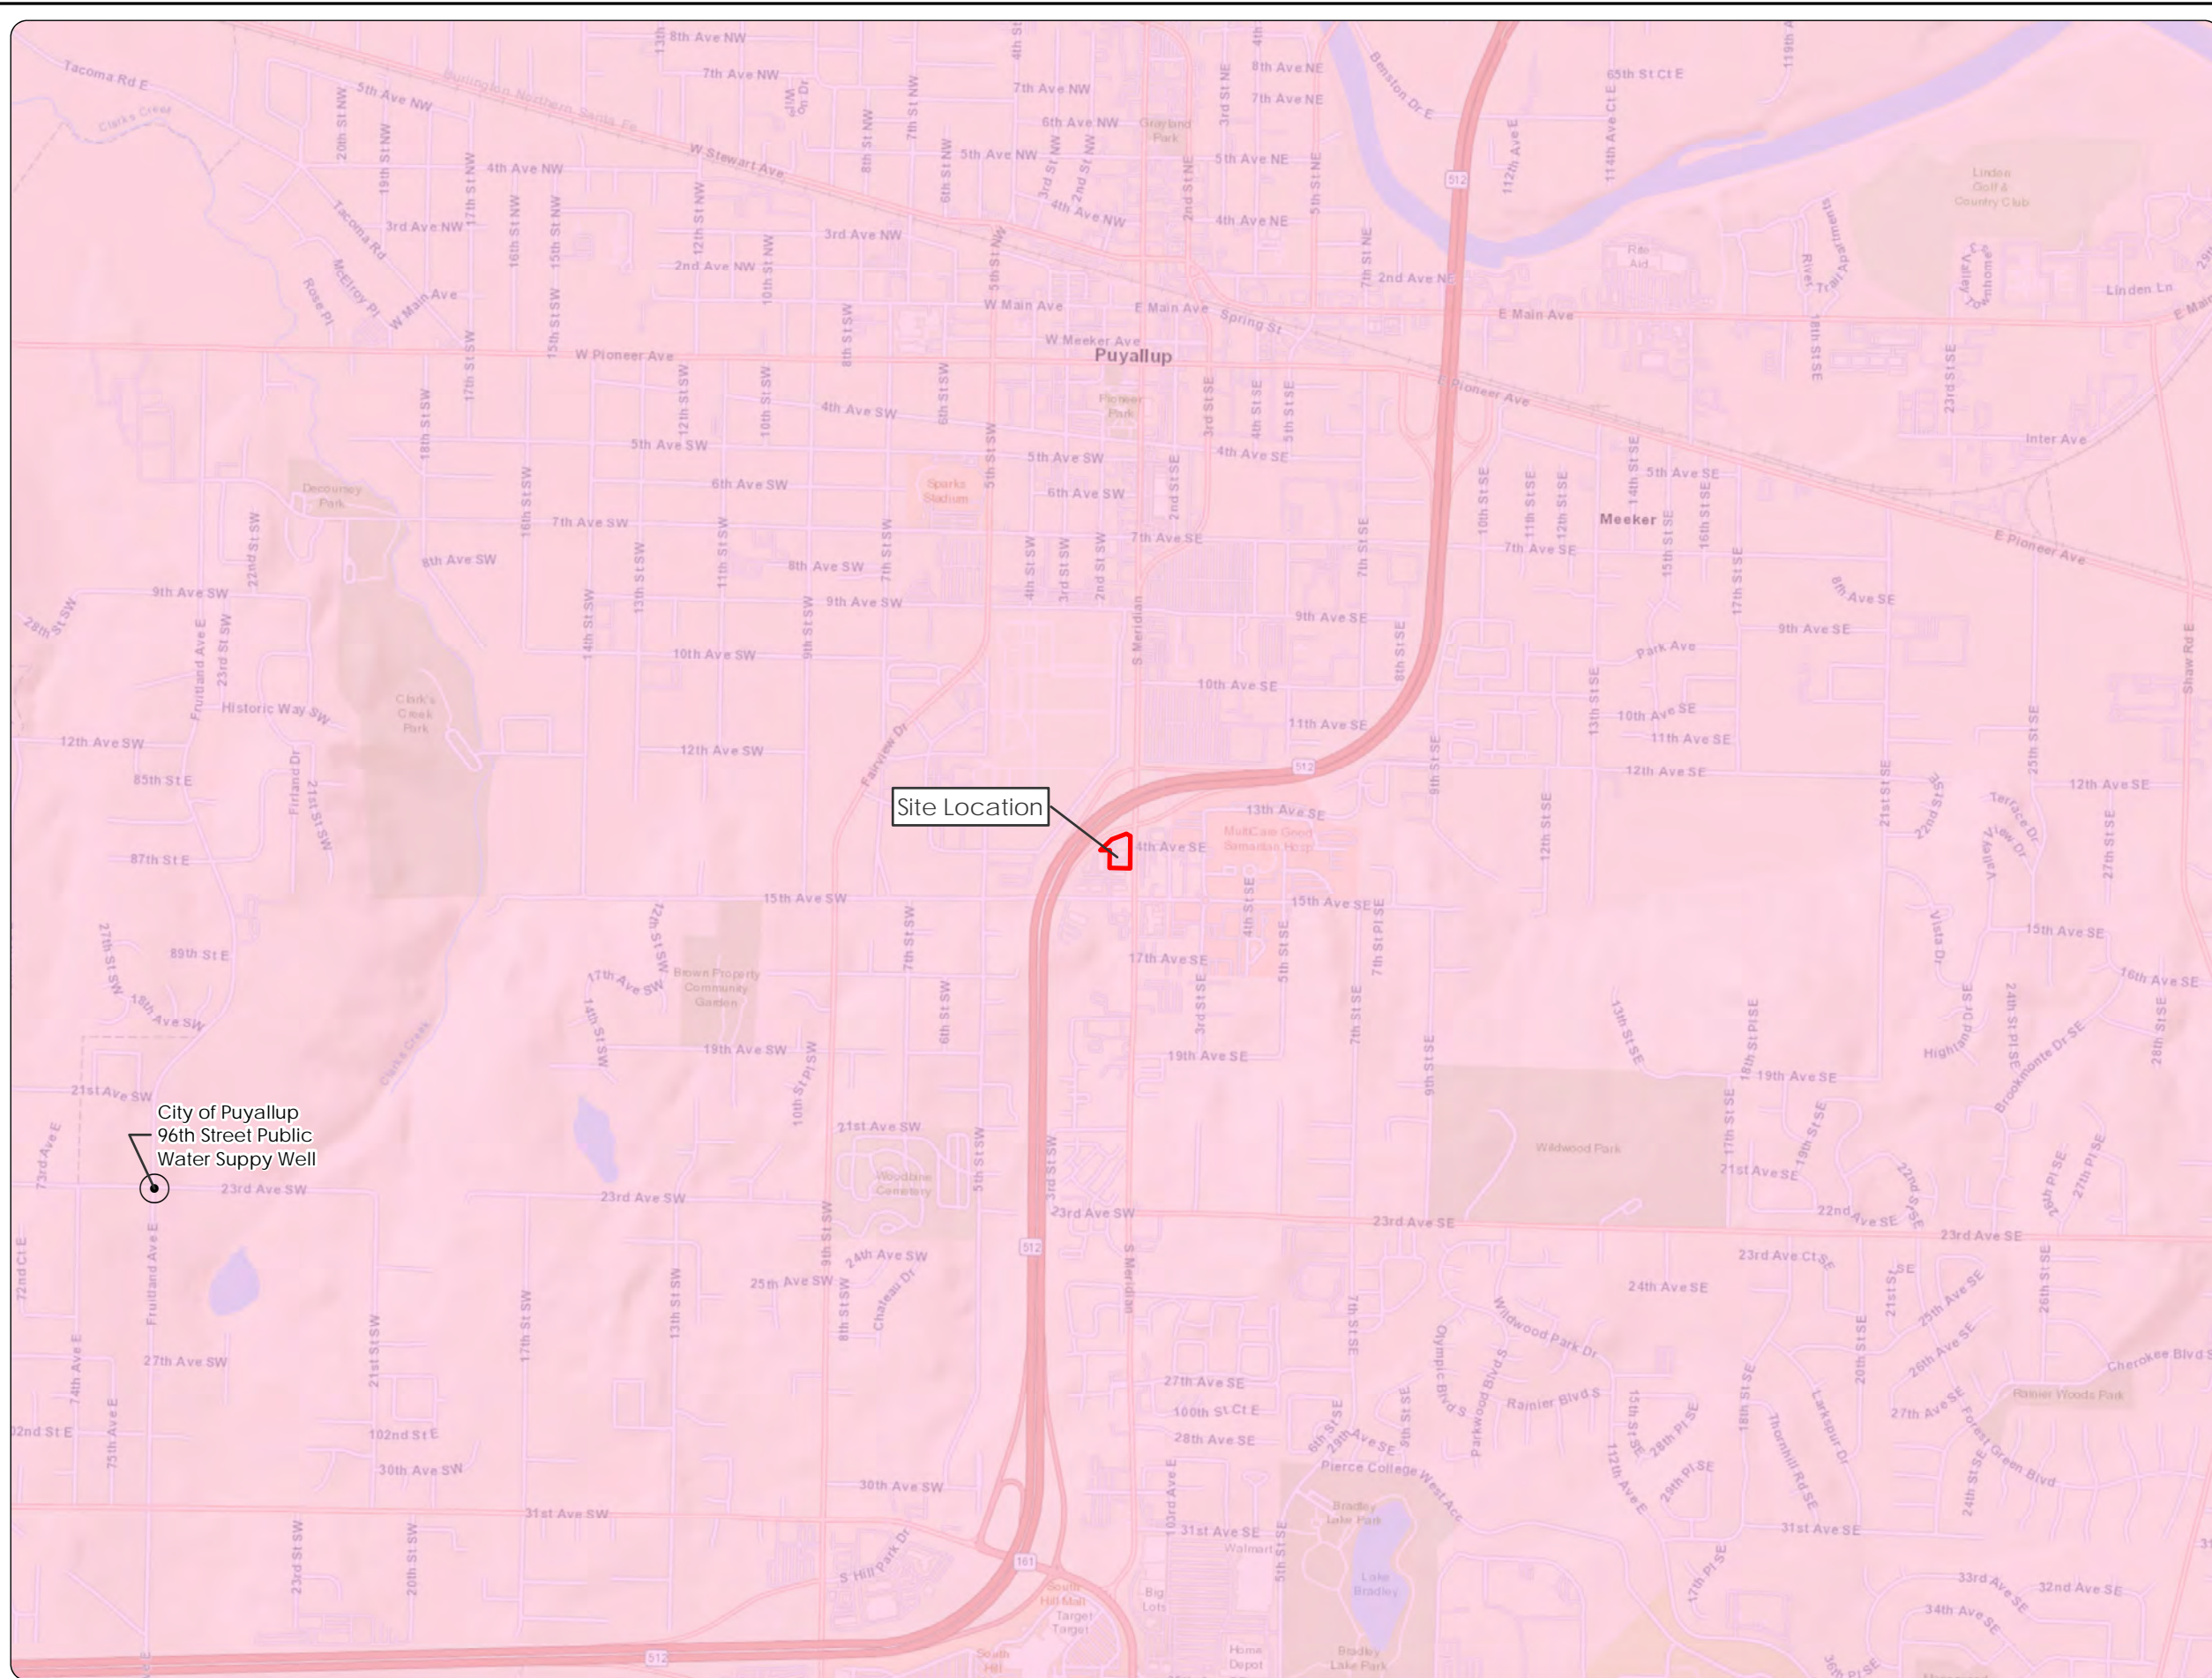
Figure 1-2
 Pierce County Critical
 Aquifer Recharge Areas

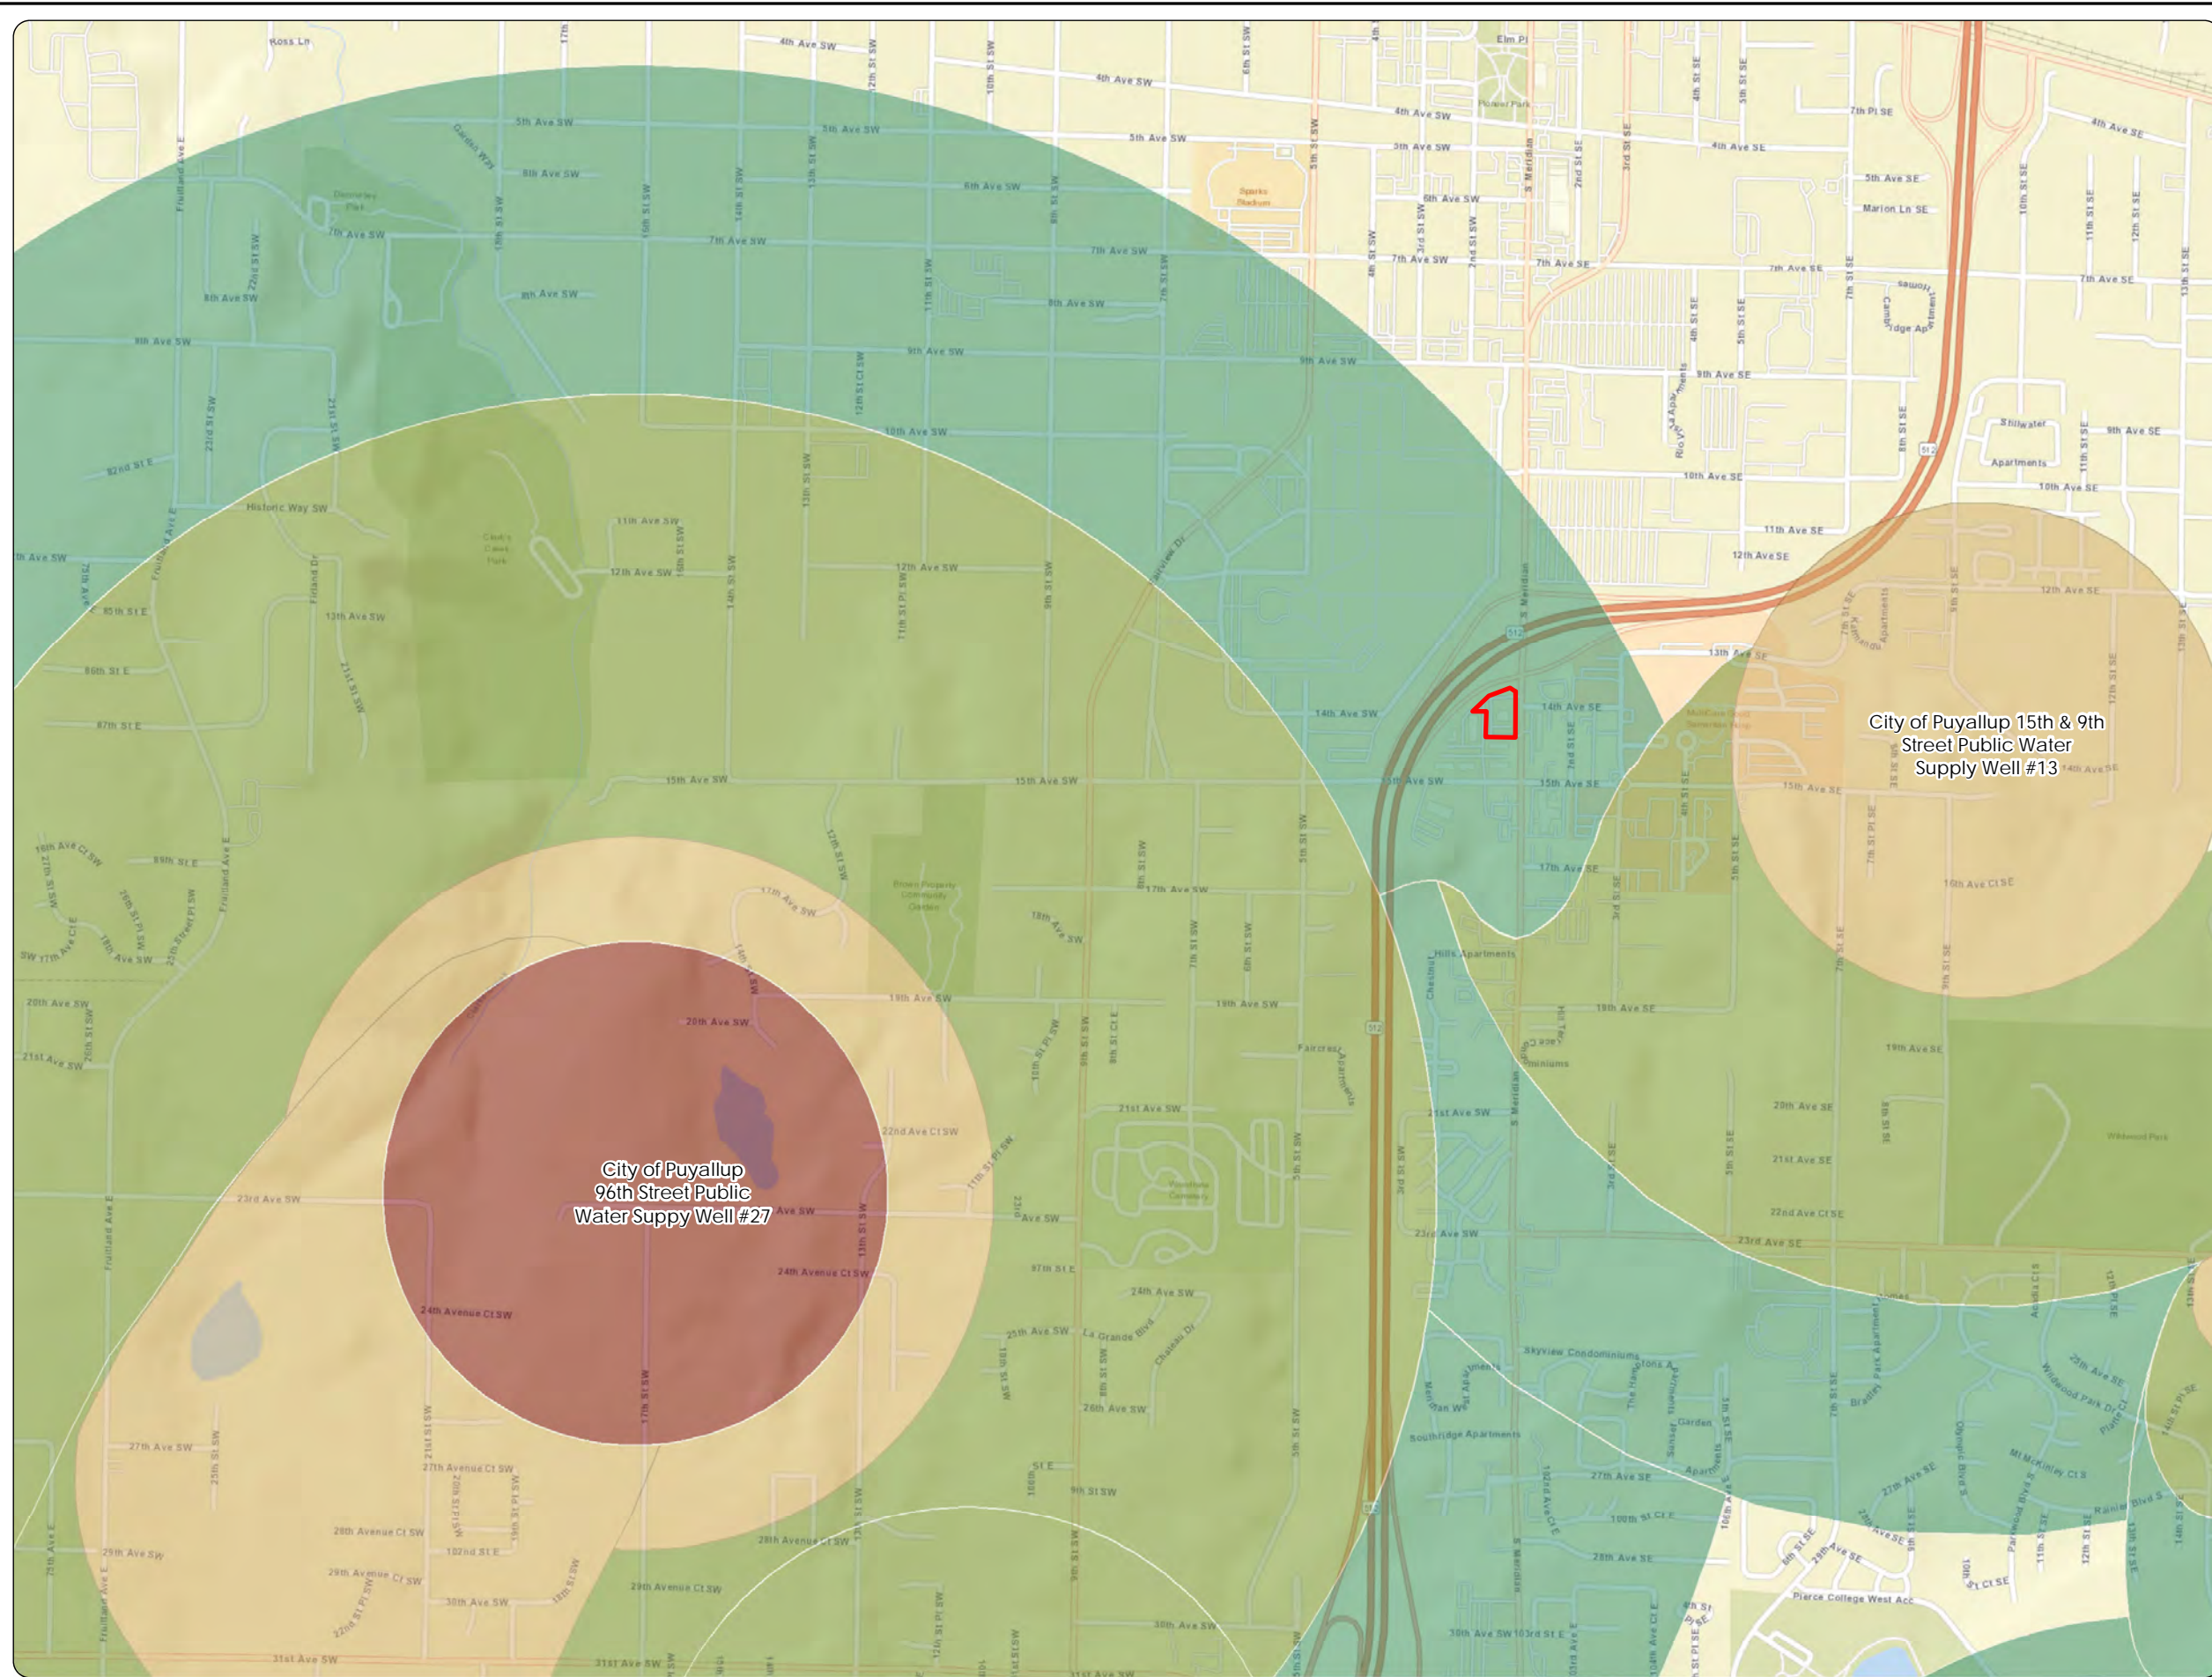
Figure 3-1
Time of Travel to Public
Water Supply Wells
 Barghausen Consulting
 Engineers, Inc.
 ARCO ampm
 Puyallup, Washington

- Legend**
- Site Boundary
 - 6-month Time of Travel
 - 1-year Time of Travel
 - 5-year Time of Travel
 - 10-year Time of Travel

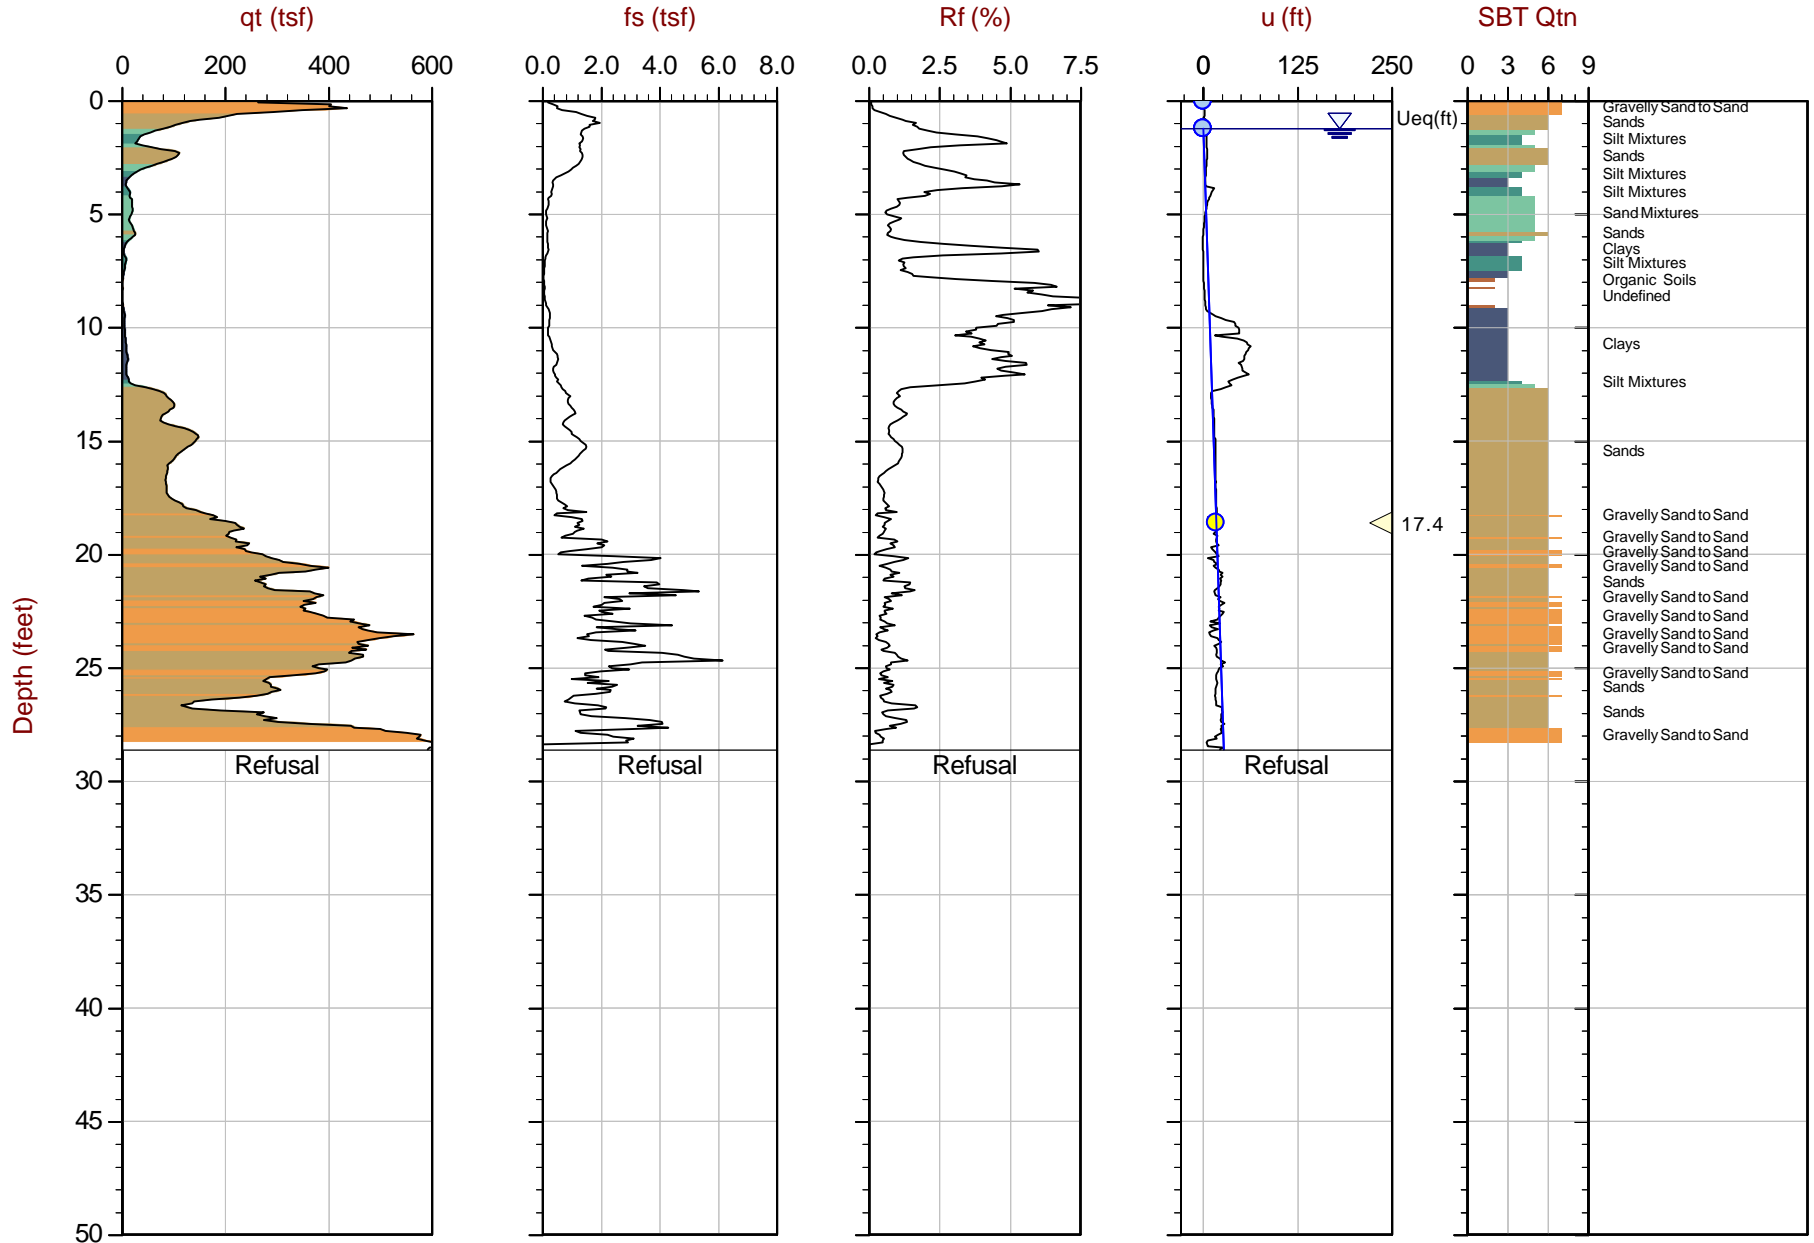
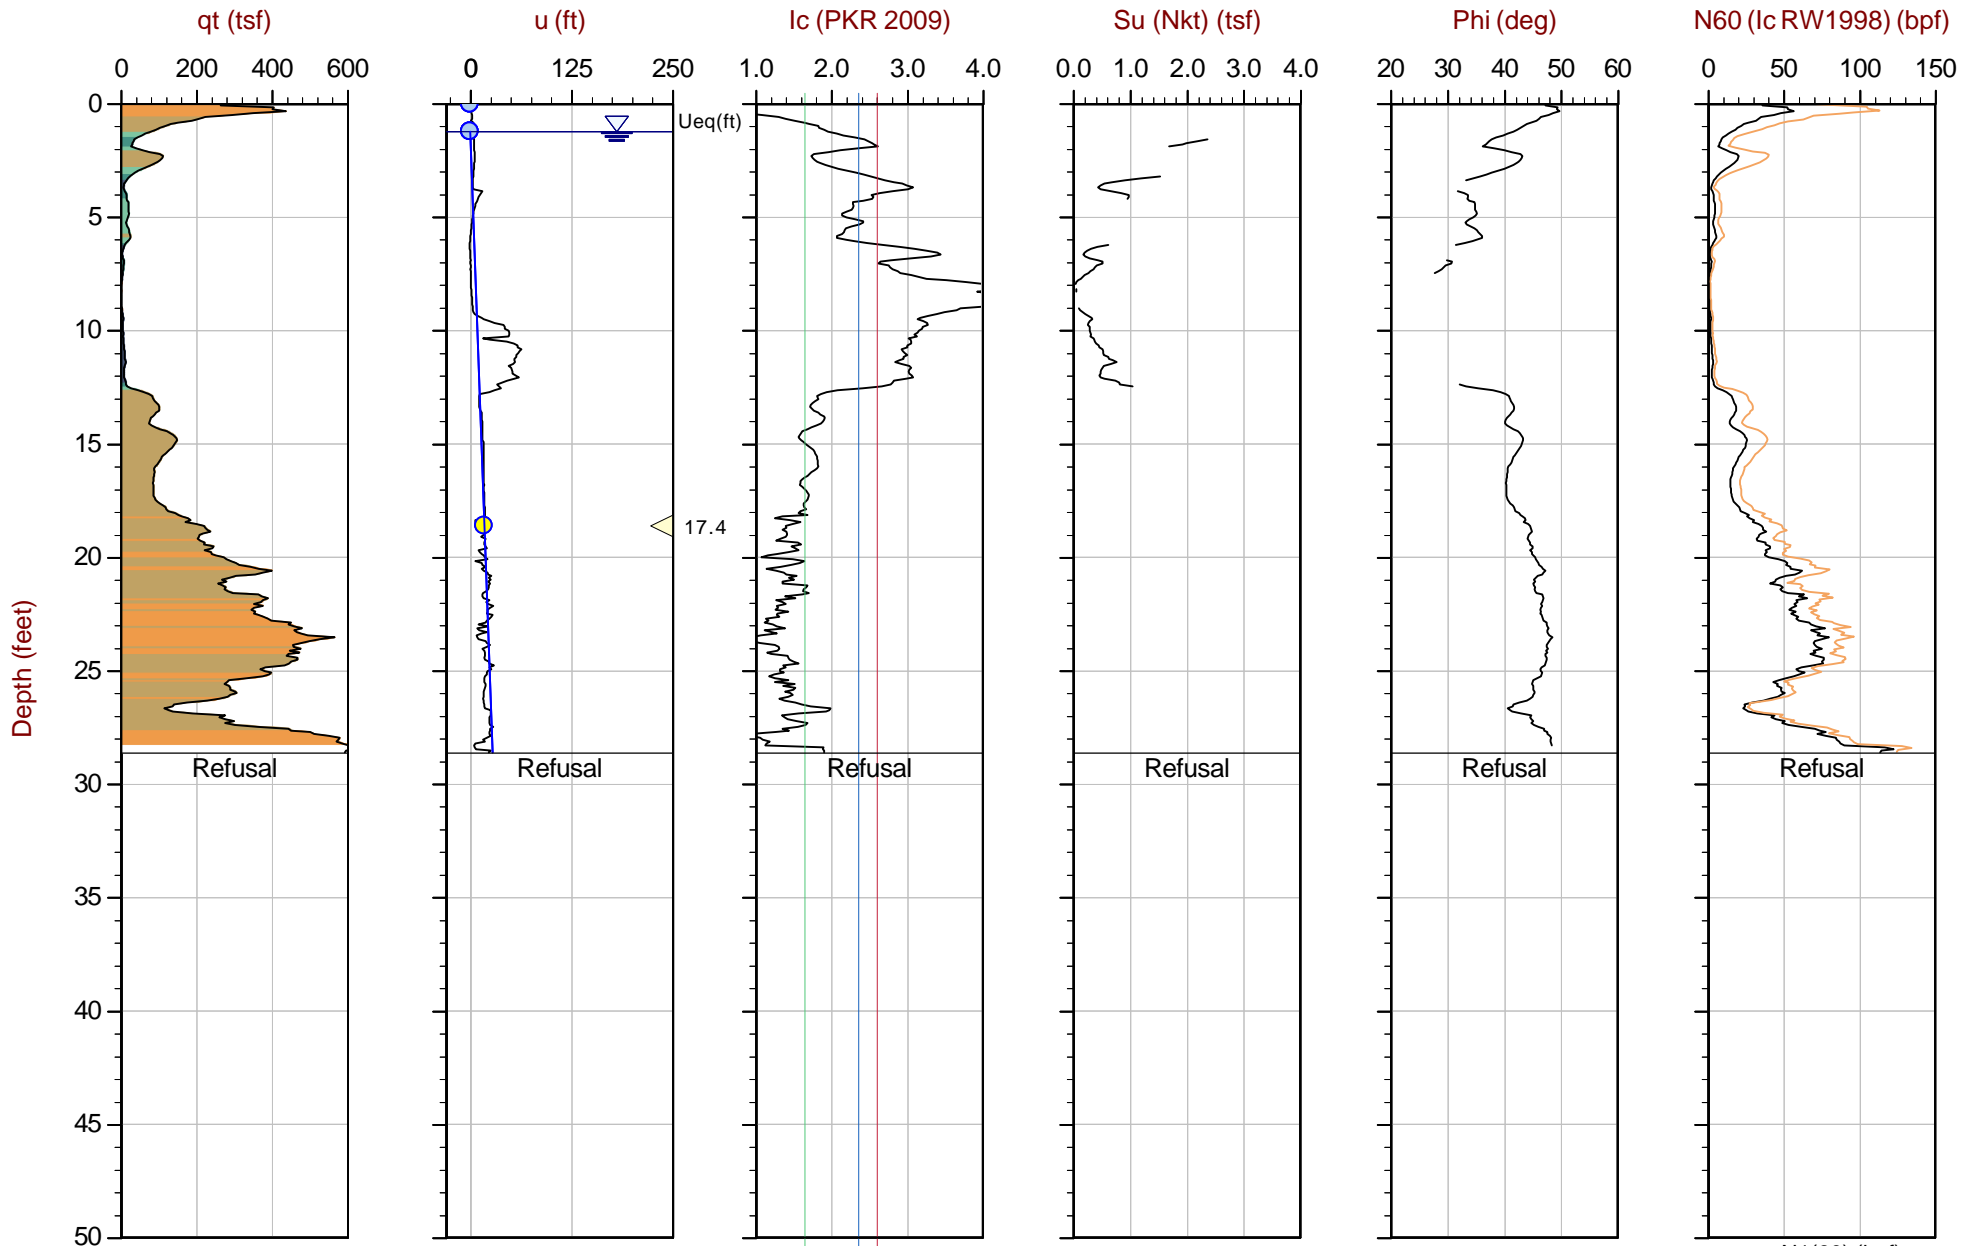
Sounding: CPT-01
Cone: 781:T1500F15U35

Max Depth: 8.725 m / 28.62 ft
Depth Inc: 0.025 m / 0.082 ft
Avg Int: Every Point

- Highly compressible, very soft to medium stiff organic silt, peat, sandy silt, and clay ranging in thickness from 9.5 feet in the northern areas (CPT-1) to 2 feet in the central areas (CPT-2), and as little as 1 foot in the southern areas (CPT-3, 4, and 5)
- Very loose to medium dense alluvial sand with varying silt content to a depth of approximately 20 to 23 feet bgs
- A layer of dense to very dense sand with gravel to gravel with sand, approximately 12 feet thick, was observed throughout the Site extending to depths of 27 to 33 feet bgs
- Another stratum of very loose to medium dense alluvial sand, approximately 5.5 to 12 feet thick
- Dense to very dense glacial sand and gravel soils to the extent of excavation at approximately 39.1 to 46.3 feet bgs.

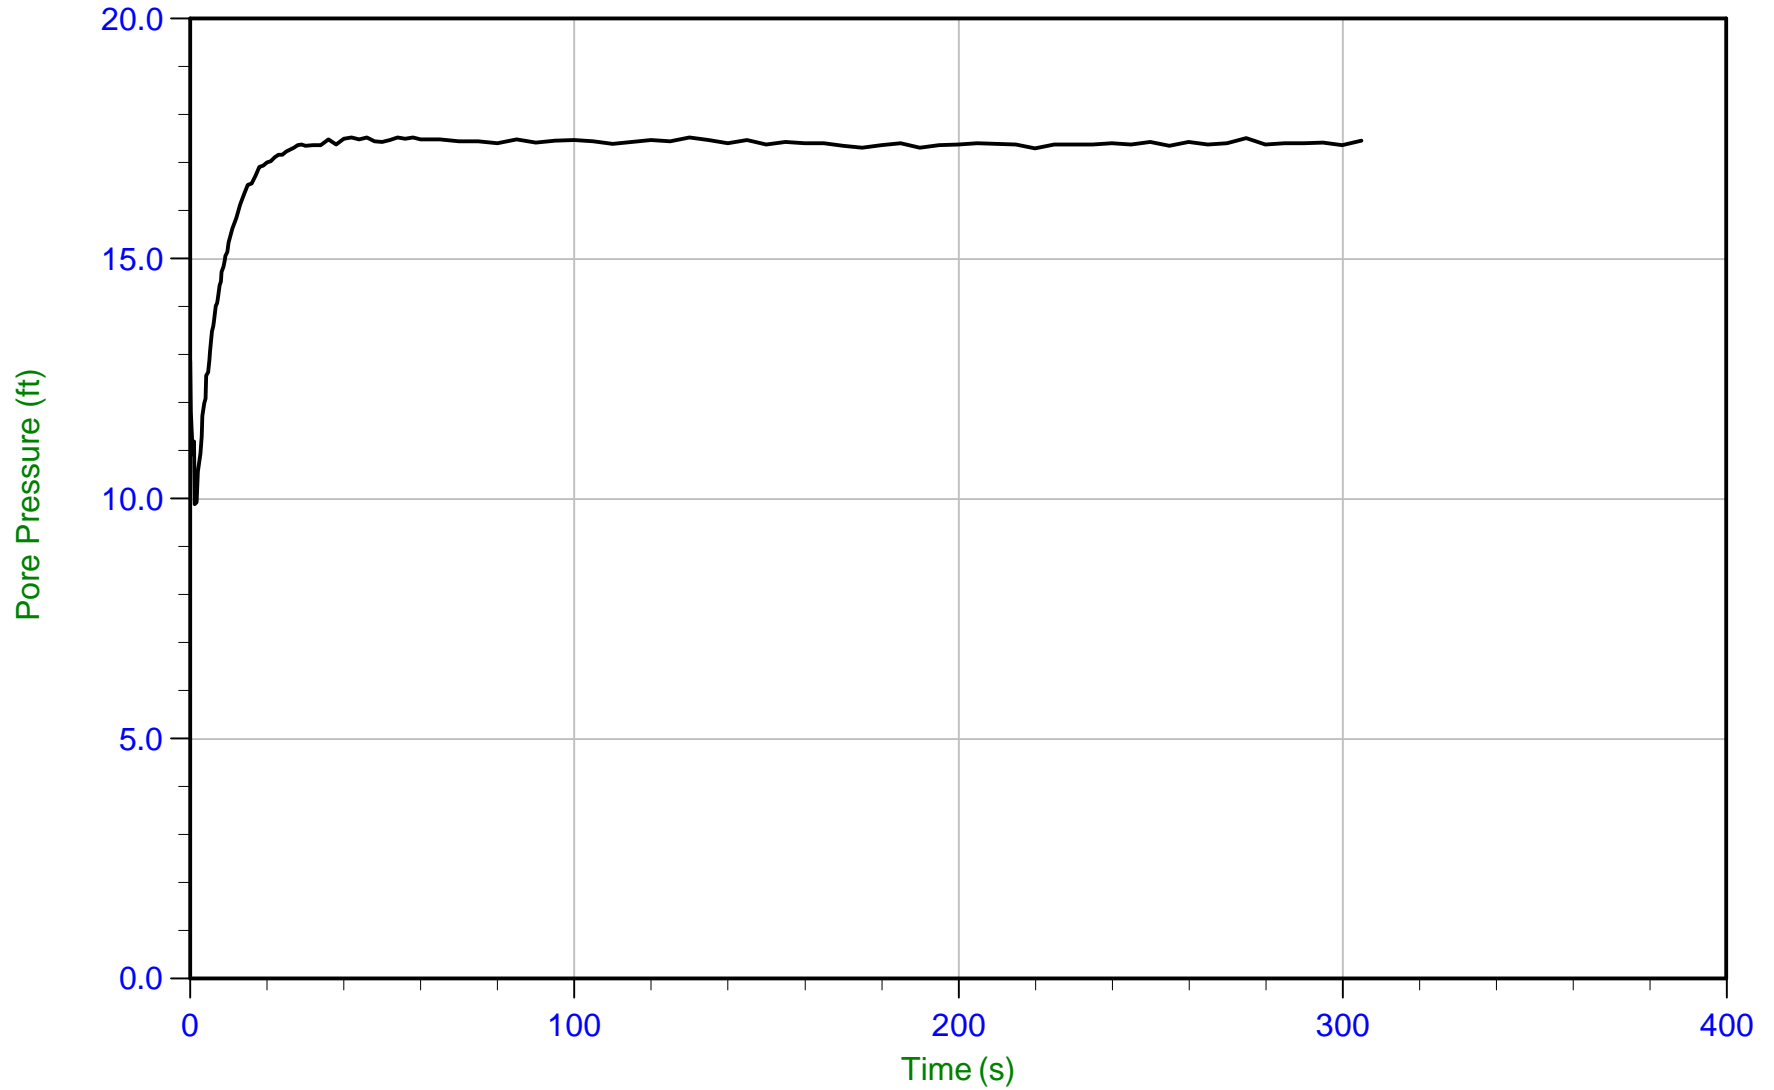
Sounding: CPT-01
Cone: 781:T1500F15U35 Area=15 cm²

Filename: 22-59-23911_CP01.ppd2
Depth: 5.675 m / 18.619 ft
Duration: 305.0 s

Although groundwater levels generally fluctuate spatially and temporally, porewater pressure dissipation testing conducted during the March 2022 geotechnical investigation provide a general indication of depth to groundwater throughout the site. The depth to groundwater in CPT borings ranged between 1.2 to 3.7 feet bgs, which was similar to depths observed in monitoring wells in the northern area of the site near CPT-1 and the southern area of the Site near CPT-4, at 4.6 feet bgs and 1.5 feet bgs respectively. Although test pits IP-1 and IP-2 were excavated with the intention of conducting infiltration testing, the presence of undocumented fill material, organic silt/peat and clay, and shallow groundwater made these tests infeasible because these conditions would be expected to inhibit infiltration test water. As a result of these conditions, onsite management of stormwater by infiltration is not considered feasible (see Appendix A).
