HYDROGEOLOGIC REPORT

ARCO AMPM, PUYALLUP, WASHINGTON

Project No. M2303.02

CRITICAL AQUIFER RECHARGE AREA
HYDROGEOLOGIC REPORT

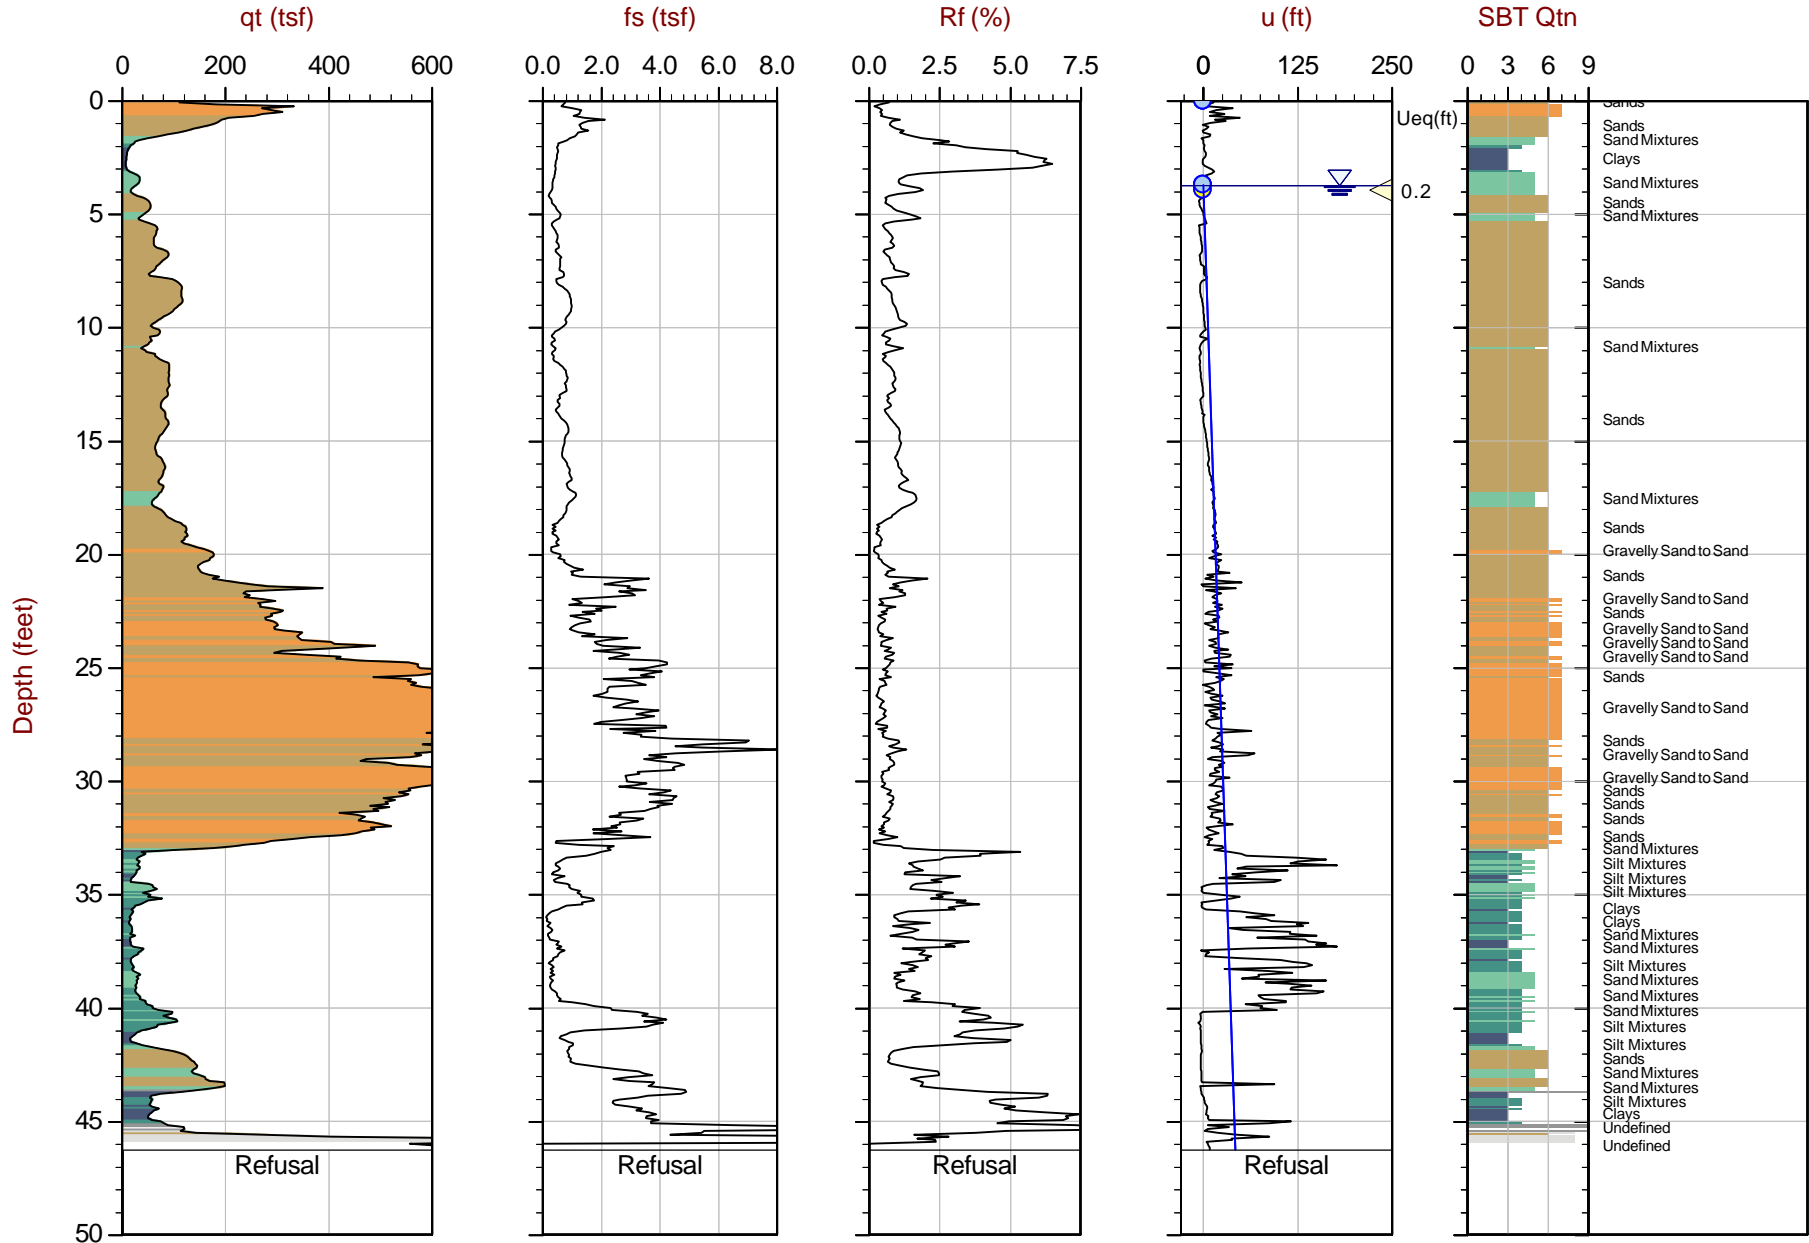
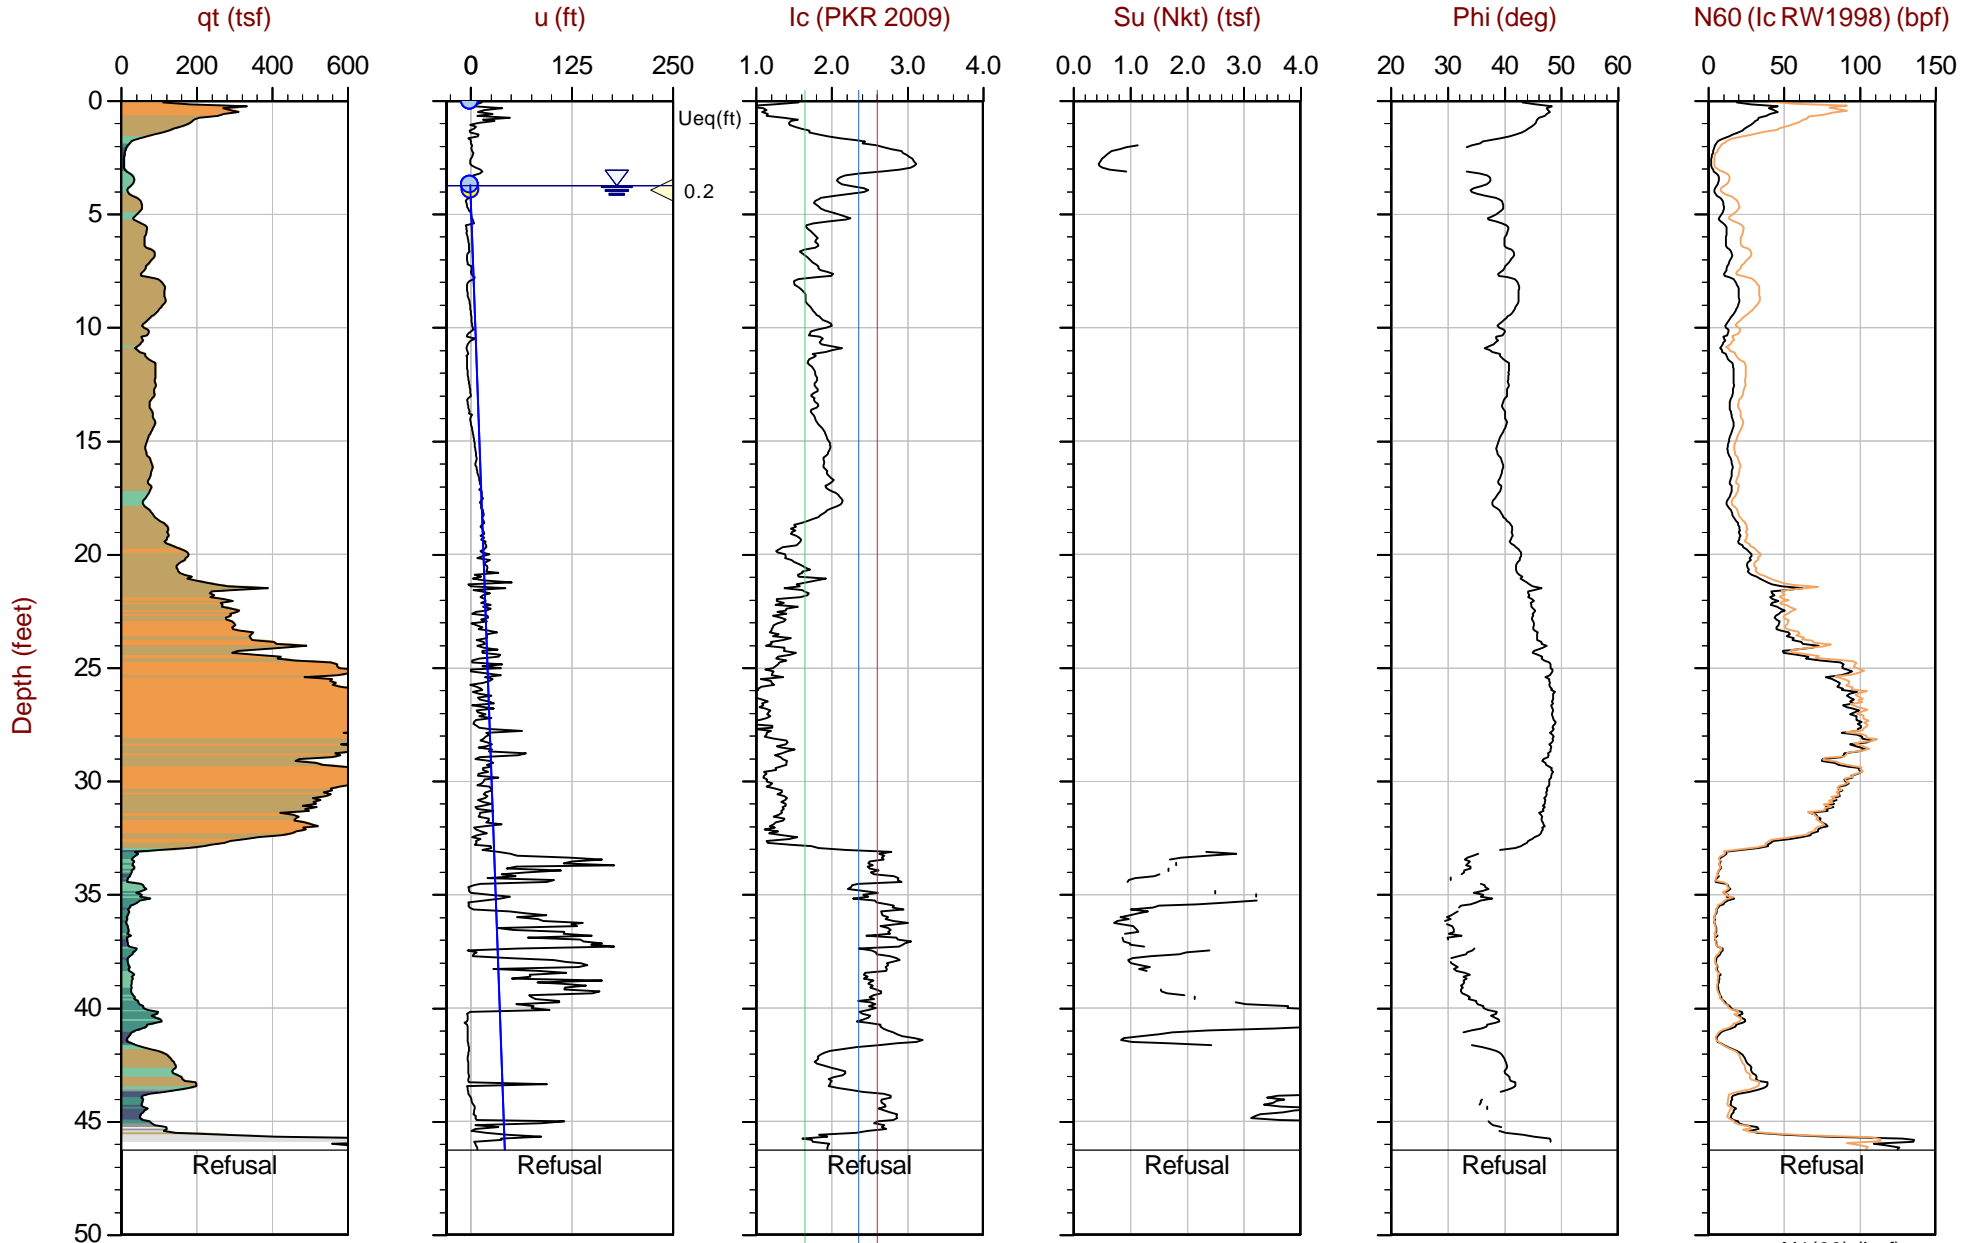
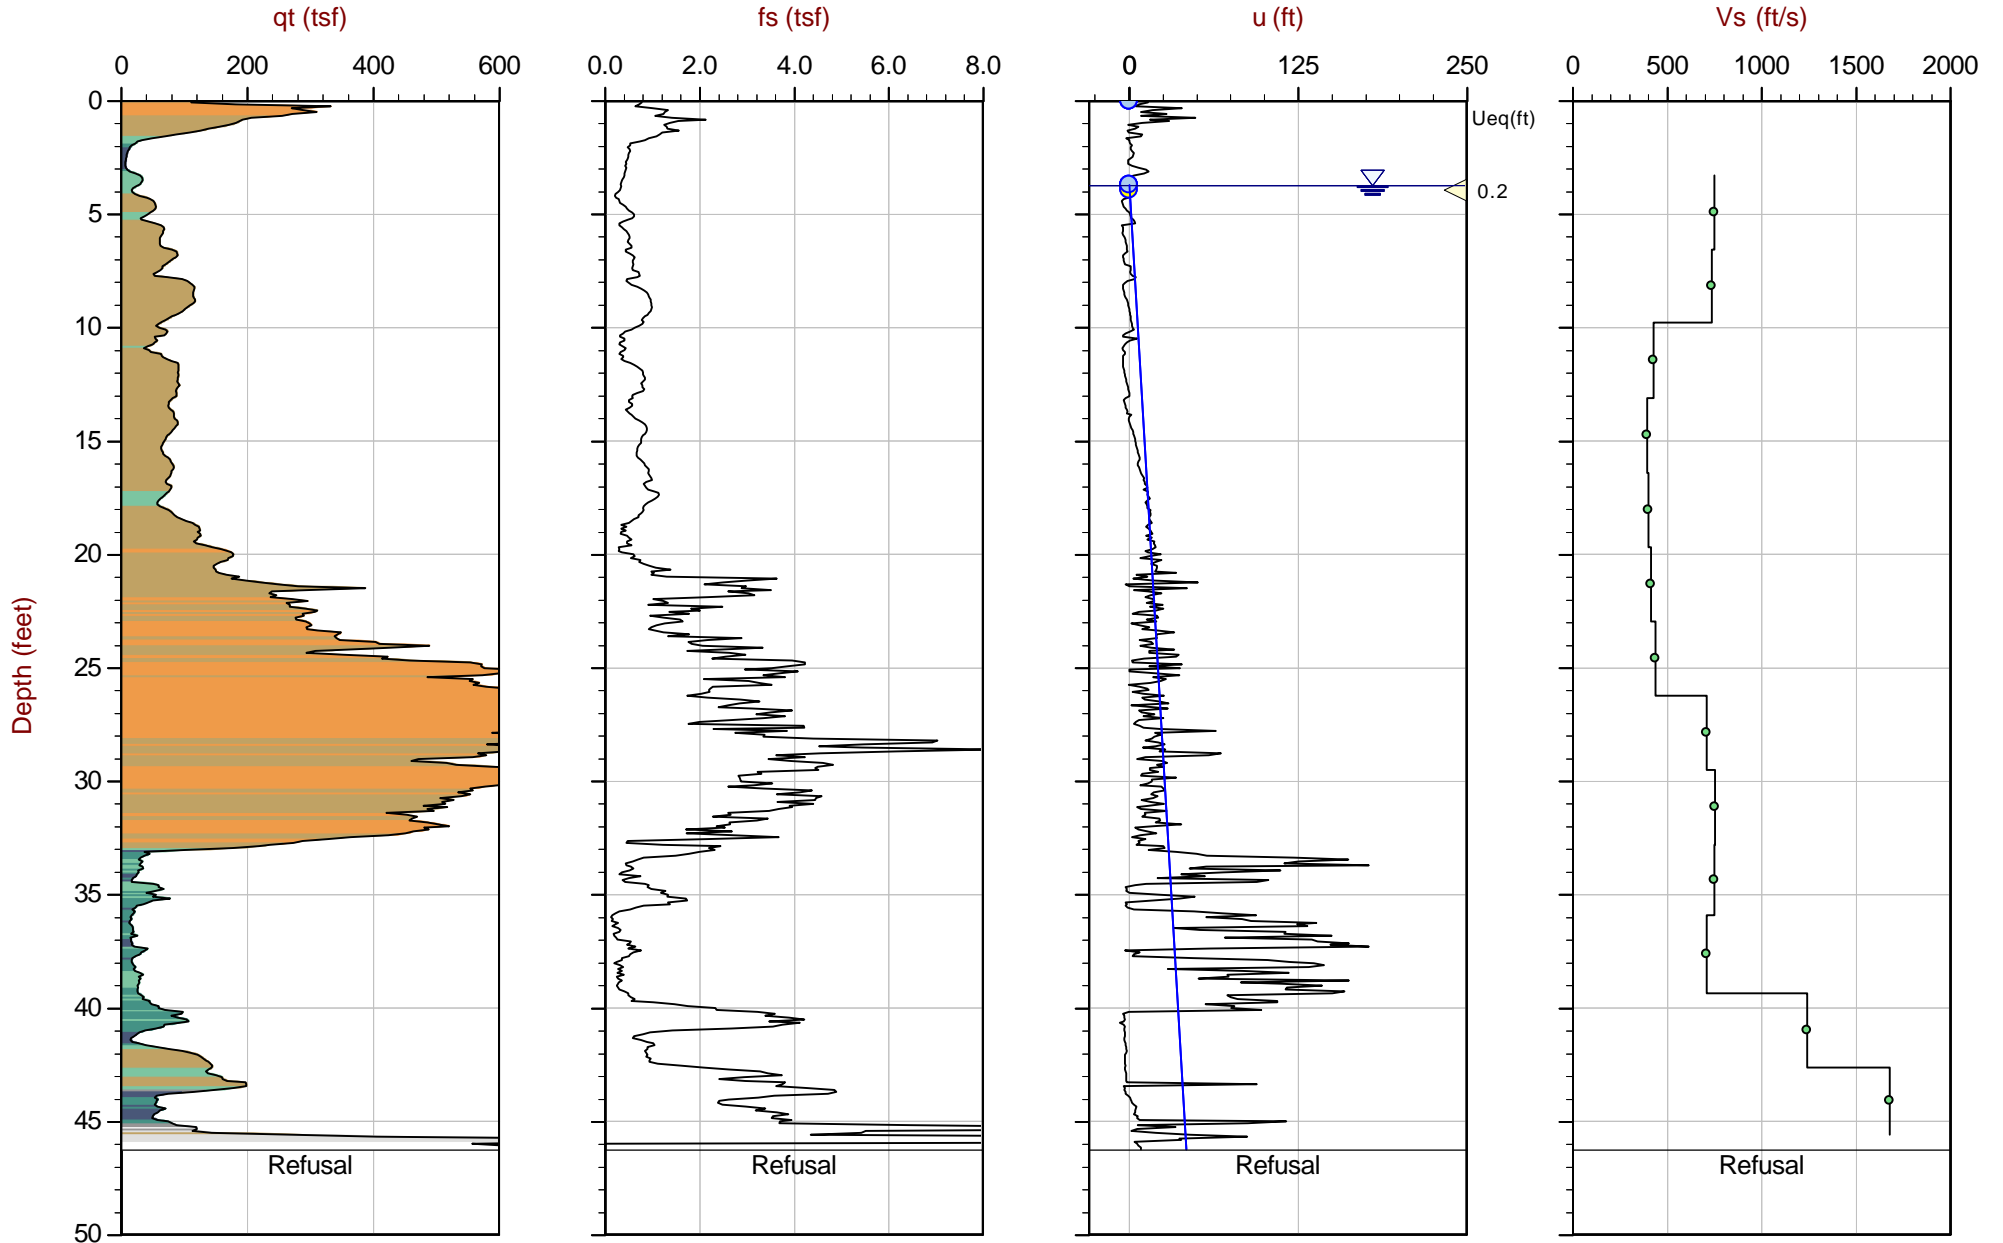
Sounding: CPT-02B
Cone: 781:T1500F15U35

Max Depth: 14.100 m / 46.26 ft
Depth Inc: 0.025 m / 0.082 ft
Avg Int: Every Point

An approximately 12-foot thick layer of dense to very dense sand with gravel to gravel with sand was encountered beneath the loose alluvial sands in CPT-2 and CPT-2B, and extended to depths of 27 to 33 feet bgs in the remaining CPTs due to refusal of the cone to further penetration in this dense soil layer.

The dense sand in CPT-2 and CPT-2B was underlain by another stratum of very loose to medium dense alluvial sand ranging from about 5.5 to 12 feet thick, followed by dense to very dense glacial sand and gravel soils to their termination depths at about 39.1 and 46.3 feet bgs, respectively.

Shear Wave Velocity: Shear wave velocity were obtained from the CPT-2B, CPT-4, and CPT-5, which were advanced to depths of about 27.0 to 46.3 feet bgs. The shear wave velocities were measured to the maximum explored depth, and we have assumed similar site conditions continue below the explored depth. The measured shear wave velocities to the maximum explored depth ranged from about 333 feet per second to 1680 feet per second. The average measured shear wave velocities in the upper 100 feet were estimated to be in the range of 778 to 1217 feet per second.

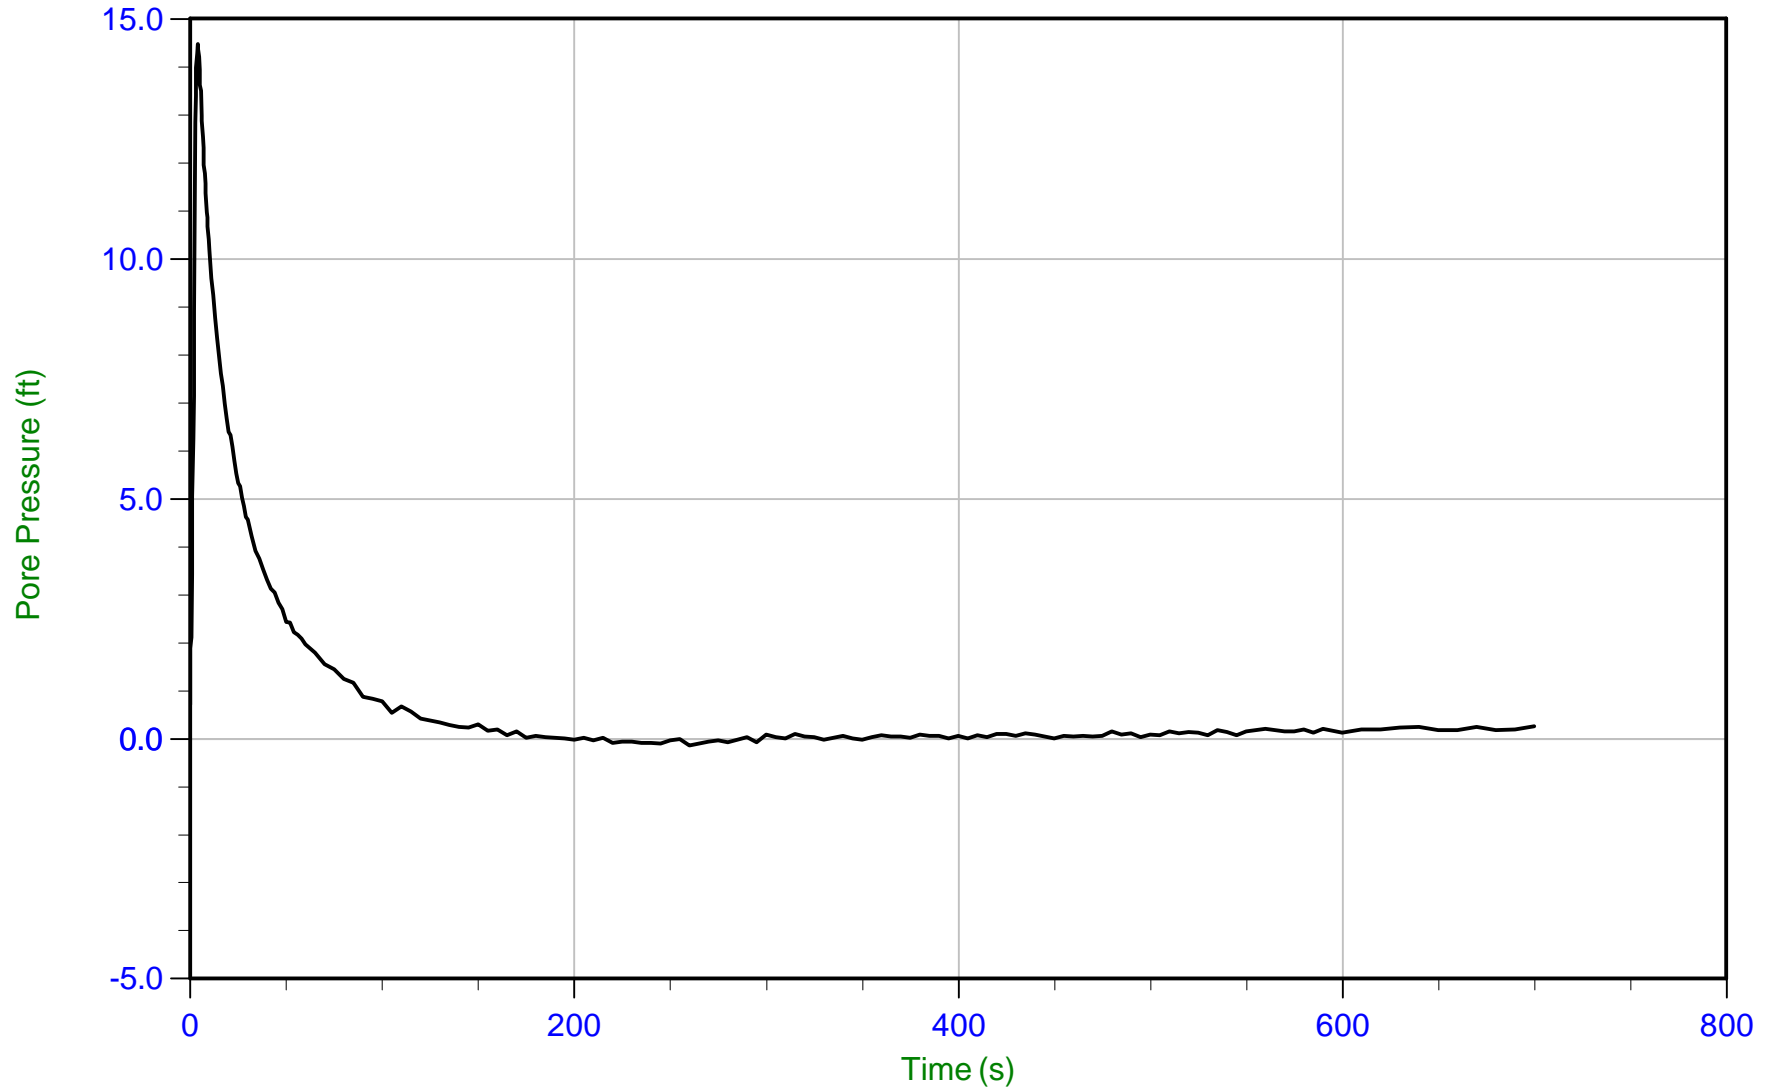
Sounding: CPT-02B
Cone: 781:T1500F15U35 Area=15 cm²

Filename: 22-59-23911_SP02B.ppd2
Depth: 1.200 m / 3.937 ft
Duration: 700.0 s

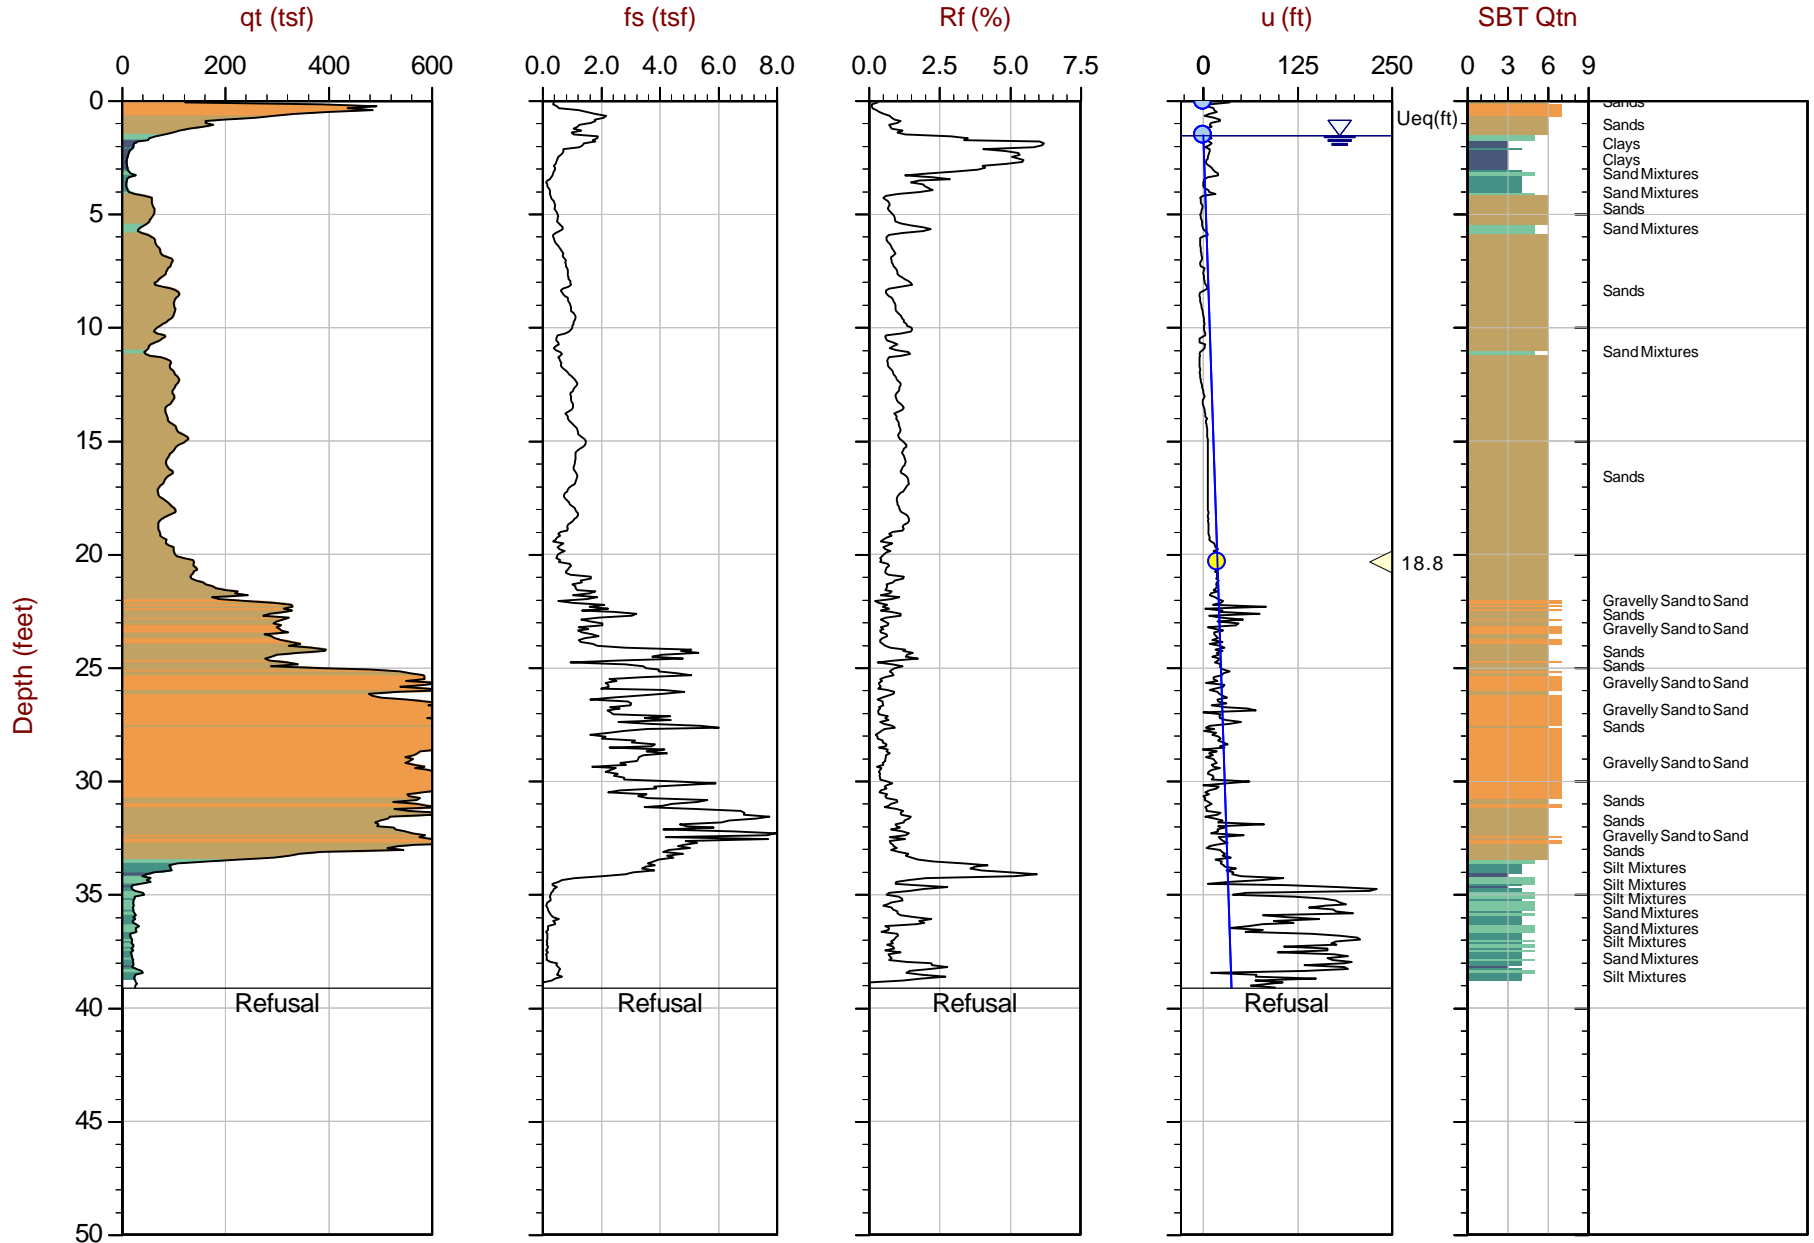
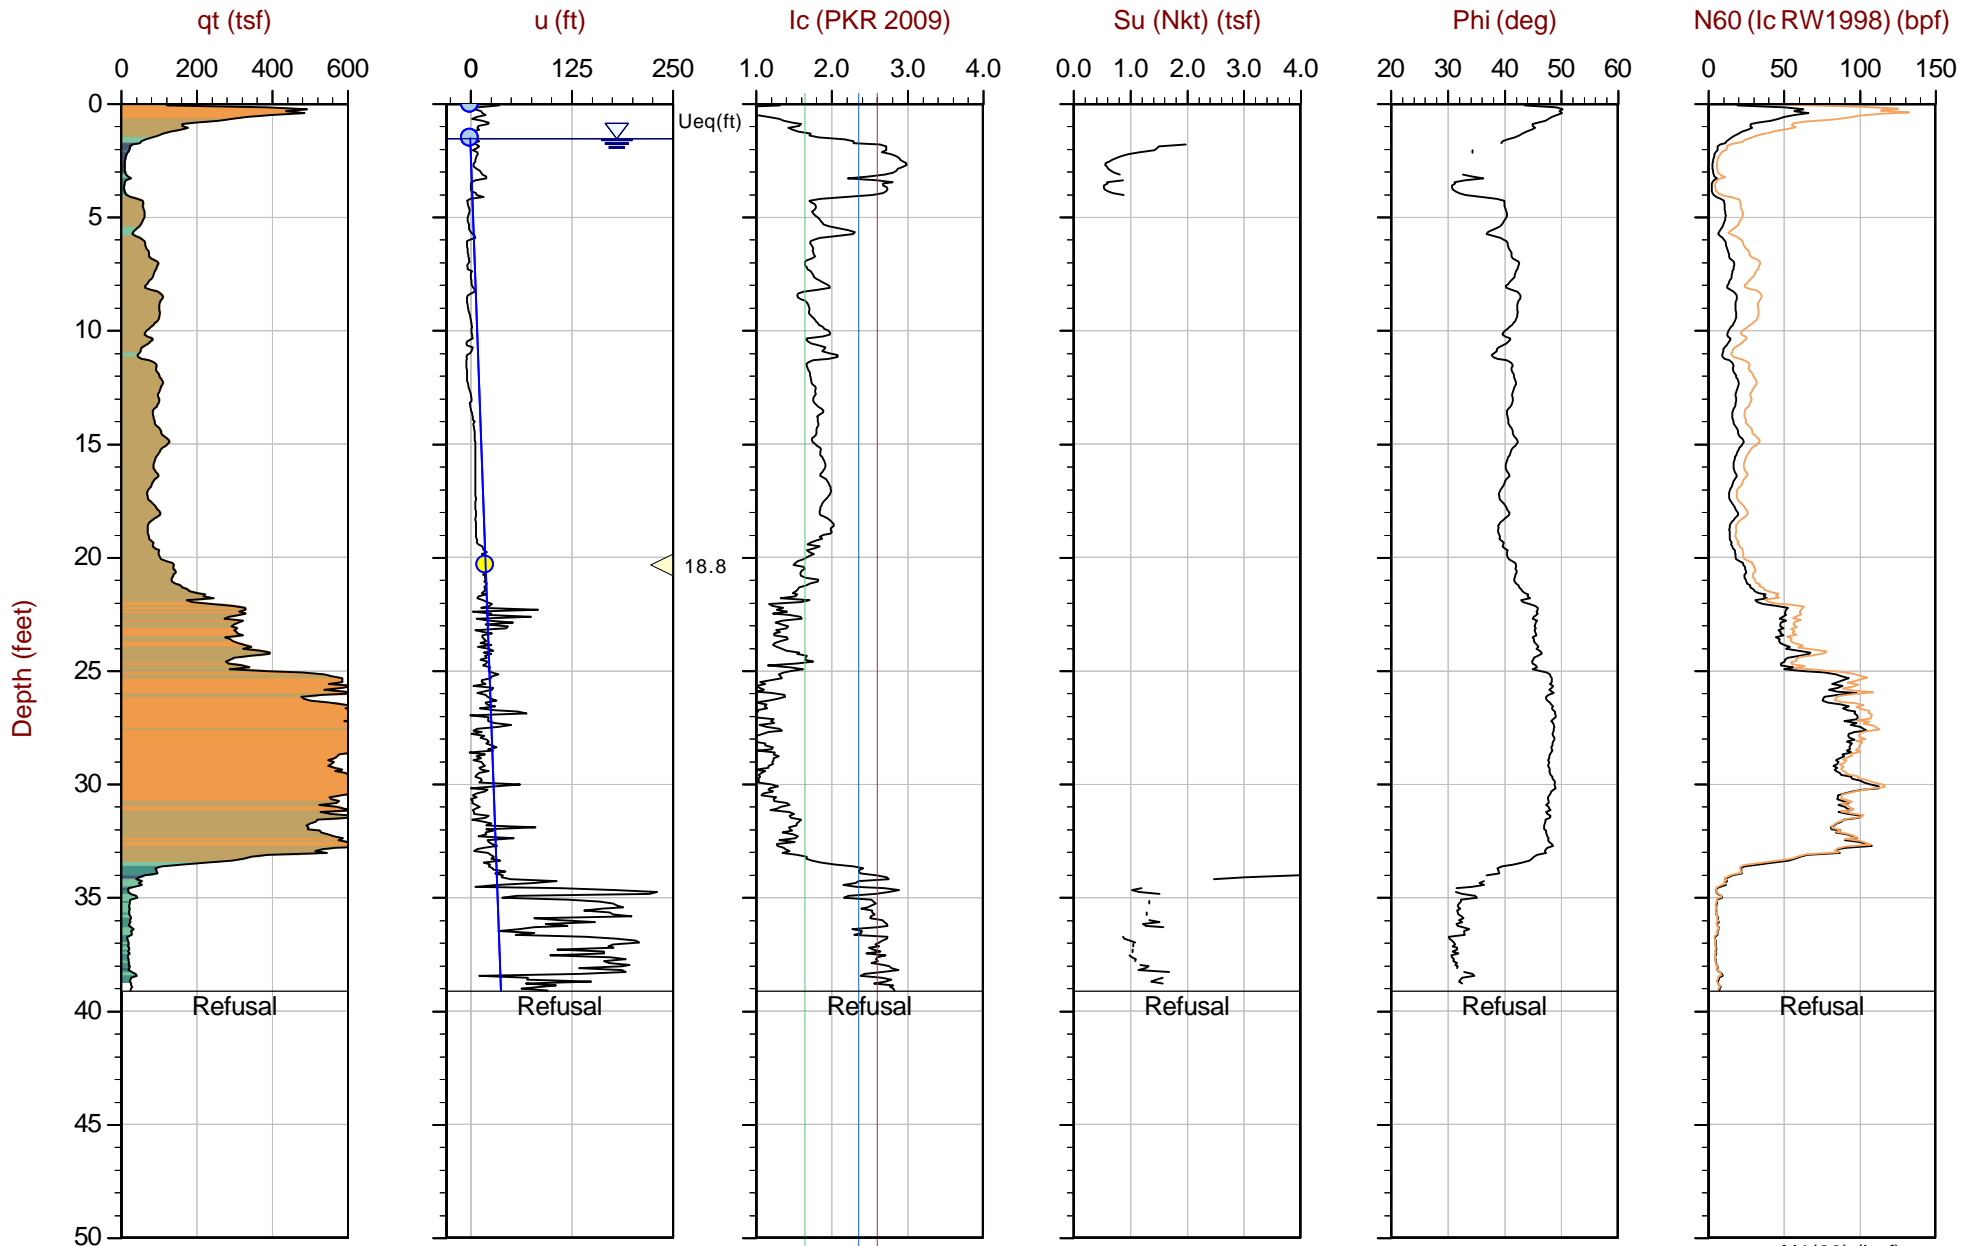
Sounding: CPT-02
Cone: 781:T1500F15U35

Max Depth: 11.925 m / 39.12 ft
Depth Inc: 0.025 m / 0.082 ft
Avg Int: Every Point

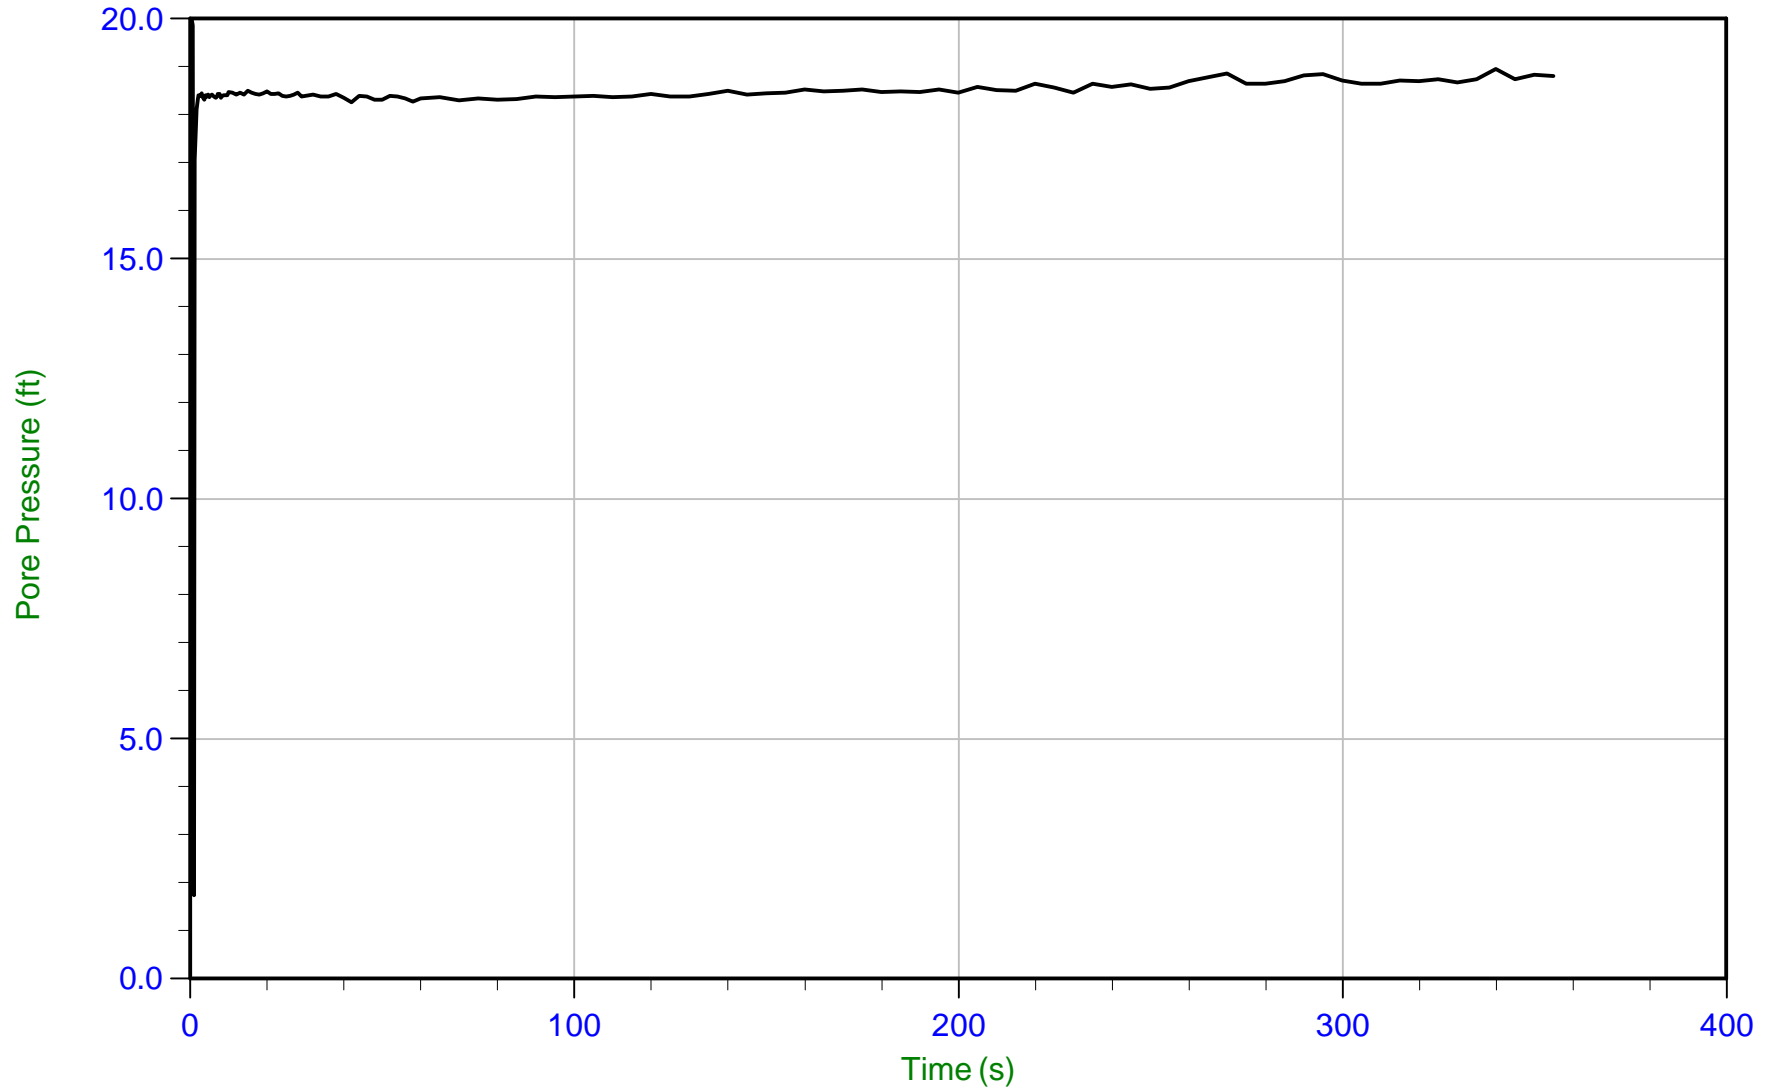
Sounding: CPT-02
Cone: 781:T1500F15U35 Area=15 cm²

Filename: 22-59-23911_CP02.ppd2
Depth: 6.200 m / 20.341 ft
Duration: 355.0 s

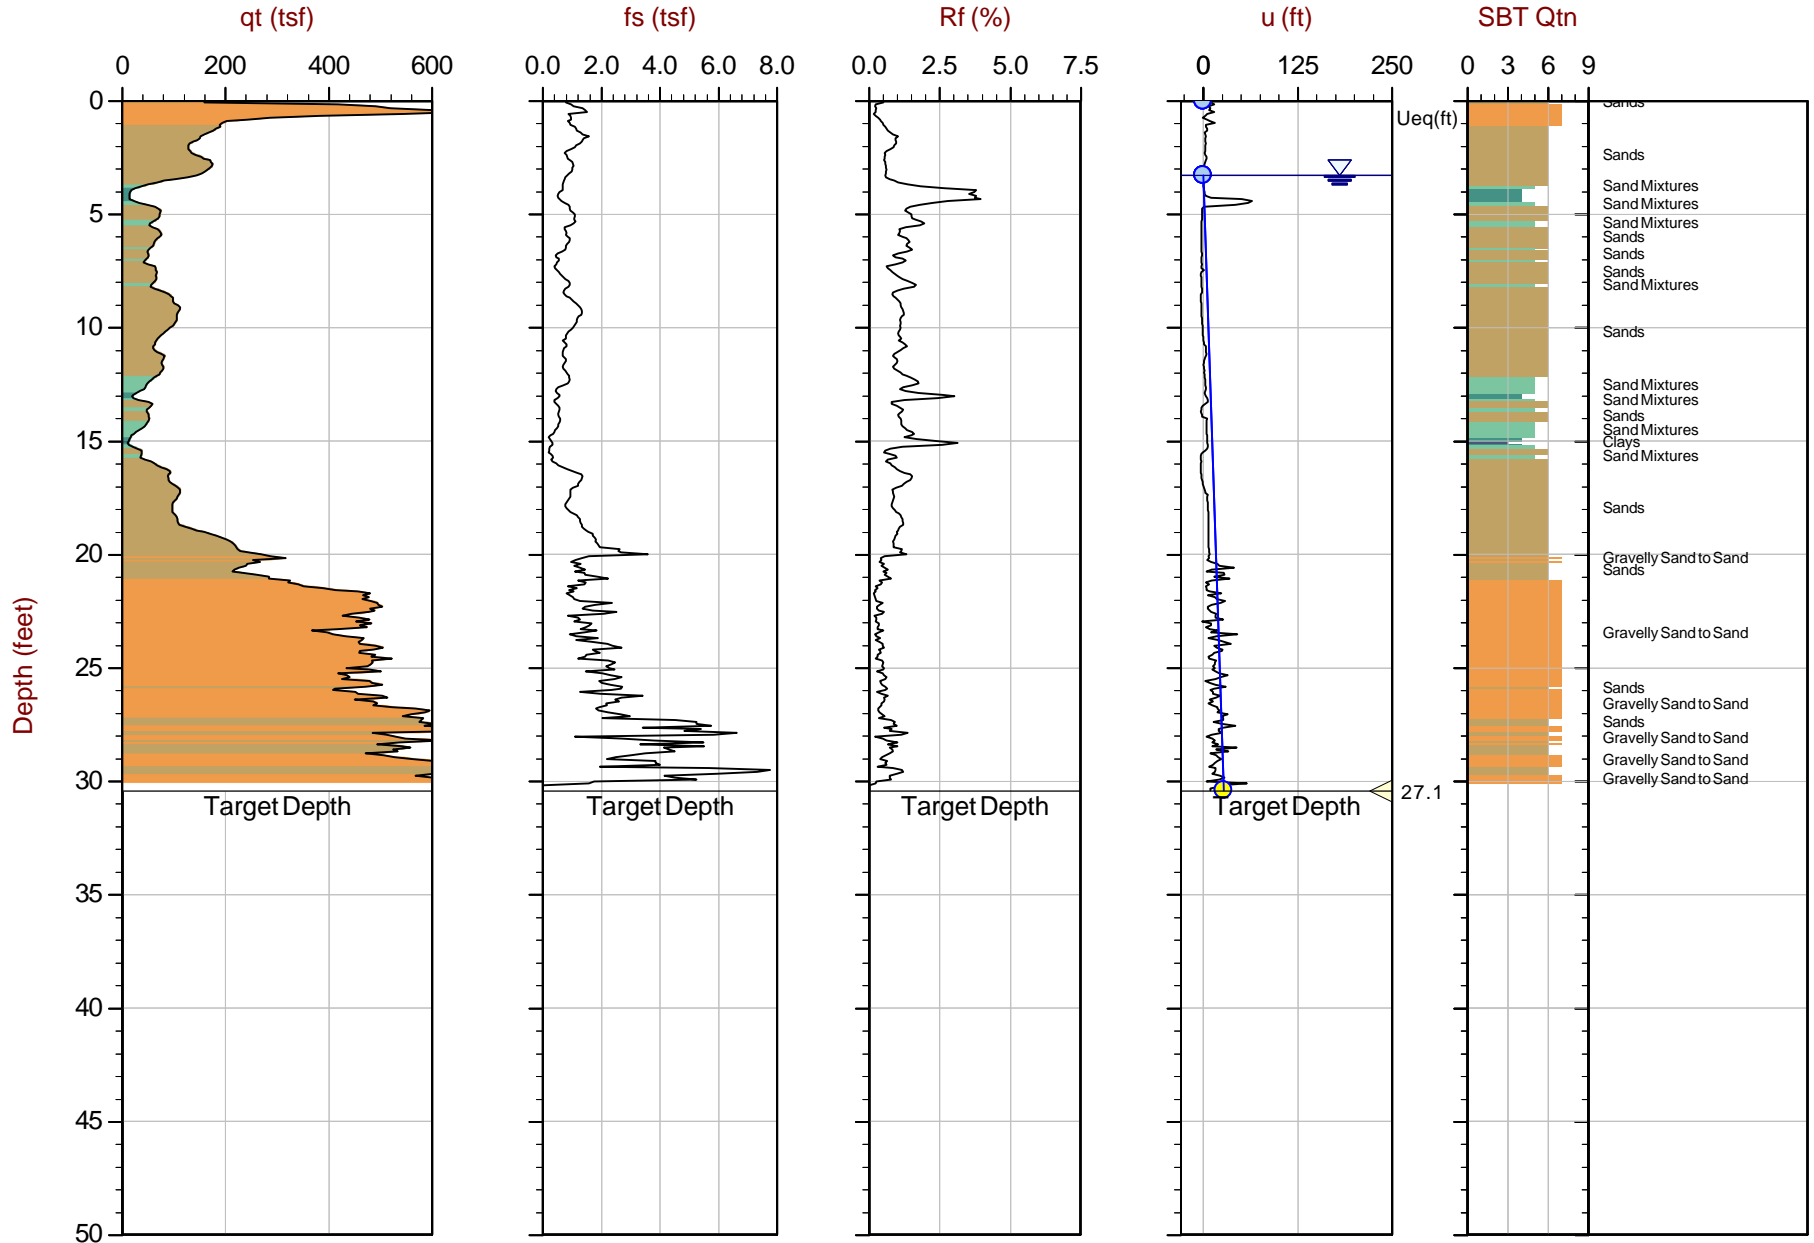
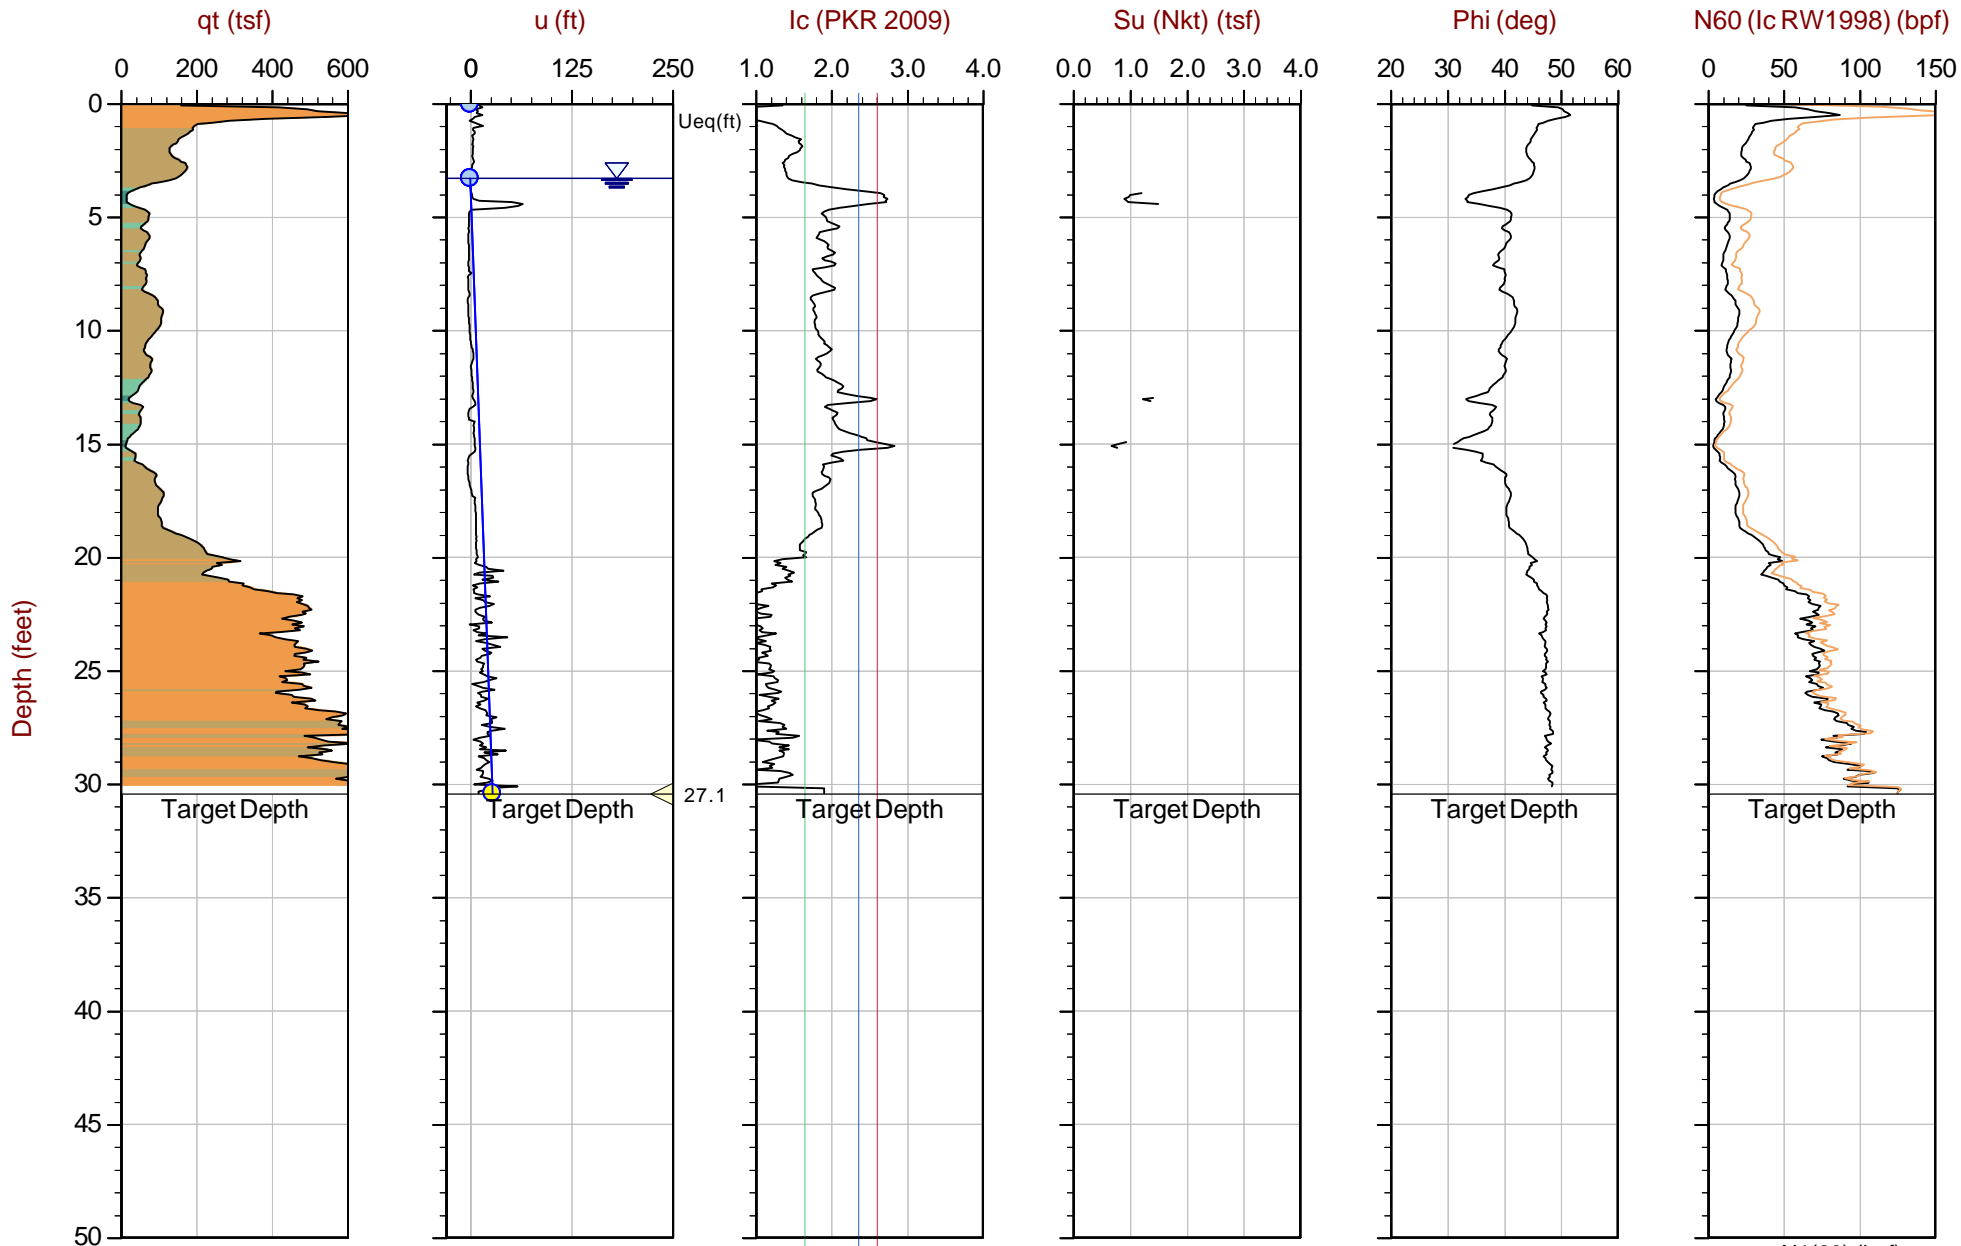
Sounding: CPT-03
Cone: 781:T1500F15U35

Max Depth: 9.275 m / 30.43 ft
Depth Inc: 0.025 m / 0.082 ft
Avg Int: Every Point

Native Alluvial and Glacial Soils: The undocumented fill was underlain by highly compressible, very soft to medium stiff organic silt, peat, sandy silt, and clay followed by very loose to medium dense sand with varying silt content to a depth of about 20 to 23 feet bgs. The compressible alluvial soils ranged from about 2 feet thick in CPT-2 and CPT-2B to up to 9.5 feet thick in CPT-1 conducted within the northeastern portion of the site, to occasional layers up to 1-foot thick in the explorations conducted within the southern part of the site (CPT-3, CPT-4, and CPT-5).

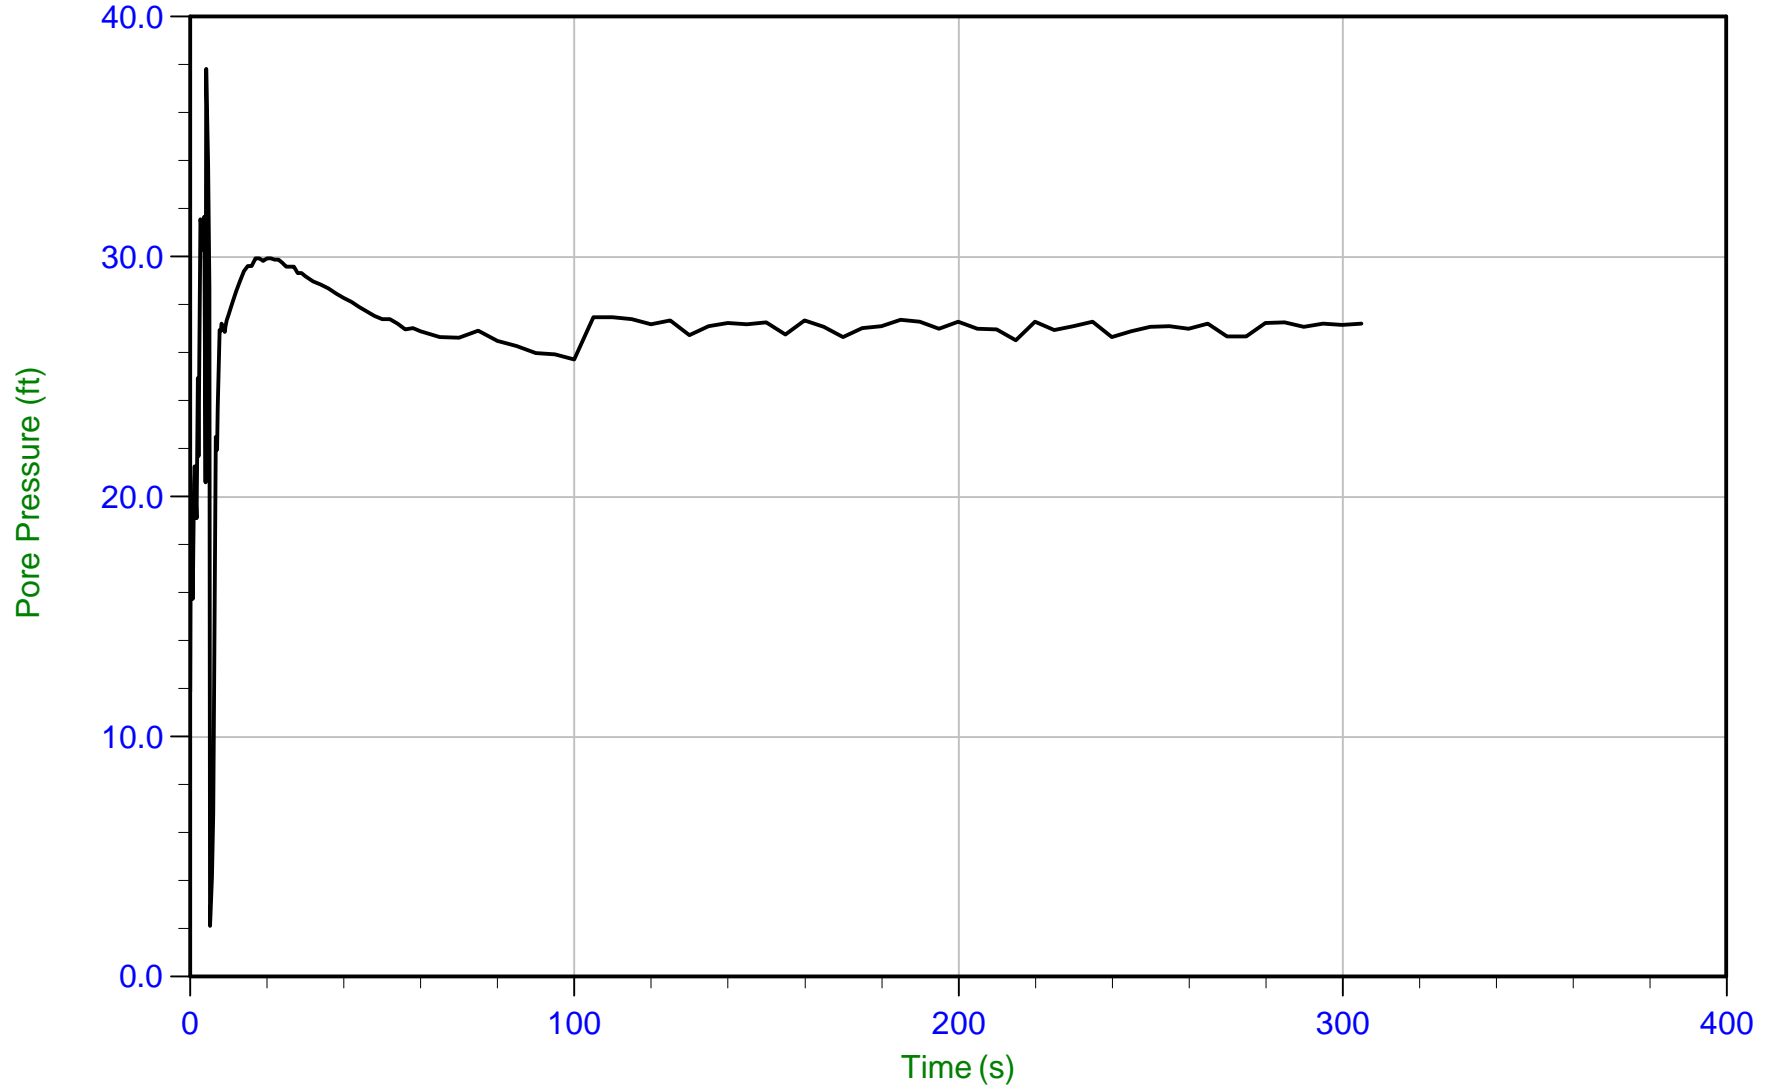
Sounding: CPT-03
Cone: 781:T1500F15U35 Area=15 cm²

Filename: 22-59-23911_CP03.ppd2
Depth: 9.275 m / 30.429 ft
Duration: 305.0 s
