HYDROGEOLOGIC REPORT

ARCO AMPM, PUYALLUP, WASHINGTON

Project No. M2303.02

CRITICAL AQUIFER RECHARGE AREA
HYDROGEOLOGIC REPORT

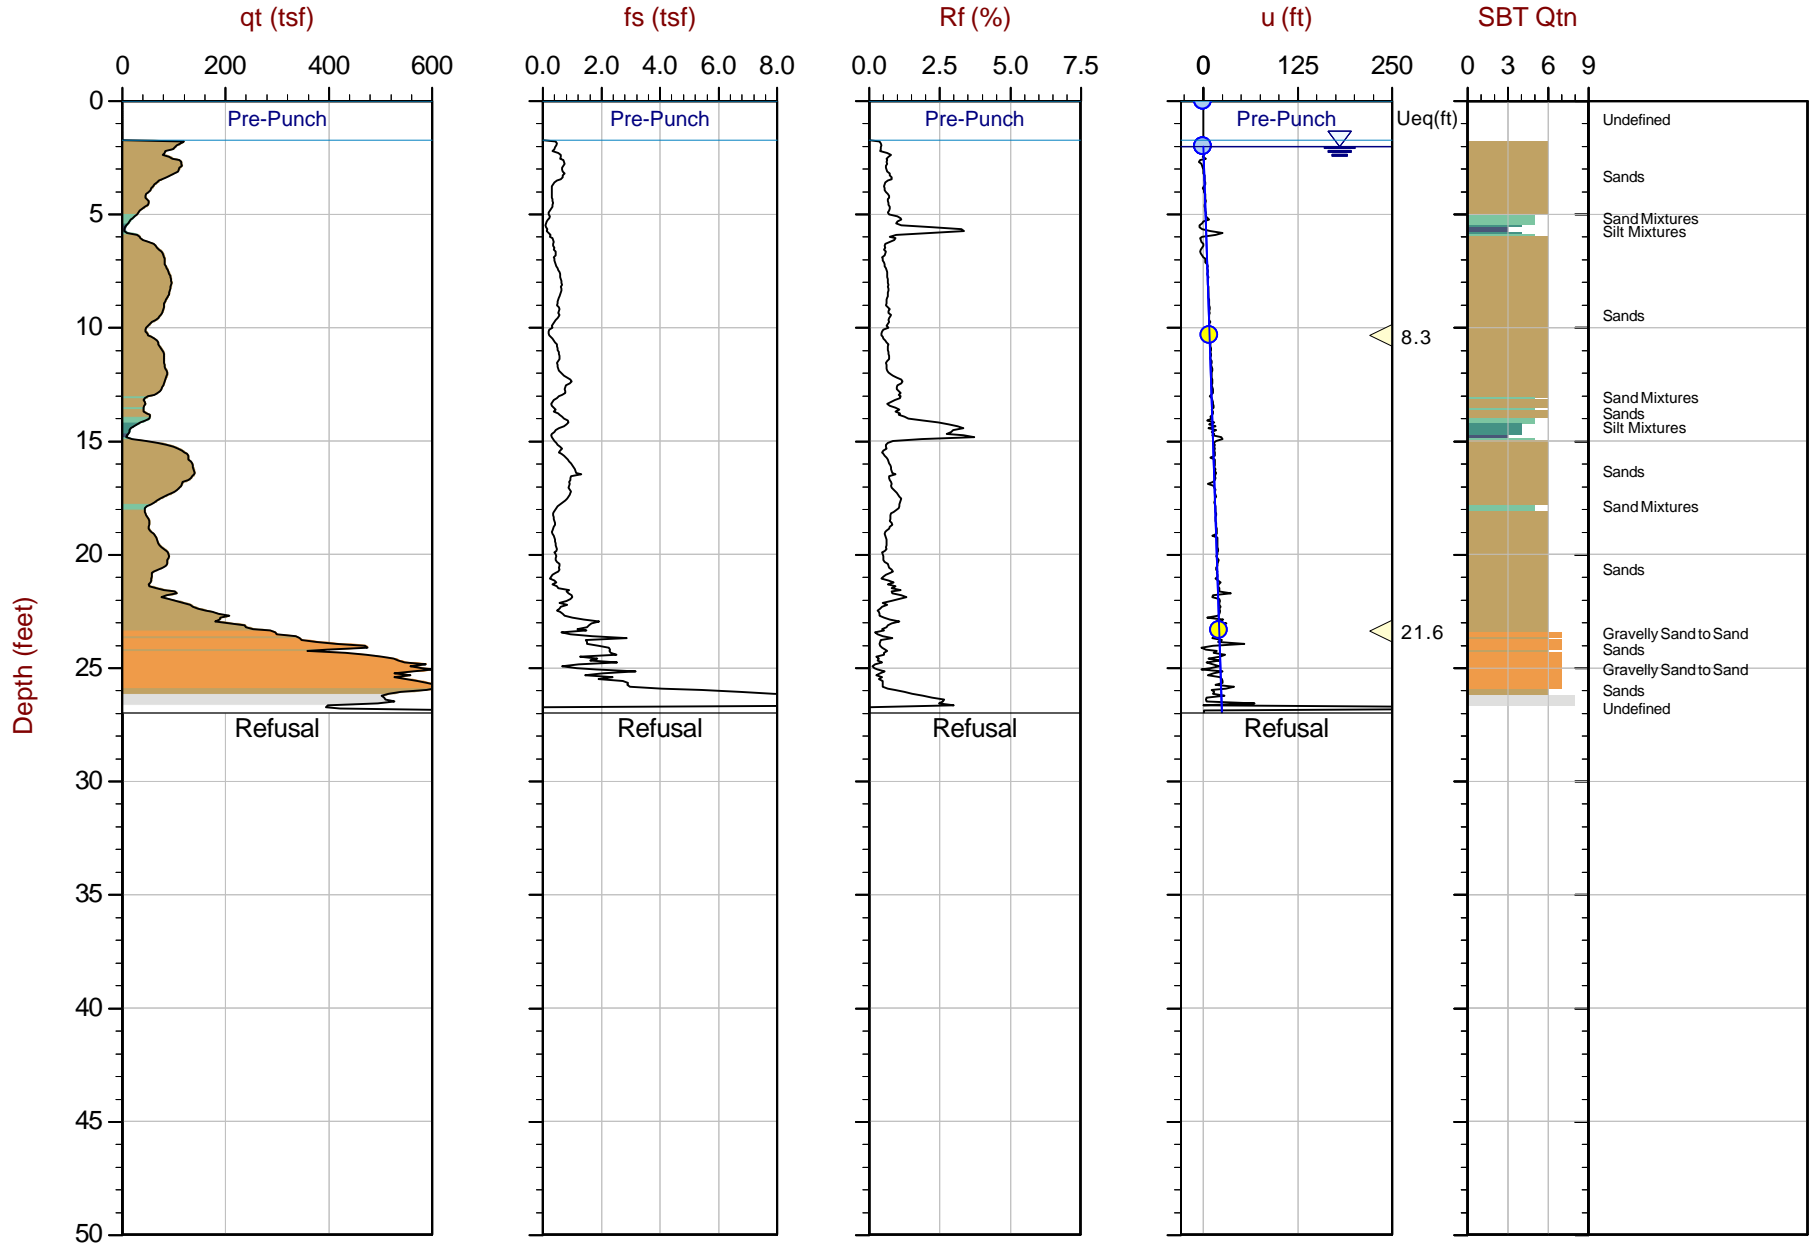
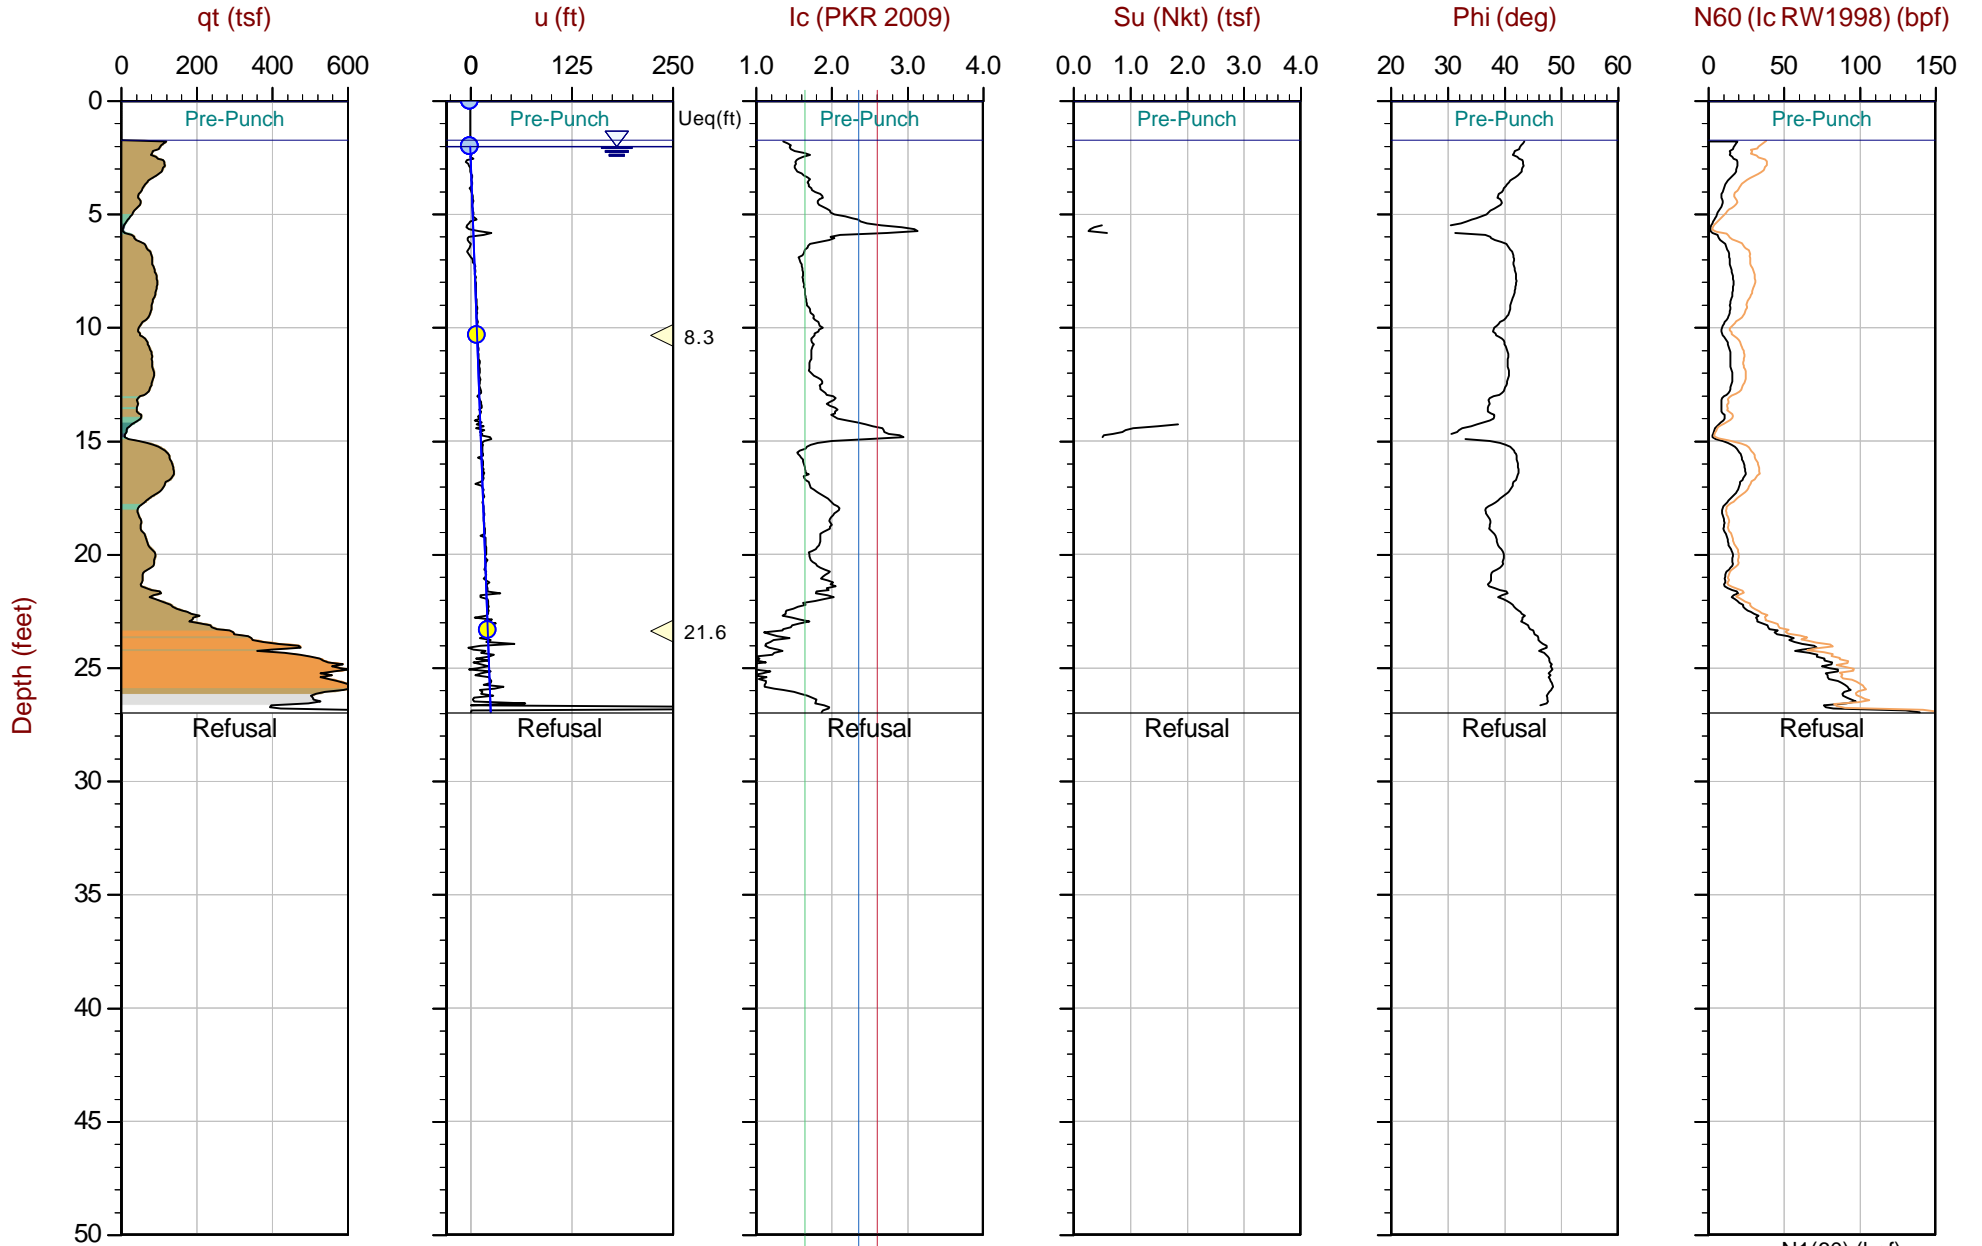
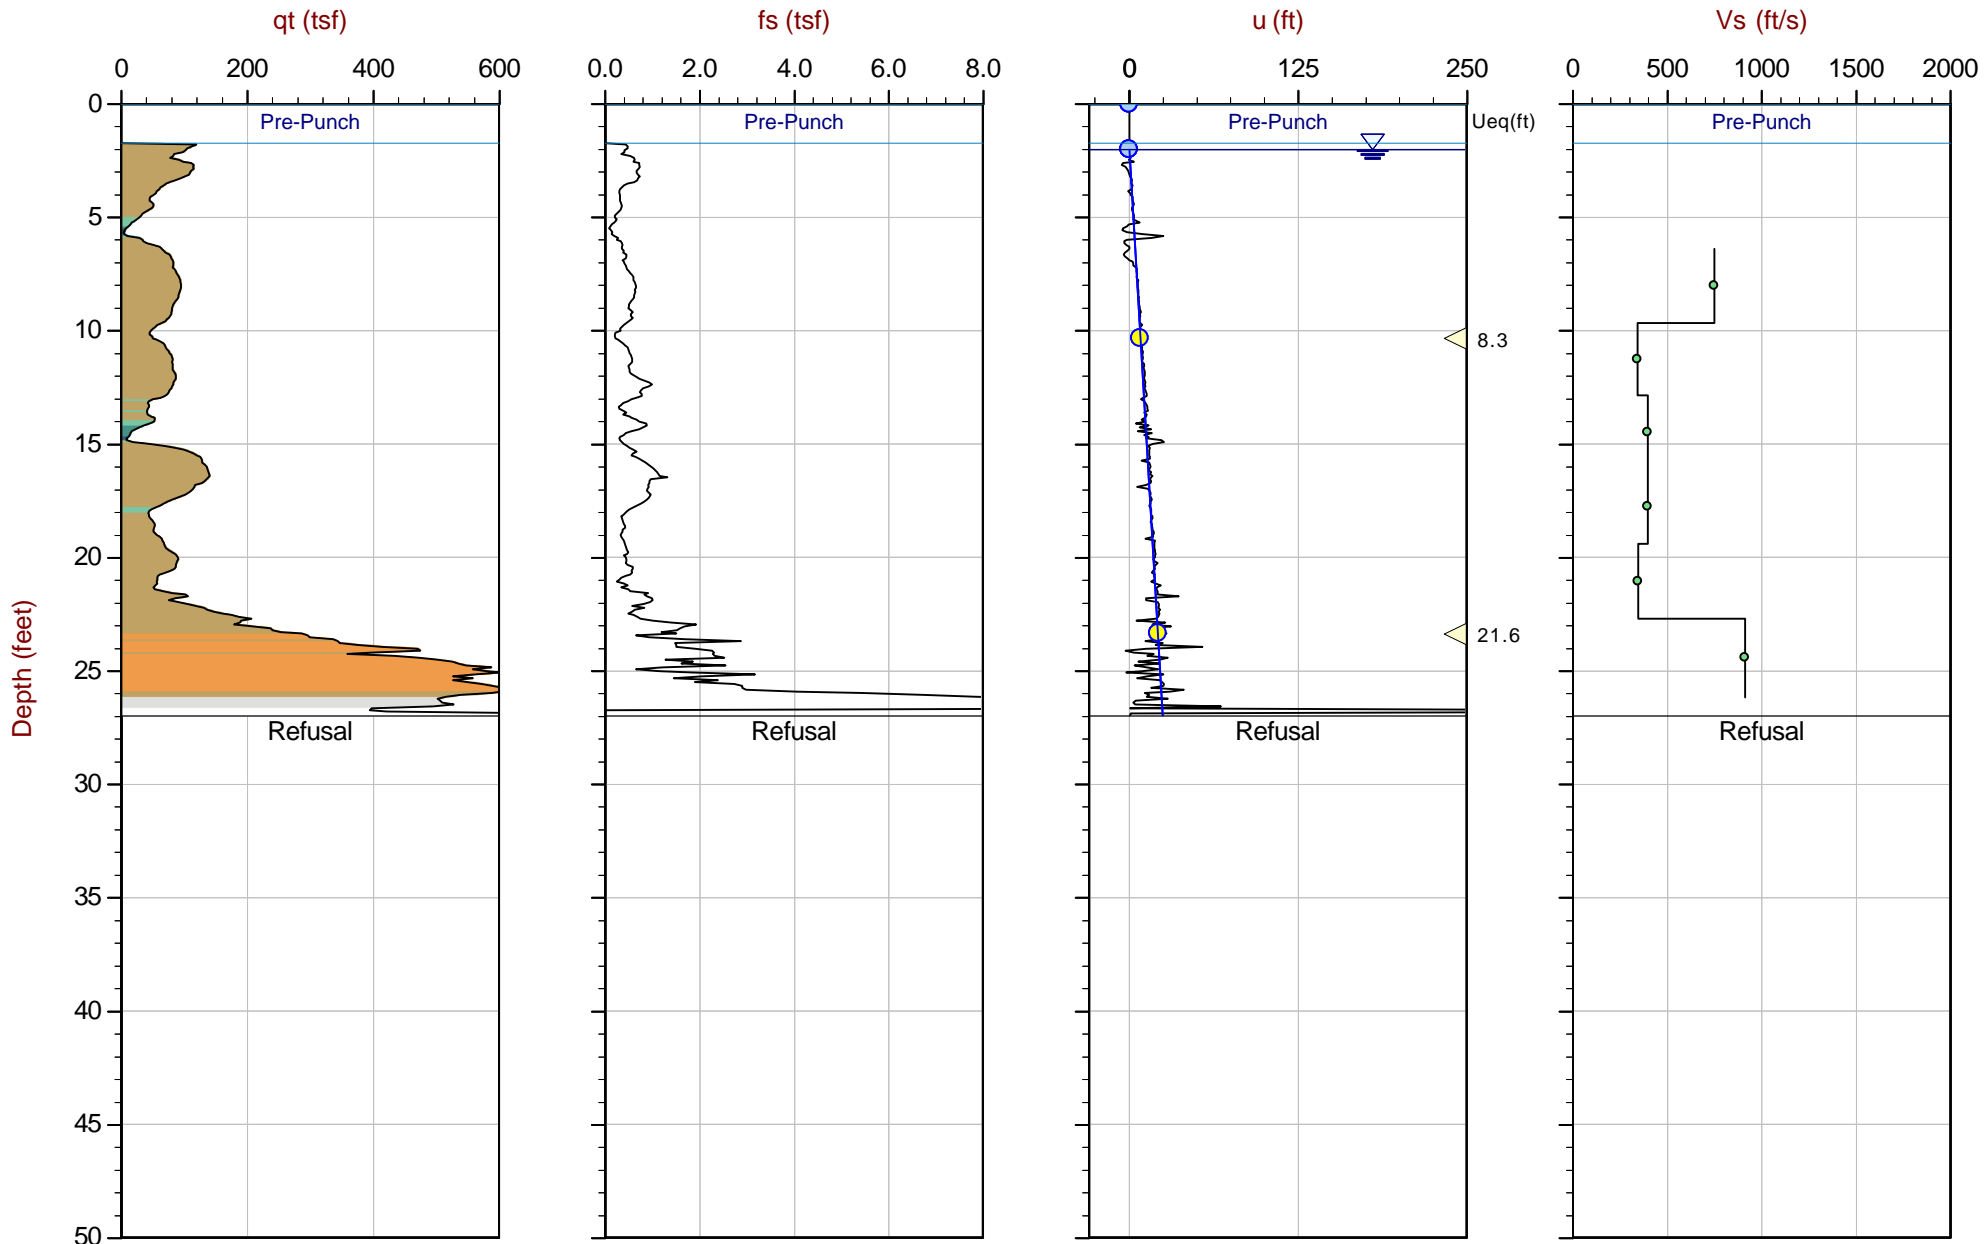
Sounding: CPT-04
Cone: 781:T1500F15U35

Max Depth: 8.225 m / 26.98 ft
Depth Inc: 0.025 m / 0.082 ft
Avg Int: Every Point

Asphalt Pavement and Undocumented Fill: CPT-4, CPT-5, and IP-2 were conducted within the paved areas of the site and encountered 3 to 3.5 inches of asphalt pavement underlain by 6 to 7.5 inches of moist, brown, silty sand (SM) with gravel base course material. Up to roughly 3 feet of undocumented fill was encountered beneath the base course material and at the ground surface in the remaining explorations.

Shear Wave Velocity: Shear wave velocity were obtained from the CPT-2B, CPT-4, and CPT-5, which were advanced to depths of about 27.0 to 46.3 feet bgs. The shear wave velocities were measured to the maximum explored depth, and we have assumed similar site conditions continue below the explored depth. The measured shear wave velocities to the maximum explored depth ranged from about 333 feet per second to 1680 feet per second. The average measured shear wave velocities in the upper 100 feet were estimated to be in the range of 778 to 1217 feet per second.

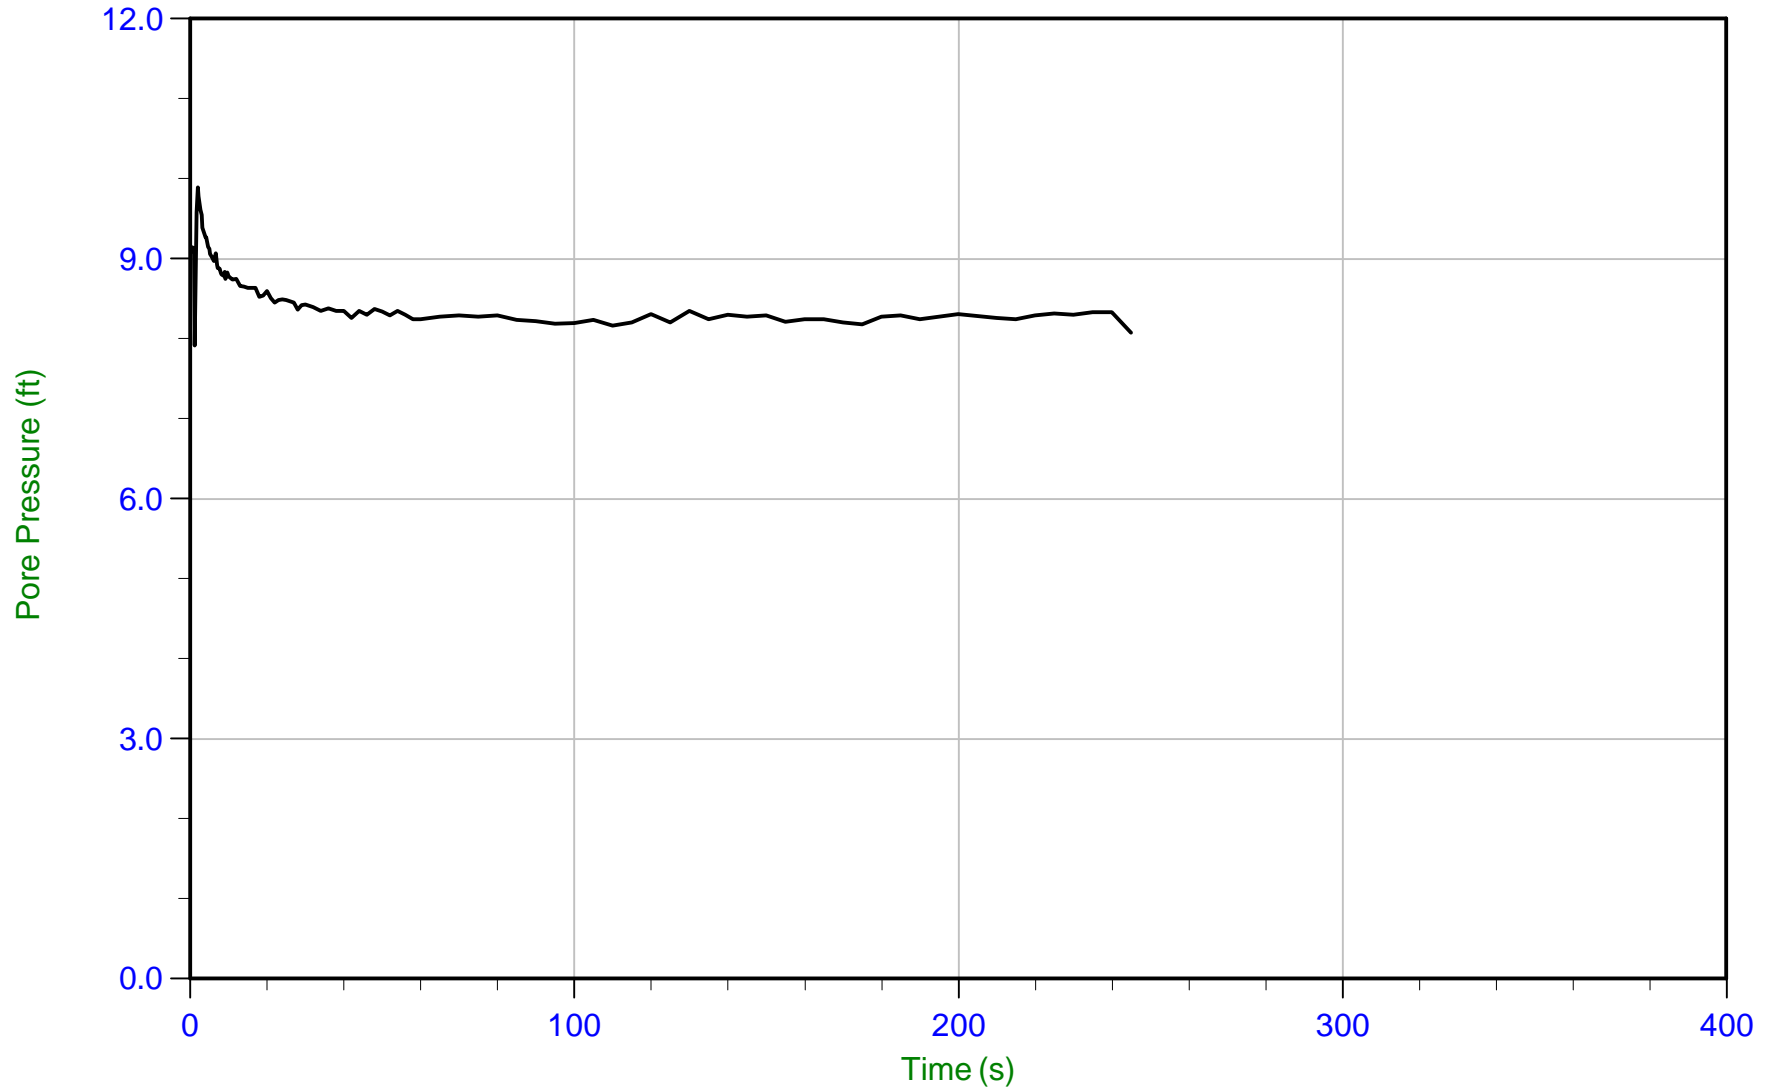
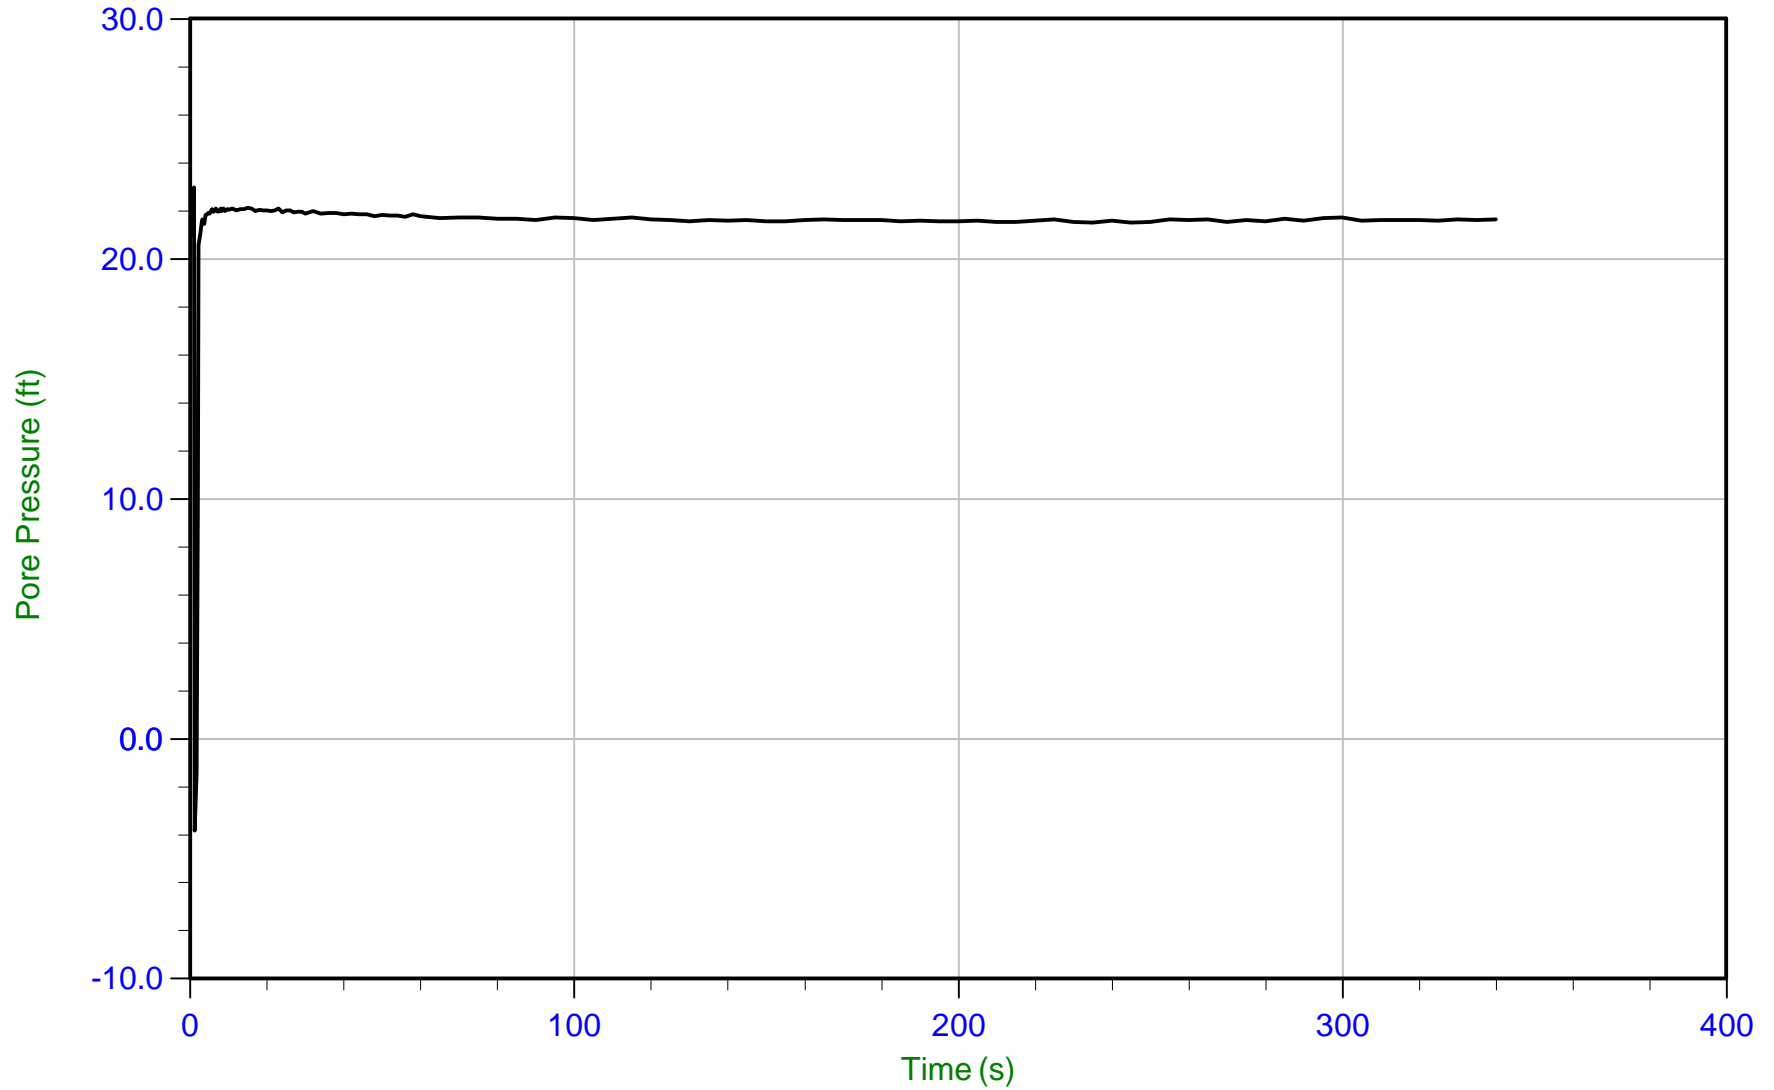
Sounding: CPT-04
Cone: 781:T1500F15U35 Area=15 cm²

Filename: 22-59-23911_SP04.ppd2
Depth: 3.150 m / 10.335 ft
Duration: 245.0 s

Filename: 22-59-23911_SP04.ppd2
Depth: 7.125 m / 23.376 ft
Duration: 340.0 s

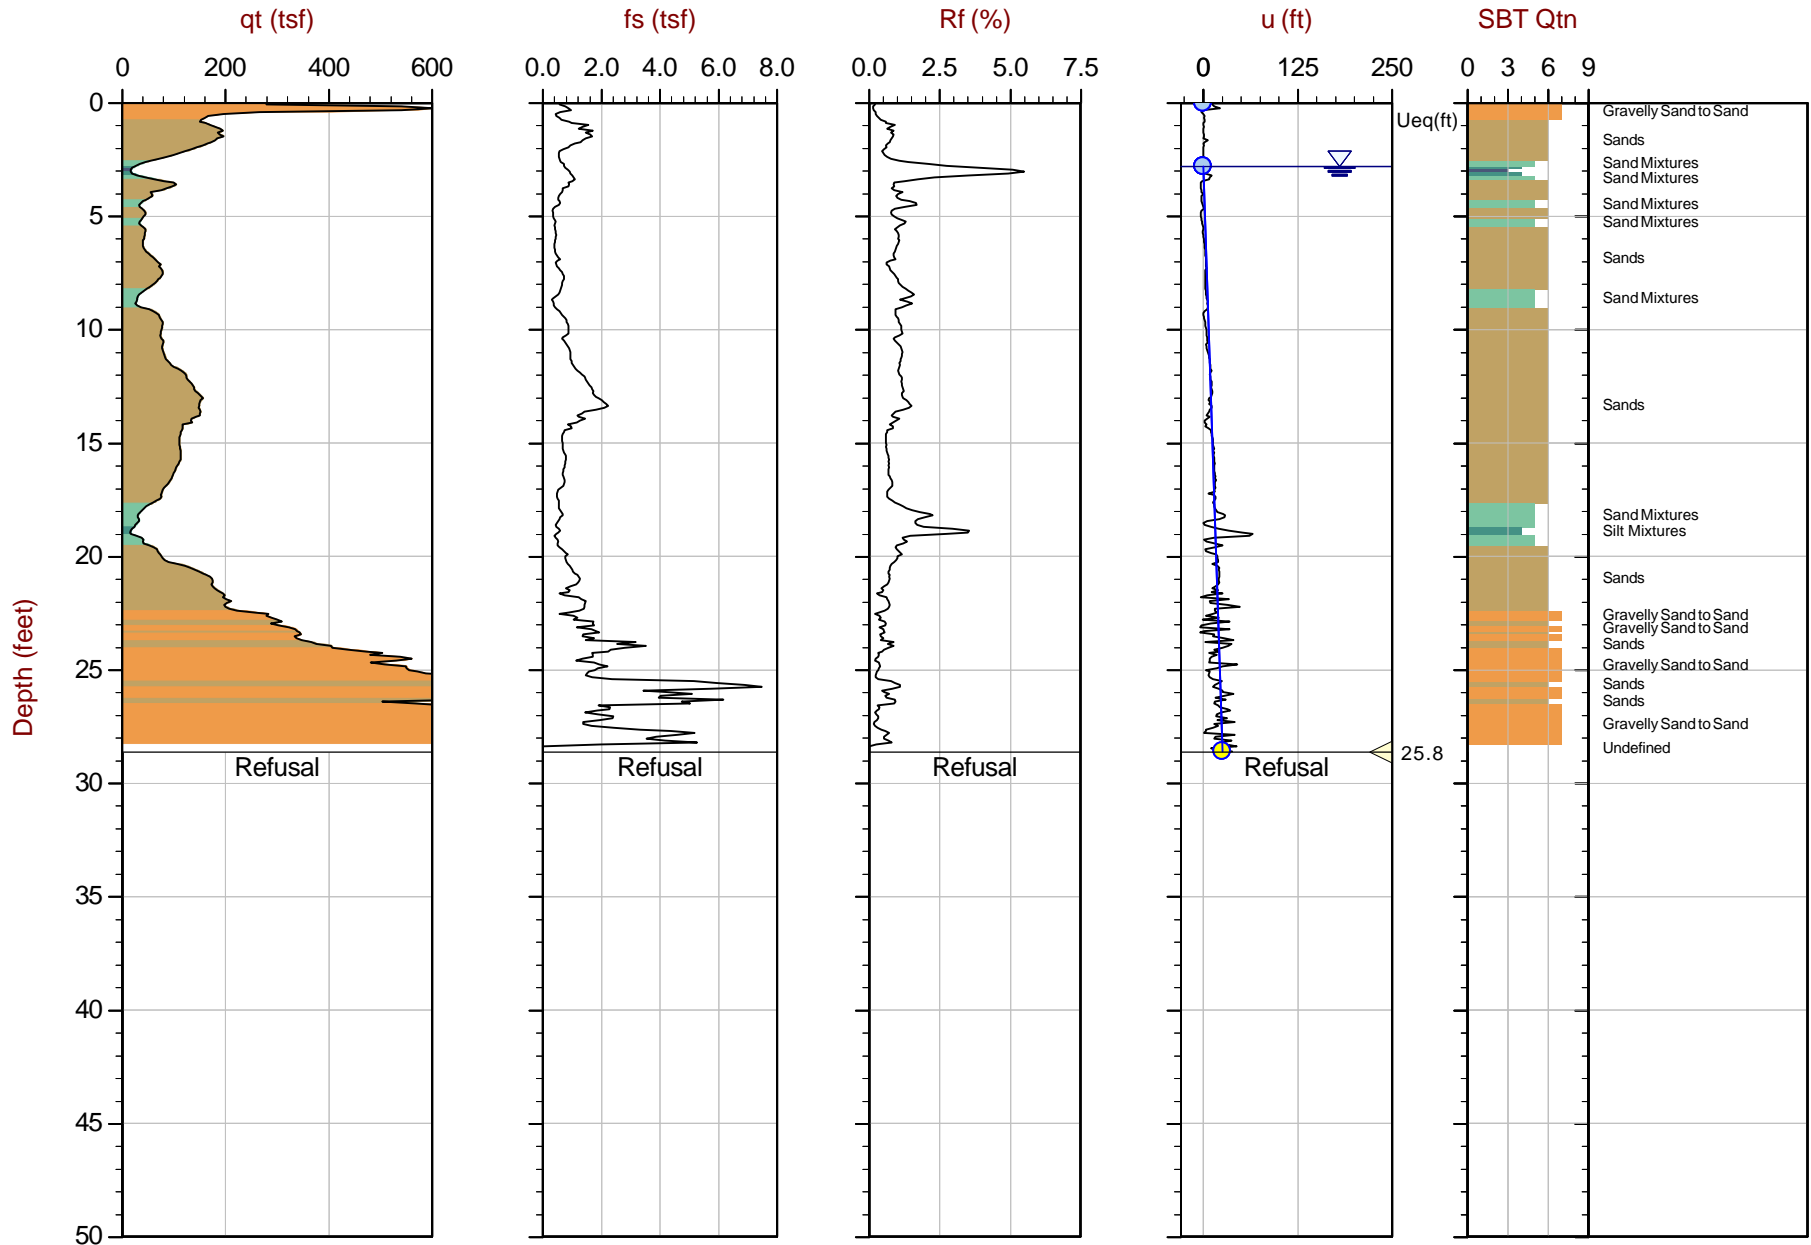
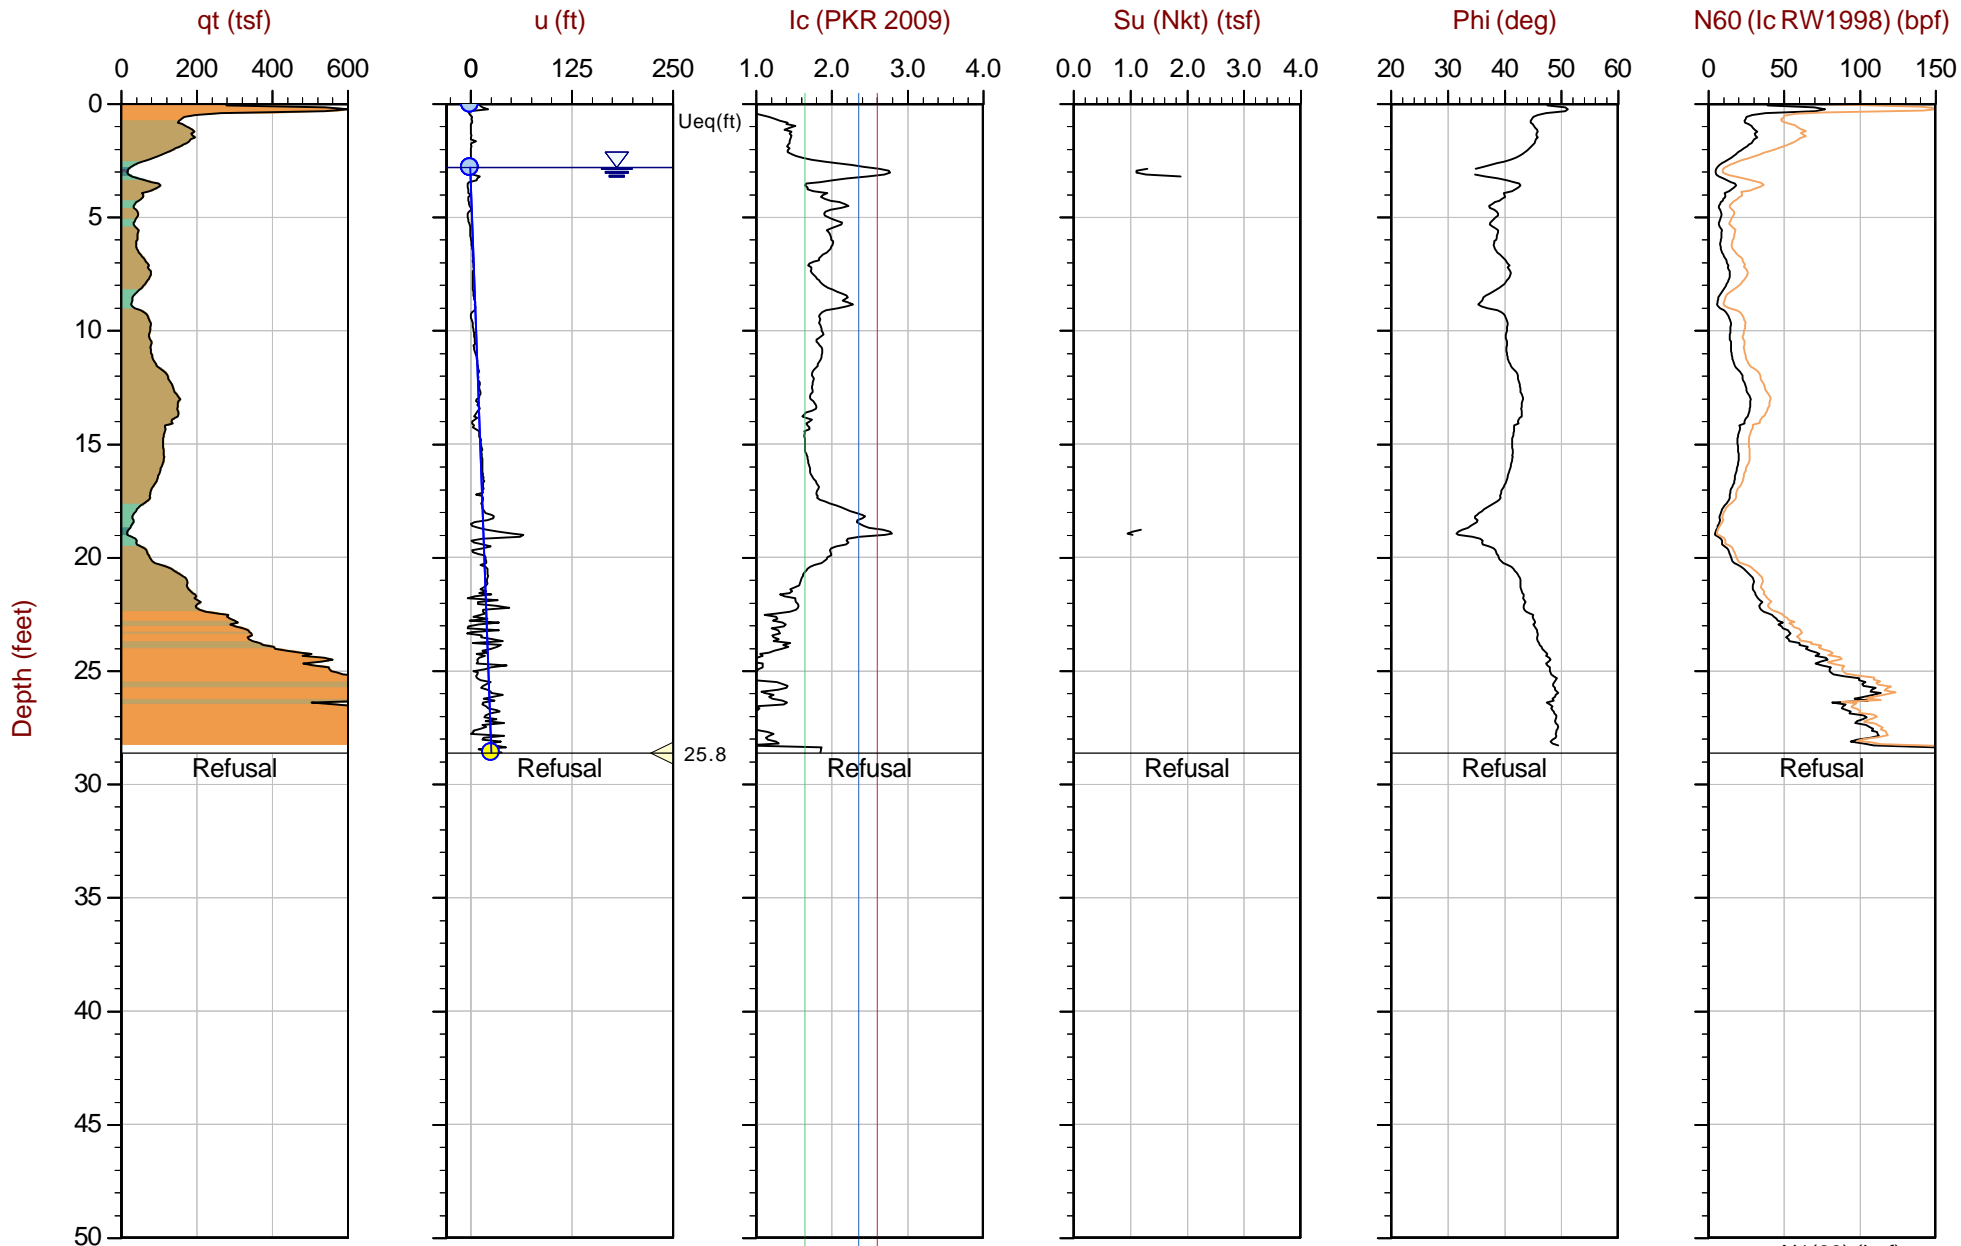
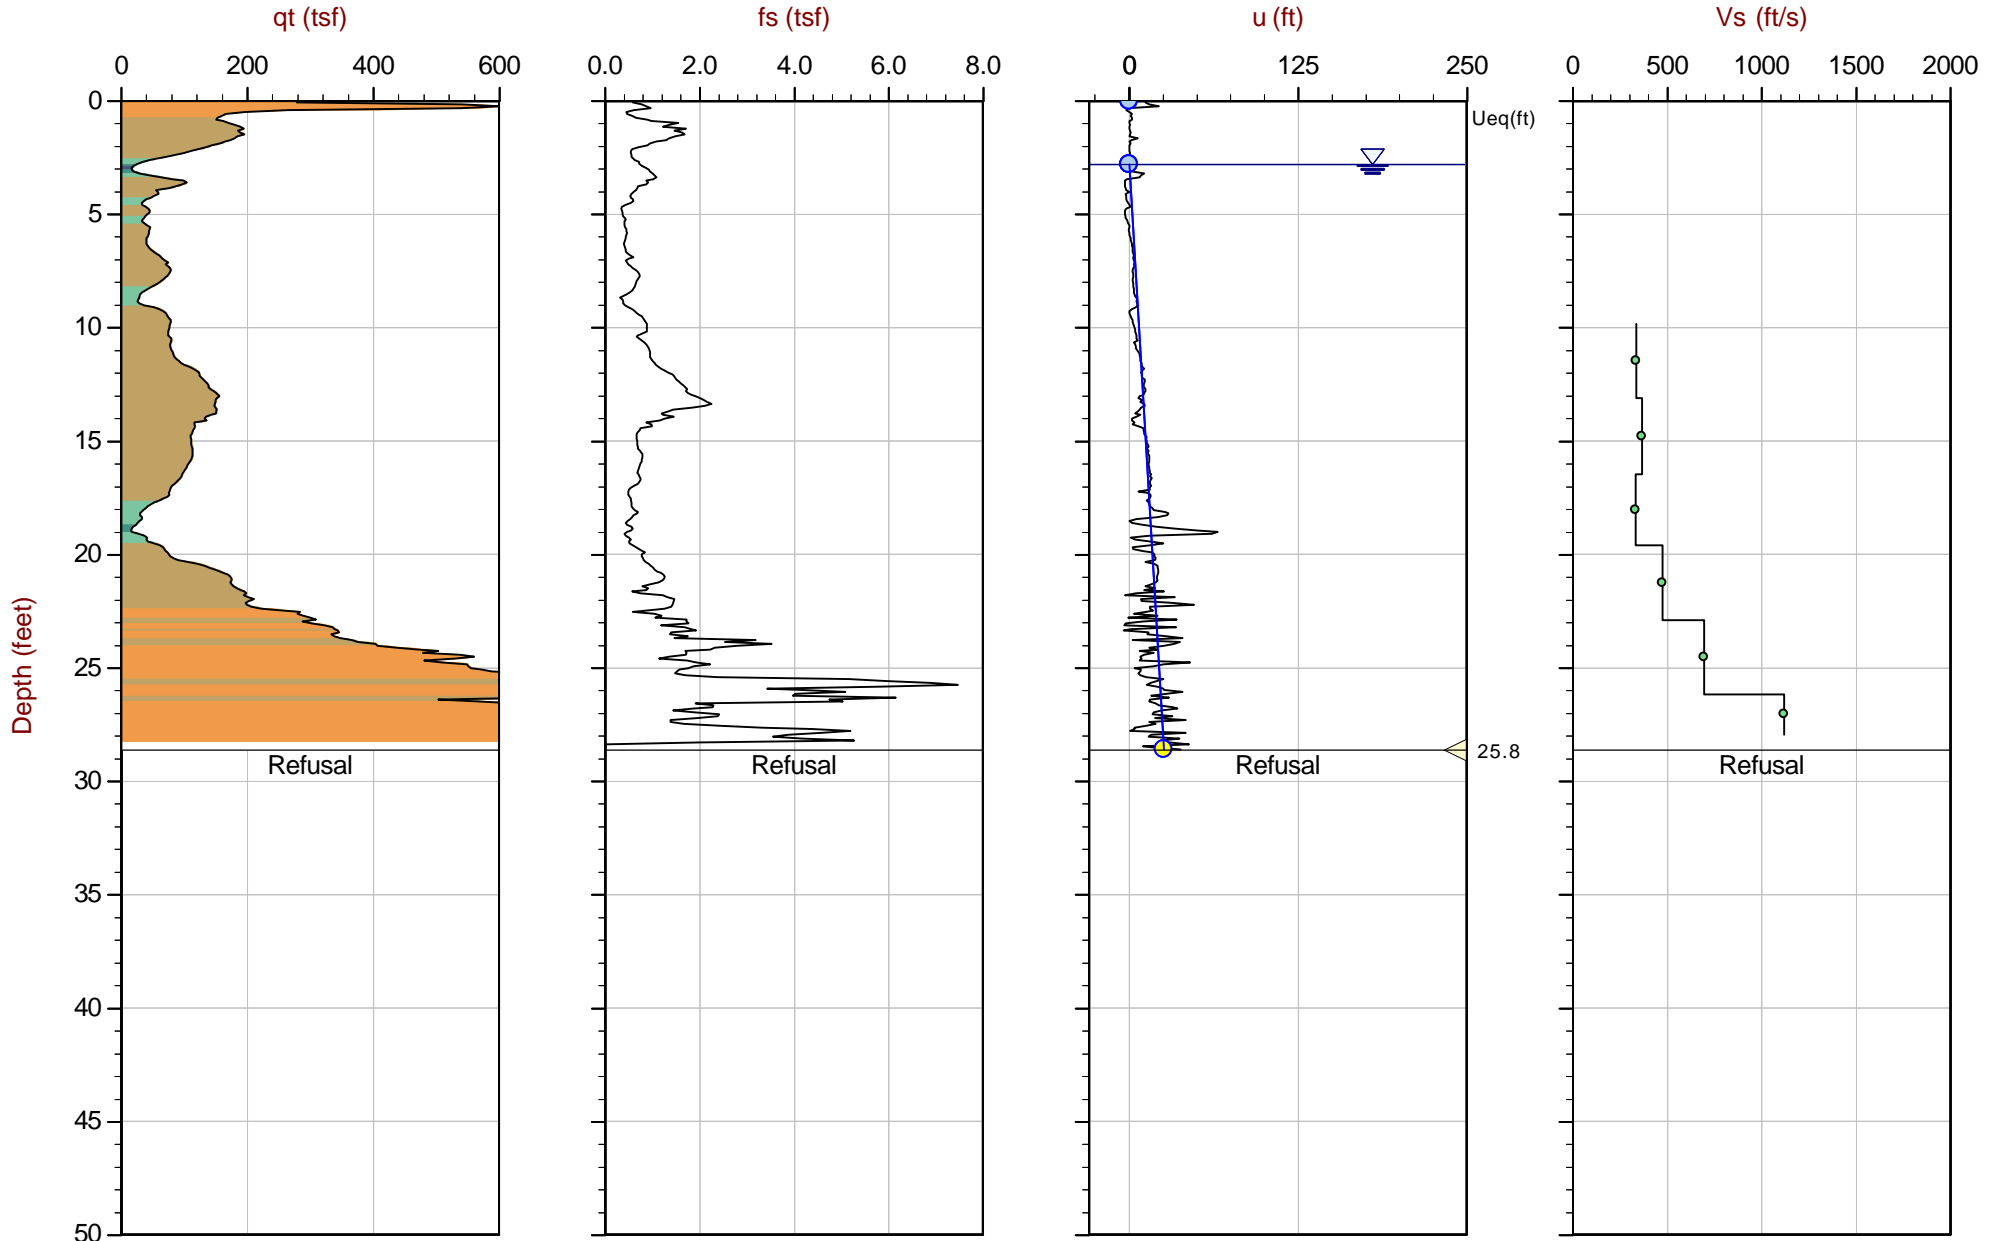
Sounding: CPT-05
Cone: 781:T1500F15U35

Max Depth: 8.725 m / 28.62 ft
Depth Inc: 0.025 m / 0.082 ft
Avg Int: Every Point

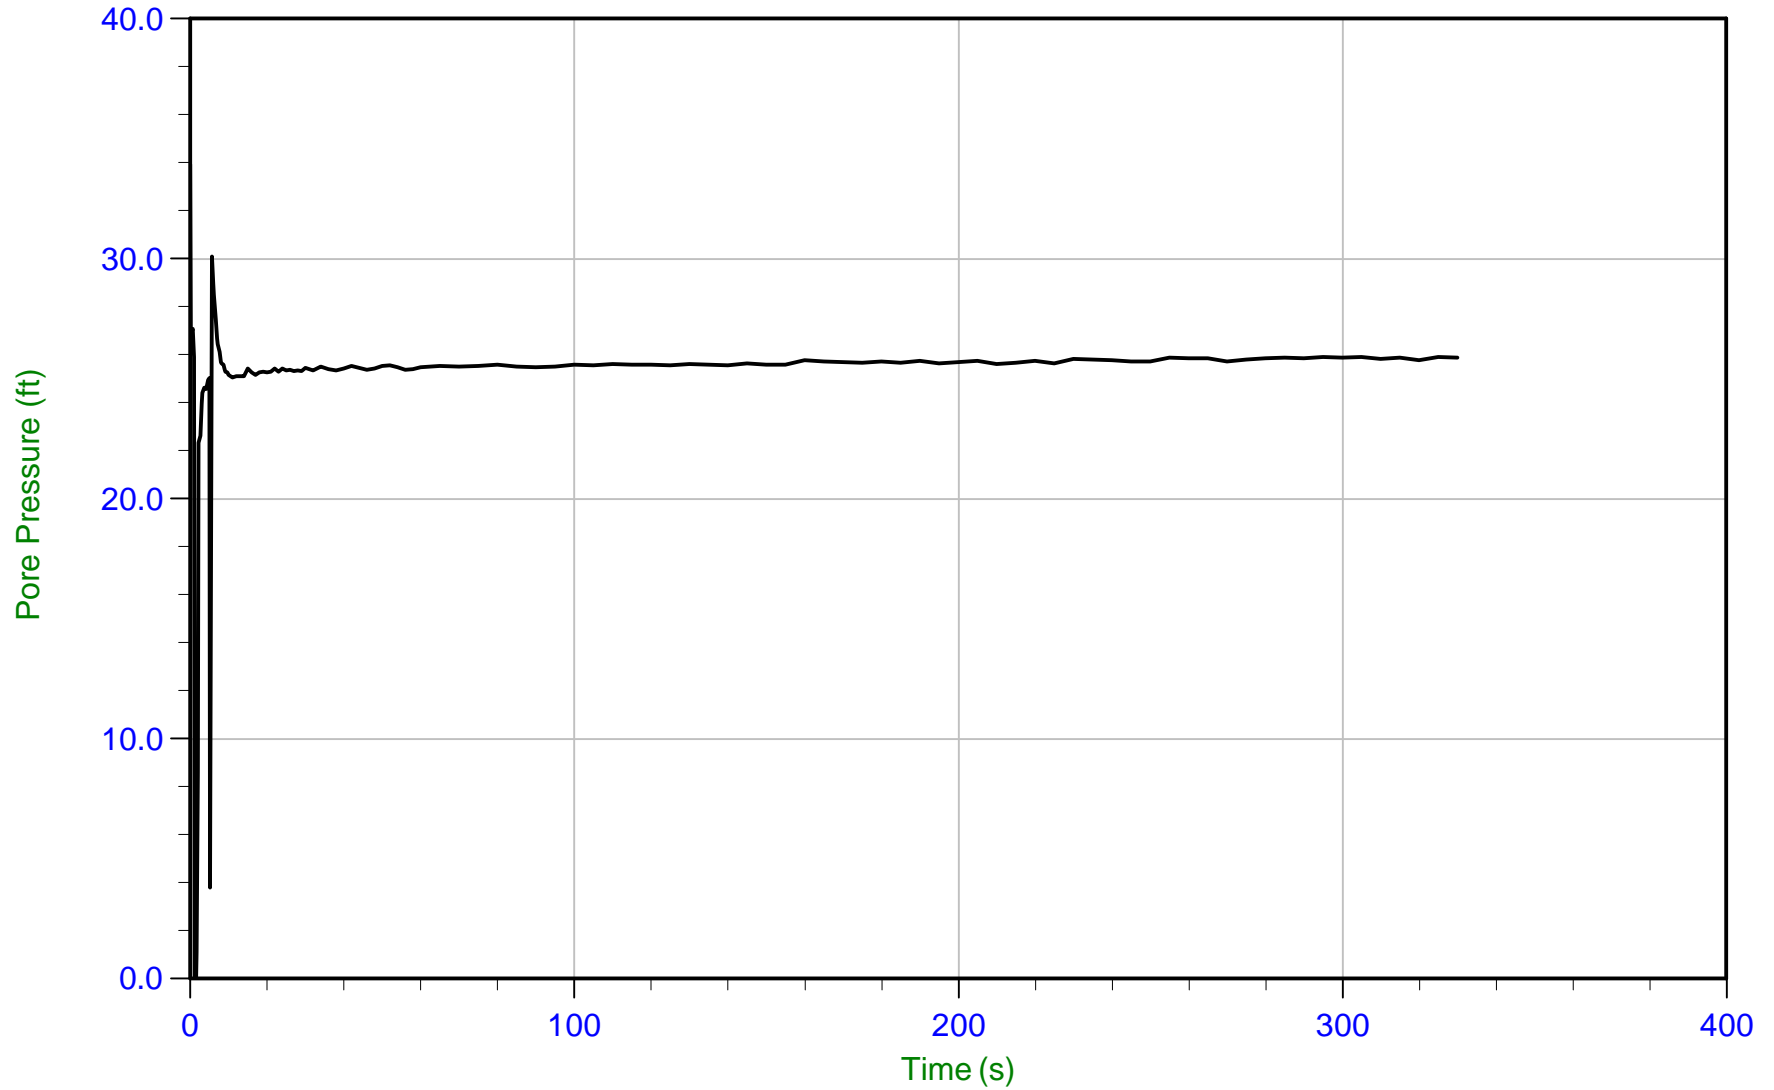
Sounding: CPT-05
Cone: 781:T1500F15U35 Area=15 cm²

Filename: 22-59-23911_SP05.ppd2
Depth: 8.725 m / 28.625 ft
Duration: 330.0 s

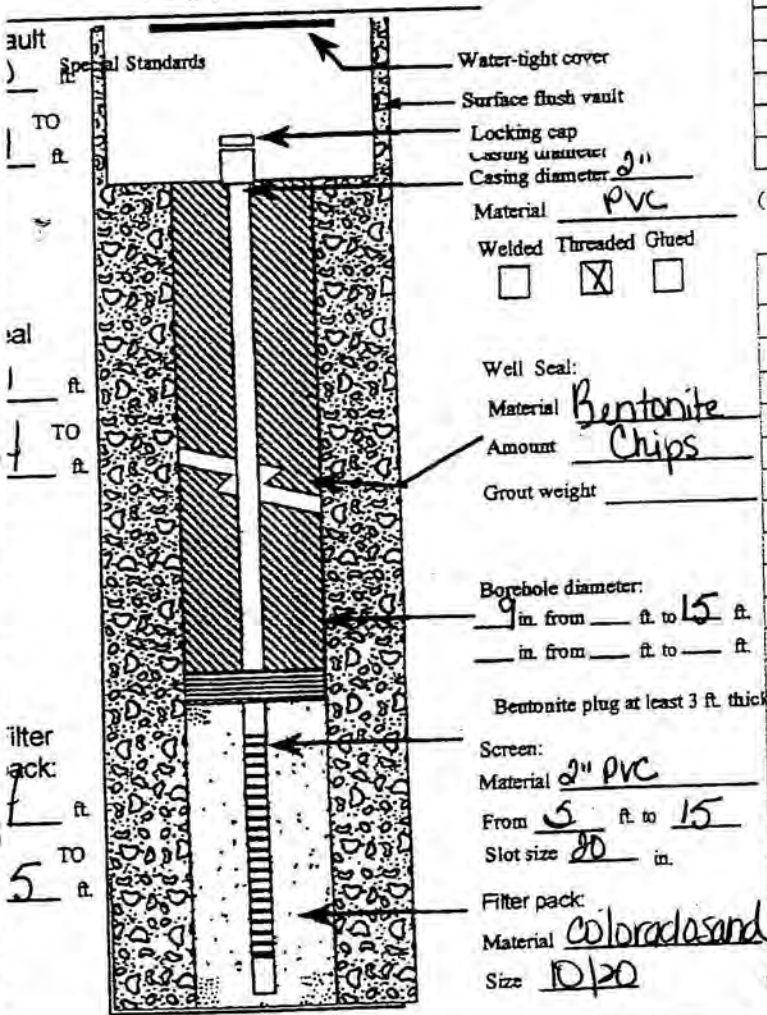
(9) WELL LOG:

Local Standards Yes No Depth of Completed Well 15 ft.

Material	Ground Elevation		SWL
	From	To	
<u>Brown Silty Sand</u>	<u>0</u>	<u>10</u>	
<u>Wet Coarse Sand</u>	<u>10</u>	<u>15</u>
