**UPDATED GEOTECHNICAL ENGINEERING STUDY  
PROPOSED NORMANDY HEIGHTS  
2007 SHAW ROAD  
PUYALLUP, WASHINGTON**

**ES-0593**

**RM HOMES, LLC**

**November 9, 2006  
Updated May 3, 2022**

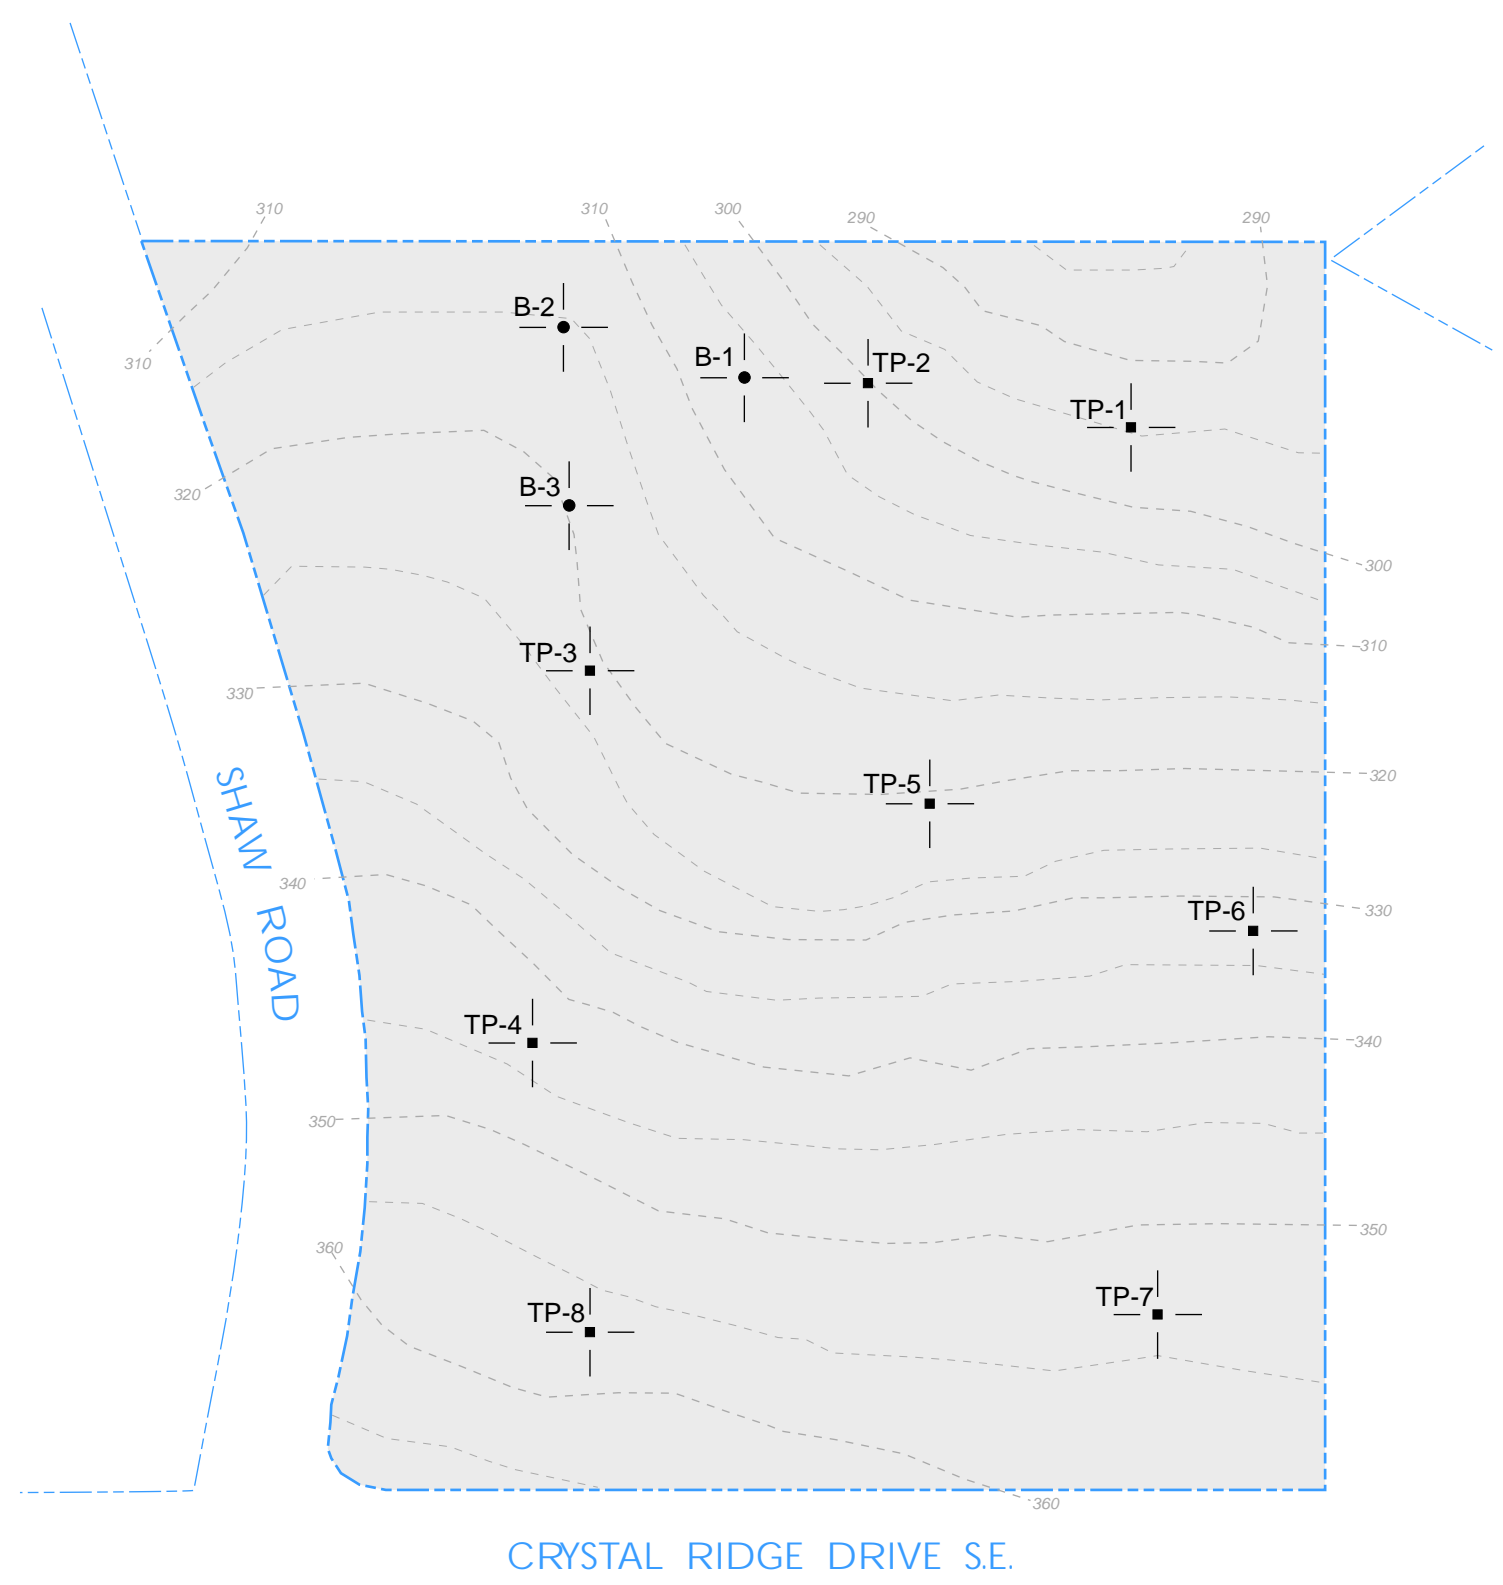
Drwn. By	MRS
Checked By	CGH
Date	05/02/2022
Proj. No.	0593
Plate	2

An ESNW representative observed, logged, and sampled the excavation of eight test pits on October 23, 2006 and three borings near the proposed stormwater facility on February 8, 2022. Both explorations were completed with machinery and operators retained by our firm. The borings were installed to monitor groundwater conditions near the proposed stormwater facility under a separate project phase (ES-593.03). The approximate locations of the explorations are depicted on Plate 2 (Subsurface Exploration Plan). Representative soil samples collected at the test pit and boring locations were analyzed in general accordance with Unified Soil Classification System (USCS) and USDA methods and procedures.

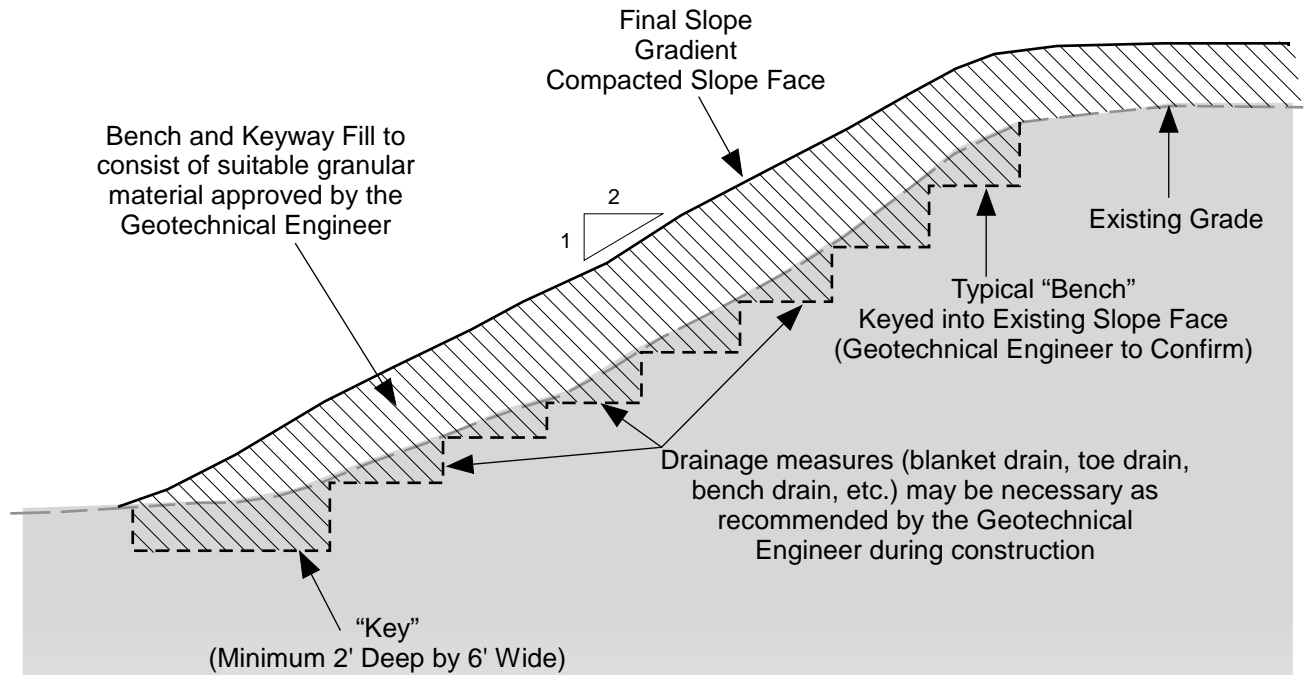
<b>Earth Solutions NW<sub>LLC</sub></b> Geotechnical Engineering, Construction Observation/Testing and Environmental Services	
<b>Slope Fill Detail          Normandy Heights          Puyallup, Washington</b>			
Drwn. MRS	Date 05/02/2022	Proj. No. 0593	
Checked SSR	Date May 2022	Plate 3

- Slope should be stripped of topsoil and unsuitable materials prior to excavating Keyway or benches.
- Benches will typically be equal to a bulldozer blade width of approximately 8 feet but shall be at least 4 feet.

- Structural fill should be placed in thin loose lifts not exceeding 12 inches in thickness. Each lift should be compacted to no less than the degree specified in the "Site Preparation and Earthwork" section of this report. No additional lift should be placed until compaction is achieved.

Structural fill within unregulated sloping areas on this site should be placed on a level bench as depicted on Plate 3 (Slope Fill Detail). Benches must be “keyed” into the slope, and subsequently filled and compacted with suitable structural fill before continuing to the next bench. Sloping finish grades should be “overbuilt” using a bench-style fill and cut to the design gradient to ensure a compacted slope face is maintained. ESNW should review the final grading plans to confirm the recommendations in this report have been incorporated. ESNW should observe structural fill placement to confirm subgrade conditions and provide additional drainage recommendations, as necessary.

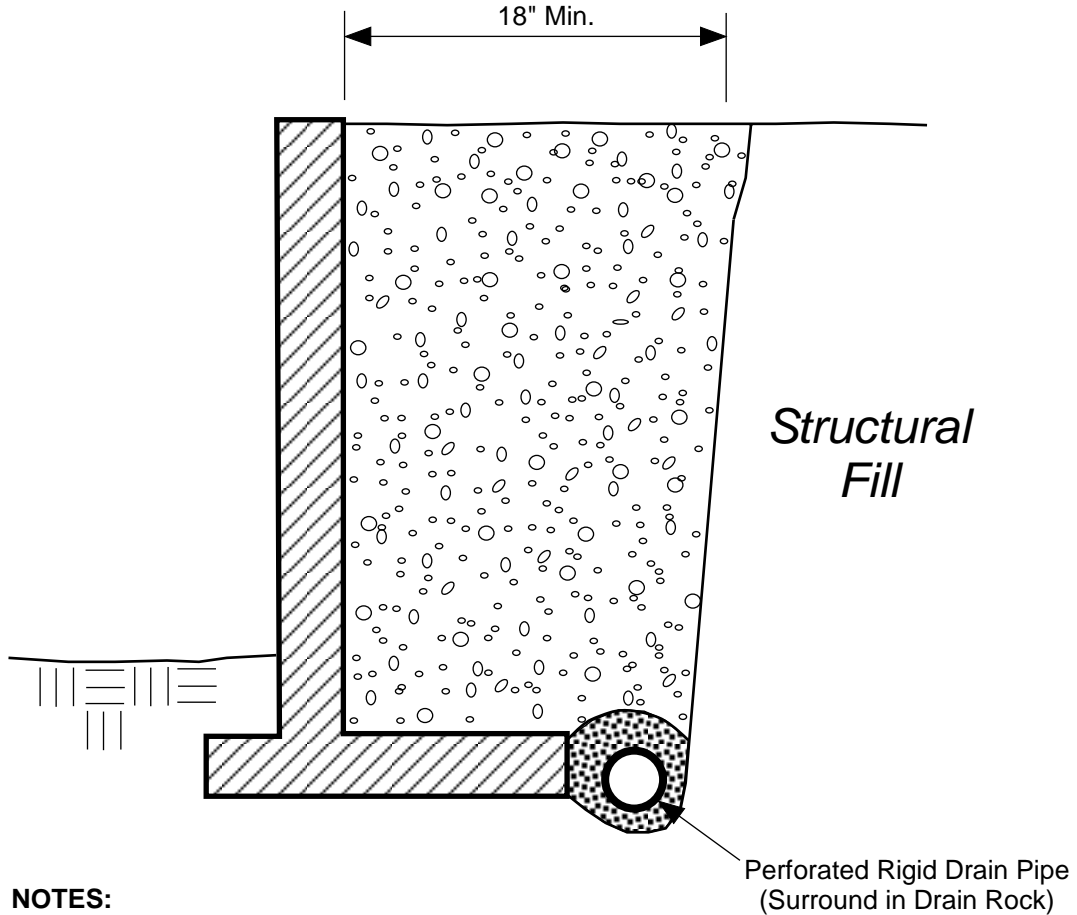
<b>Earth Solutions NW<sub>LLC</sub></b> Geotechnical Engineering, Construction Observation/Testing and Environmental Services	
<b>Retaining Wall Drainage Detail</b> <b>Normandy Heights</b> <b>Puyallup, Washington</b>			
Drwn. MRS	Date 05/02/2022	Proj. No. 0593	
Checked SSR	Date May 2022	Plate 4

- Free-draining Backfill should consist of soil having less than 5 percent fines. Percent passing No. 4 sieve should be 25 to 75 percent.
- Sheet Drain may be feasible in lieu of Free-draining Backfill, per ESNW recommendations.
- Drain Pipe should consist of perforated, rigid PVC Pipe surrounded with 1-inch Drain Rock.

Retaining walls should be backfilled with free-draining material that extends along the height of the wall and a distance of at least 12 inches behind the wall. The upper one foot of the wall backfill may consist of a less permeable (surface seal) soil, if desired. In lieu of free-draining backfill, use of an approved sheet drain material may also be considered, based on the observed subsurface and groundwater conditions. ESNW should review conditions at the time of construction and provide recommendations for sheet drain material, as appropriate. A perforated drainpipe should be placed along the base of the wall and connected to an appropriate discharge location. A typical retaining wall drainage detail is illustrated on Plate 4.

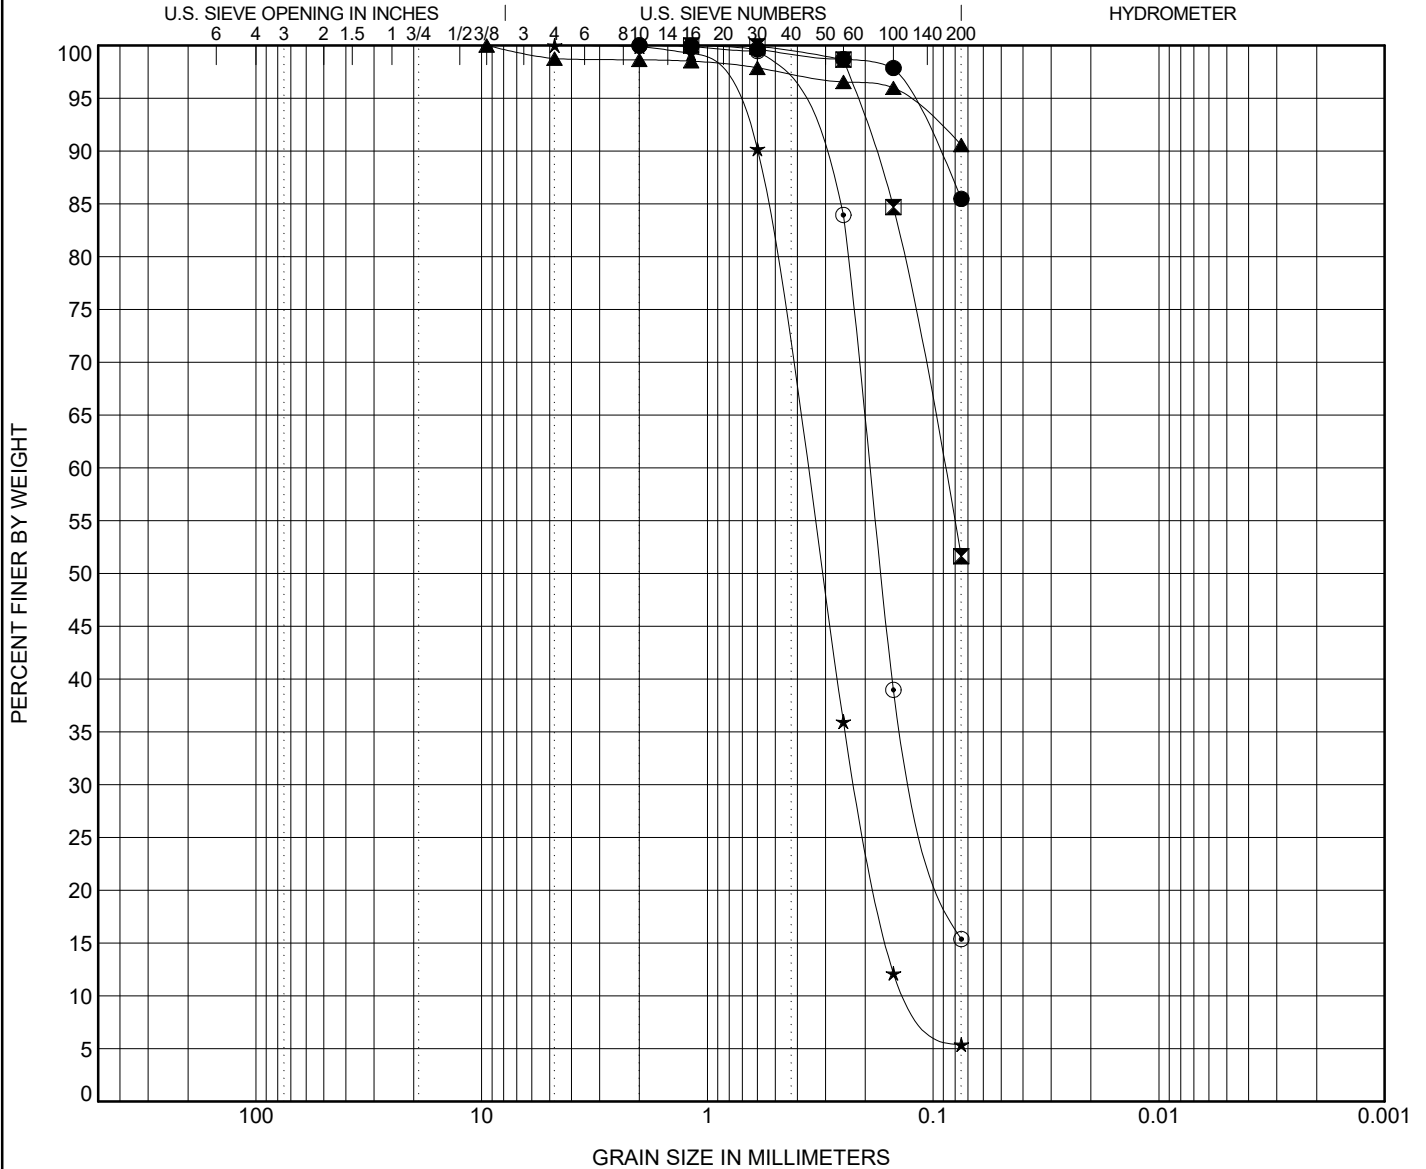
Specimen Identification	Classification						Cc	Cu
● B-01 5.00ft.	USDA: Brown Loam. USCS: ML.							
☒ B-01 15.00ft.	USDA: Gray Loam. USCS: Sandy ML.							
▲ B-02 10.00ft.	USDA: Brown Slightly Gravelly Loam. USCS: ML.							
★ B-02 20.00ft.	USDA: Gray Slightly Gravelly Sand. USCS: SP-SM.						1.09	3.06
⊙ B-03 10.00ft.	USDA: Gray Loamy Fine Sand. USCS: SM.

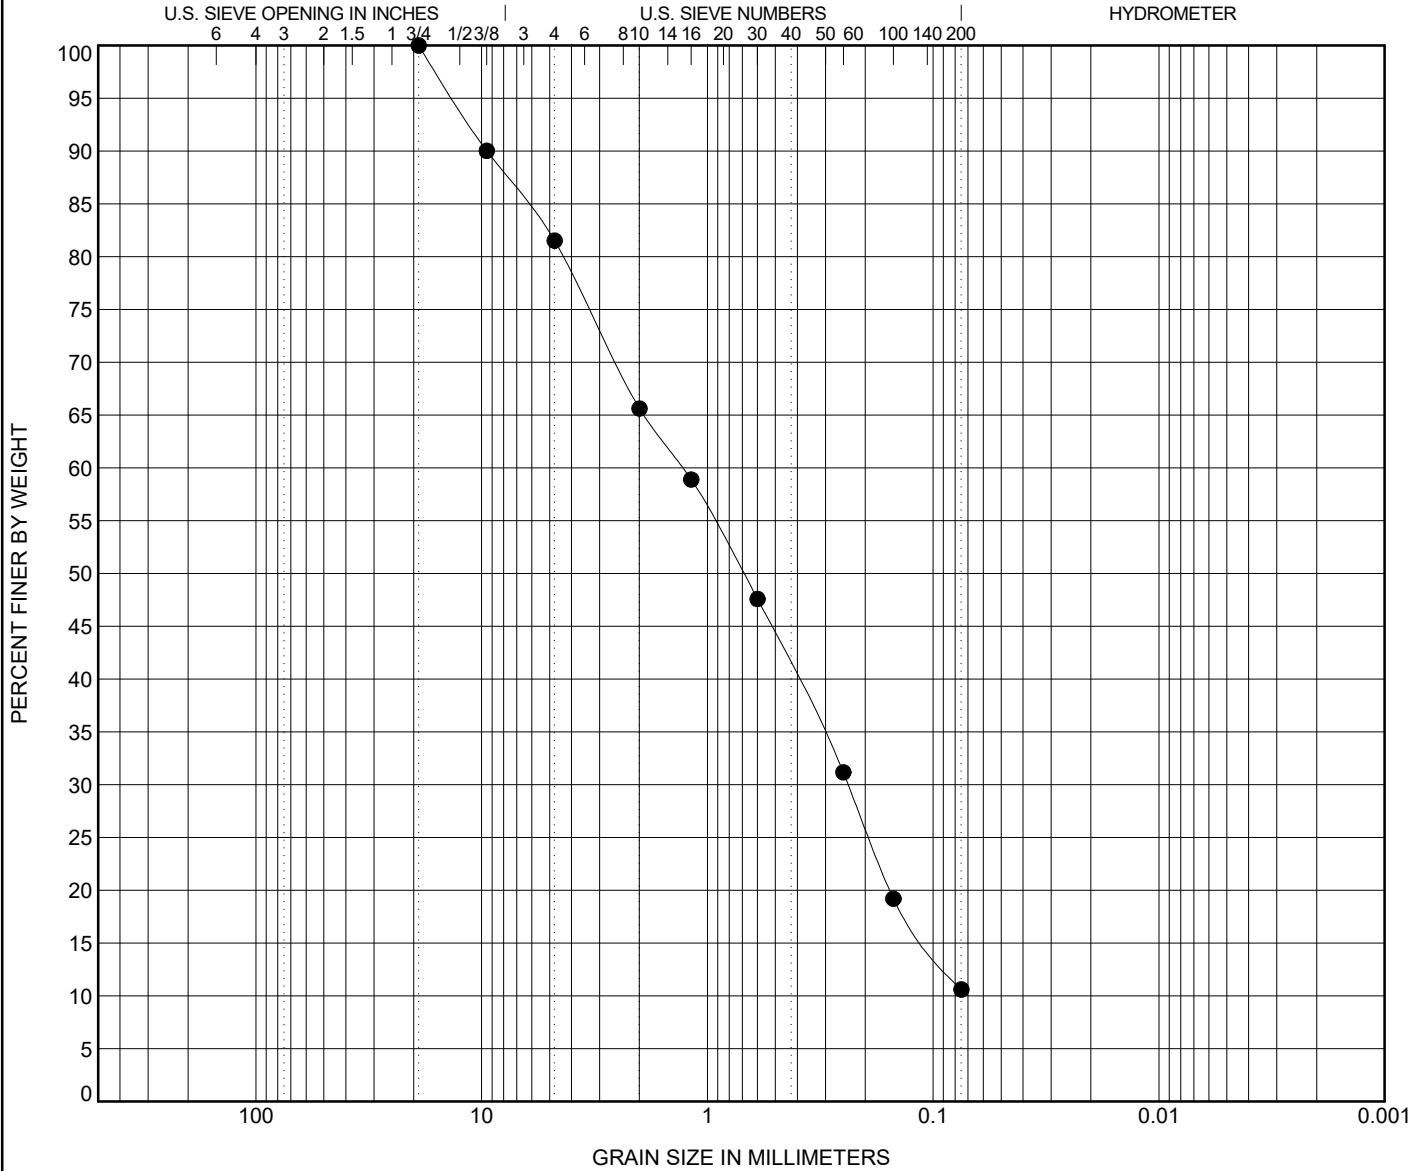
Specimen Identification		Classification							Cc	Cu	
●	<b>B-03</b>	<b>20.00ft.</b>	<b>USDA: Gray Gravelly Loamy Coarse Sand. USCS: SP-SM with Gravel.</b>							<b>0.62</b>	<b>18.02</b>

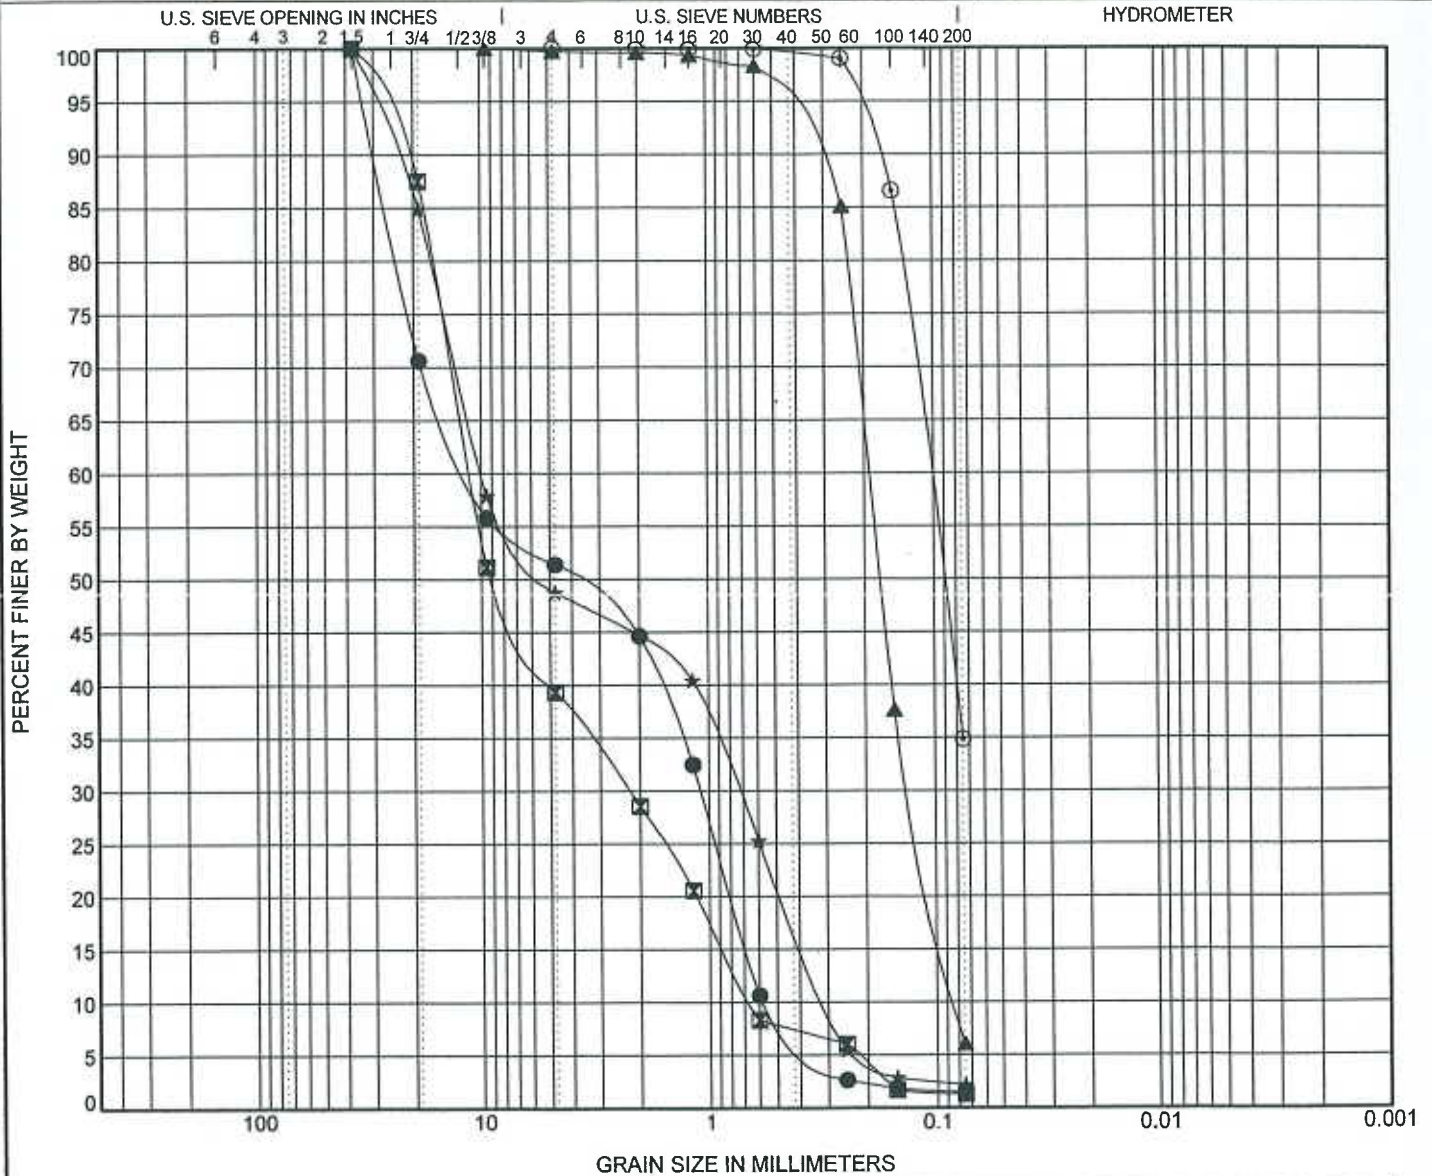
Specimen Identification	Classification					LL	PL	PI	Cc	Cu
● TP-01 10.0ft.	USDA: Brown very gravelly coarse sand, USCS: SP								0.18	20.63
☒ TP-01 17.0ft.	USDA: Light brown extremely gravelly coarse sand, USCS: GP								0.68	17.06
▲ TP-02 8.0ft.	USDA: Light brown fine sand, USCS: SP-SM								1.03	2.33
★ TP-02 11.0ft.	USDA: Gray very gravelly coarse sand, USCS: GP								0.18	32.81
⊙ TP-02 15.0ft.	USDA: Gray fine sandy loam, USCS: SM									
Specimen Identification	D100	D60	D30	D10	%Gravel	%Sand	%Silt	%Clay		
● TP-01 10.0ft.	37.5	11.554	1.093	0.56	48.6	49.9	1.5			
☒ TP-01 17.0ft.	37.5	11.246	2.248	0.659	60.7	38.1	1.3			
▲ TP-02 8.0ft.	9.5	0.191	0.127	0.082	0.3	93.7	6.1			
★ TP-02 11.0ft.	37.5	10.02	0.741	0.305	51.2	46.6	2.2			
⊙ TP-02 15.0ft.	4.75	0.105			0.0	65.2	34.8

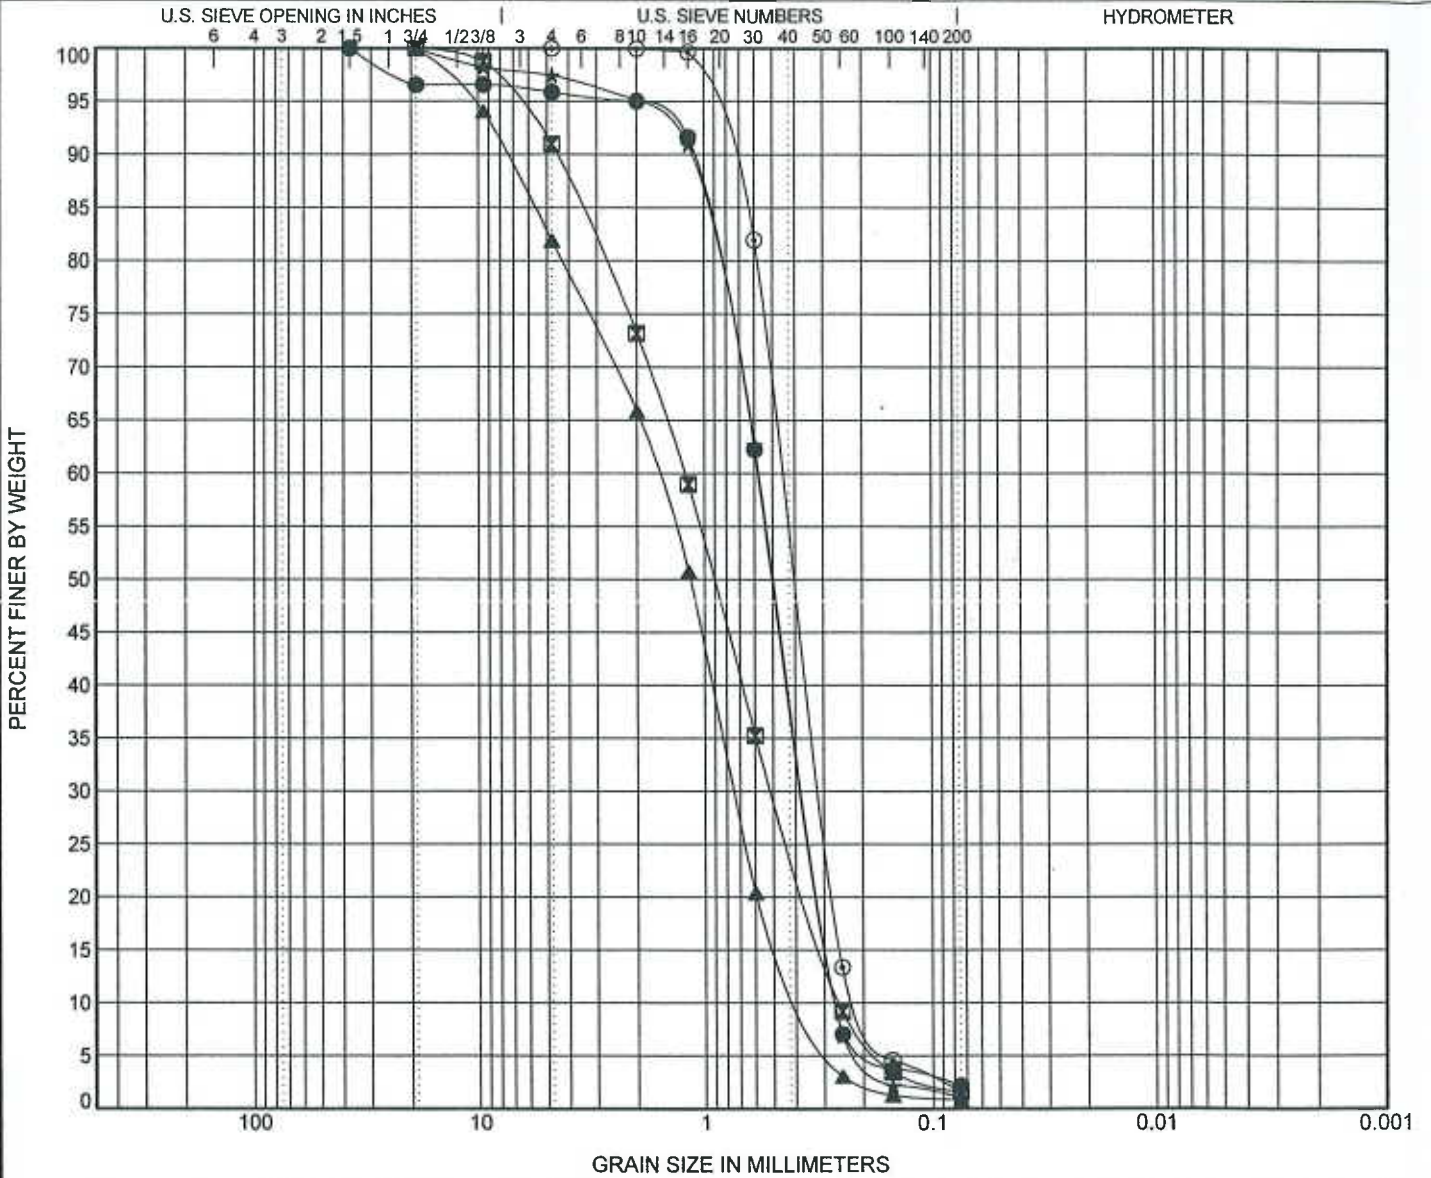
Specimen Identification	Classification					LL	PL	PI	Cc	Cu
● TP-03 3.0ft.	USDA: Light brown sand, USCS: SP								0.85	2.21
☒ TP-04 4.0ft.	USDA: Brown gravelly coarse sand, USCS: SP								0.80	4.77
▲ TP-06 4.0ft.	USDA: Light brown gravelly coarse sand, USCS: SP								0.95	4.59
★ TP-07 4.0ft.	USDA: Brown sand, USCS: SP								0.85	2.19
◎ TP-08 8.0ft.	USDA: Gray sand, USCS: SP								1.03	2.21
Specimen Identification	D100	D60	D30	D10	%Gravel	%Sand	%Silt	%Clay		
● TP-03 3.0ft.	37.5	0.579	0.36	0.262	4.1	93.7	2.2			
☒ TP-04 4.0ft.	19	1.226	0.503	0.257	9.0	89.4	1.6			
▲ TP-06 4.0ft.	19	1.631	0.743	0.355	18.1	81.1	0.8			
★ TP-07 4.0ft.	19	0.575	0.359	0.263	2.6	96.4	1.0			
◎ TP-08 8.0ft.	4.75	0.453	0.309	0.205	0.0	98.4	1.6
